Oak Bay Eelgrass Inventory

Prepared for the District of Oak Bay by:
SeaChange Marine Conservation Society
Leanna Boyer, B.Sc., M.A.
Nikki Wright, B.A.

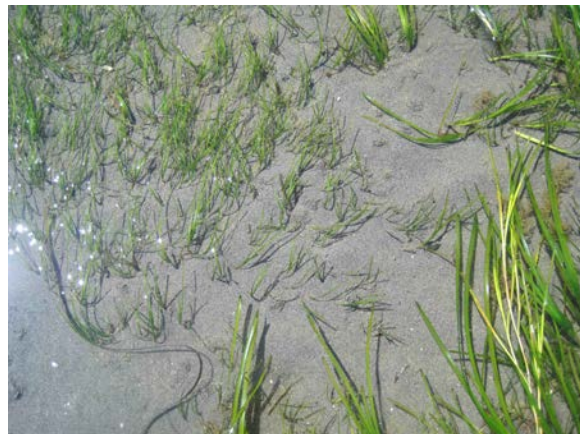
Photo credit: Alison Prentice

Two species of eelgrass occur in British Columbia—the more productive, native species, *Zostera marina*, and the introduced *Zostera japonica*, or Japanese eelgrass (pictured right: the smaller *Z. japonica* mixes with *Z. marina*). Both species are vascular plants that grow in relatively shallow and protected marine areas, but *Z. japonica* typically grows higher in the intertidal zone than *Z. marina*. The two species are not considered competitive for the

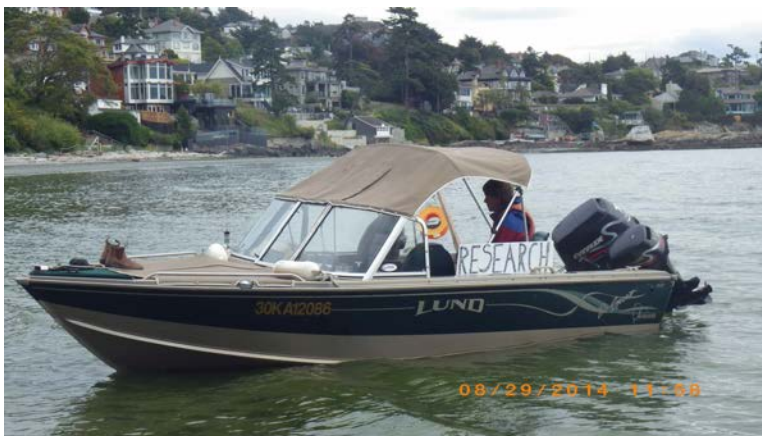
Photo:SeaChange research boat with towed underwater camera

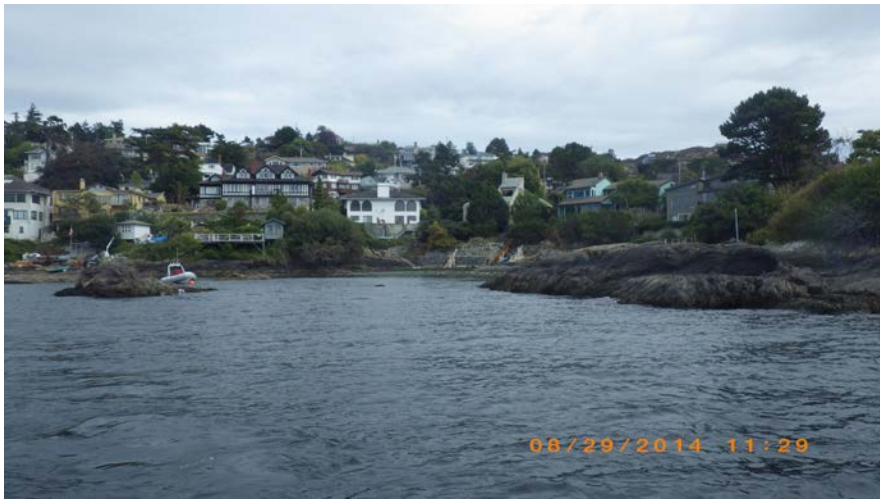
A small portion of Gonzales Beach that is within the Oak Bay municipal border was surveyed on August 29, 2014 (**see Map 2, pg. 25**). Four polygons were mapped in a cove bound by rocky outcroppings on the eastern shore. All polygons were continuous and fringing and had a primary percent cover of 1-25%. The beds were shallow and flanked by rocky outcroppings. The depth range for each polygon is as

follows: Polygon 1 [+0.2m to -3.2m]; Polygon 2 [+0.3m to -0.7m]; Polygon 3 [-0.8m to -2.1m]; Polygon 4 [-0.6m to -4.0m]. There is a mooring buoy placed in Polygon 2.

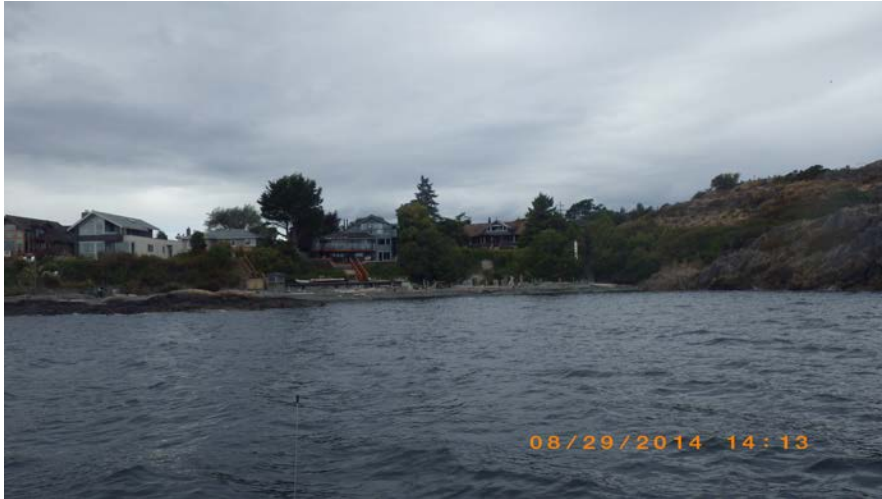
The eelgrass bed located in the cove adjacent to (West) Trafalgar Park was surveyed on August 29, 2014. This bed was continuous and flat with a primary percent cover of 26-75%, with the exception of a small patchy area on the East side of the cove. The minimum depth of the bed was -1.2m and therefore did not extend into the intertidal zone. The maximum depth was between -6.5m and -7.8m, an indication of good water quality.

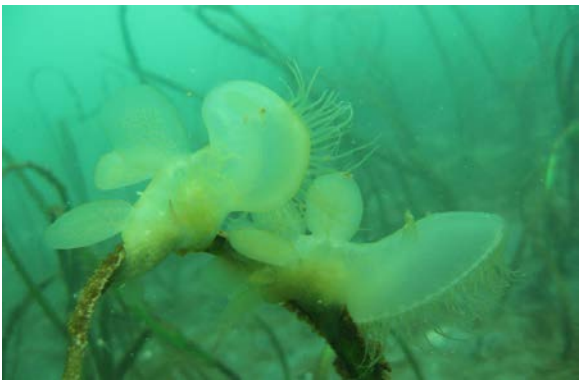
Photo credit: Sharon Jeffery

A large school of forage fish (small fish upon which other marine life depend) was observed along with yellow egg masses deposited by the hooded nudibranch (pictured on the left).

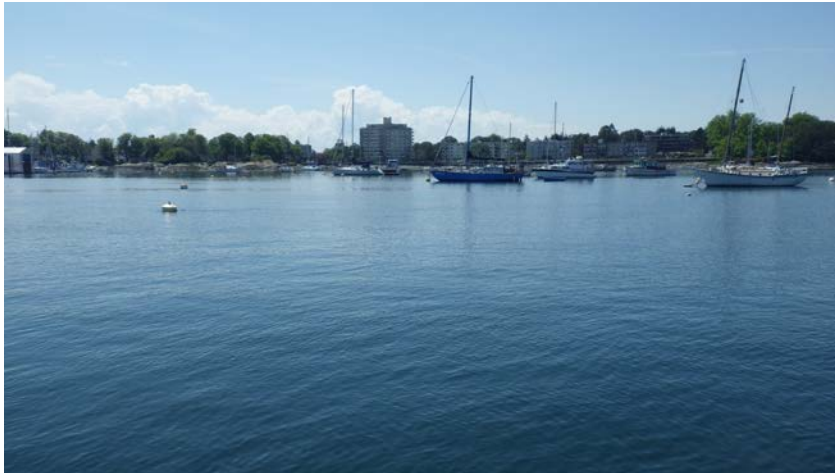
The eelgrass bed between the Oak Bay Marina and Mary Tod Island was surveyed on May 18th and 19th, 2015 (see **Map 3, pg. 26**). The continuous portion of the bed had a primary percent cover of 1-25% and a secondary cover of 26-75%. The patchy portions had 1-25% cover. The substrate was mud or a mud/sand combination, typical of estuarine habitat at the foot of a stream, in this case Bowker Creek.

The average maximum depth of eelgrass facing the marina was -6.0m. The average minimum depth of eelgrass facing Bowker Creek was -1.9m. The eelgrass bed facing Mary Tod Island extended into the intertidal zone and terminated where algae species grew on rocky substrate.

The patchy portions flanking the bed, facing Mary Tod and Bowker Creek, had a significant amount of mixing with bottom kelp (most likely *Laminaria spp.*). Although only the mud/sand substrate was visible, the kelp would have been attached cobble or rock. The patchy part of the bed facing the marina was intermingled with moored boats.

Map 3, Inset 1 illustrates a circled area where eelgrass restoration could be considered. As described in the inventory observations, the substrate at this location was mud/sand, suitable substrate for eelgrass, yet it ceased to grow between -2.5m and -4.8m. However, it is not recommended that restoration be initiated where there is unrestricted boat moorage or active dredging.

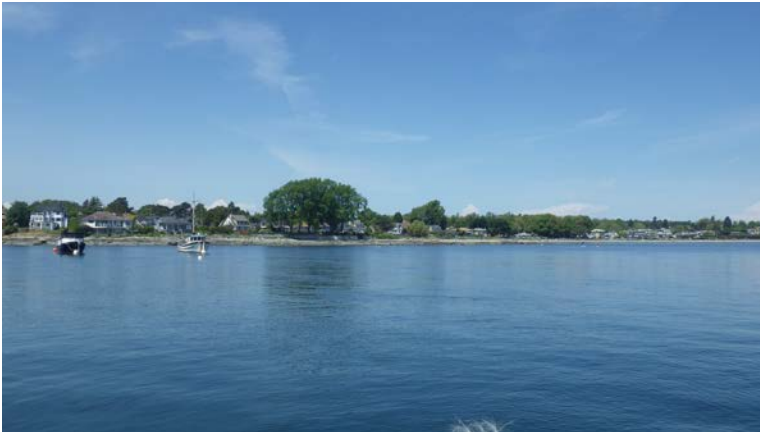
Photo shows the area between Mary Tod Island and Oak Bay proper

Eelgrass growing on the North and East side of Mary Tod Island was surveyed on May 19th and July 3rd. It extended East to Emily Islet and North towards Willows Beach. The continuous portion of the bed had a primary percent cover of 1-25% and a secondary cover of 26-75% and a sandy substrate. Eelgrass mixed with bottom kelp throughout most of the bed. The circled area in **Map 3, Inset 1** shows where bed terminated despite the continuance of suitable substrate (sand/mud) and depth (-2.5 to -4.8m) for eelgrass growth. The maximum depth of the Eastern edge of the bed ranged from -5.5m to -7.6m.
