# **Saanich Inlet and Peninsula Atlas of Shorelines 2020**

## **Technical Report**

**Report by  
SeaChange Marine Conservation Society  
For the Public and  
Districts of North and Central Saanich and the Town of Sidney  
August 2020**

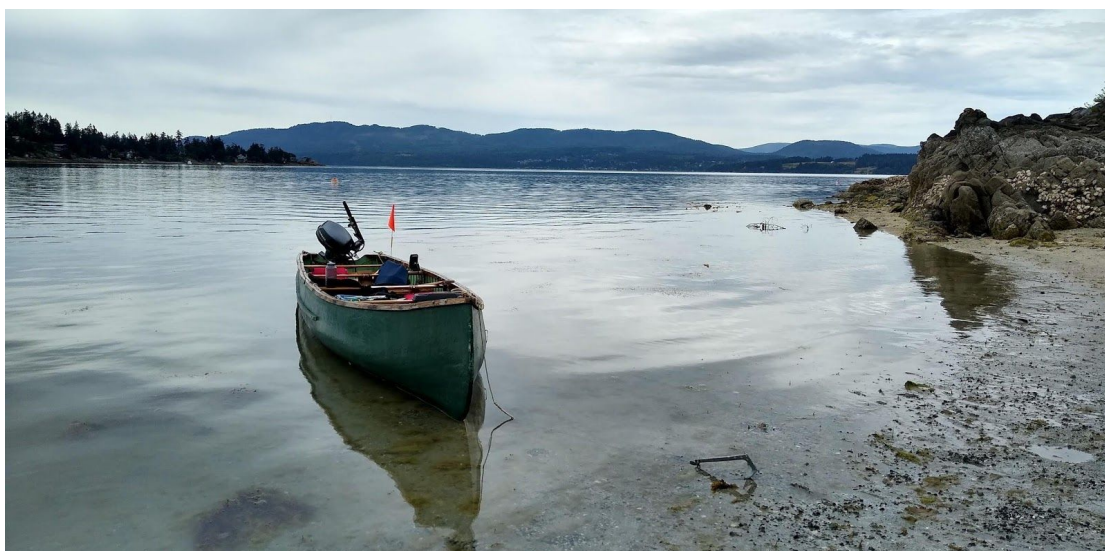
*Surveying Deep Cove by boat.*

Nearshore surveying was completed by two SeaChange technicians from June to August 2020. A 20ft wooden freight canoe outfitted with a small motor was used to assess shore attributes, as much of the shoreline is inaccessible by foot. Waypoints and observations were taken from as close to shore as possible. Pocket beach details and forage fish sampling were completed on foot, accessing the shore by boat.

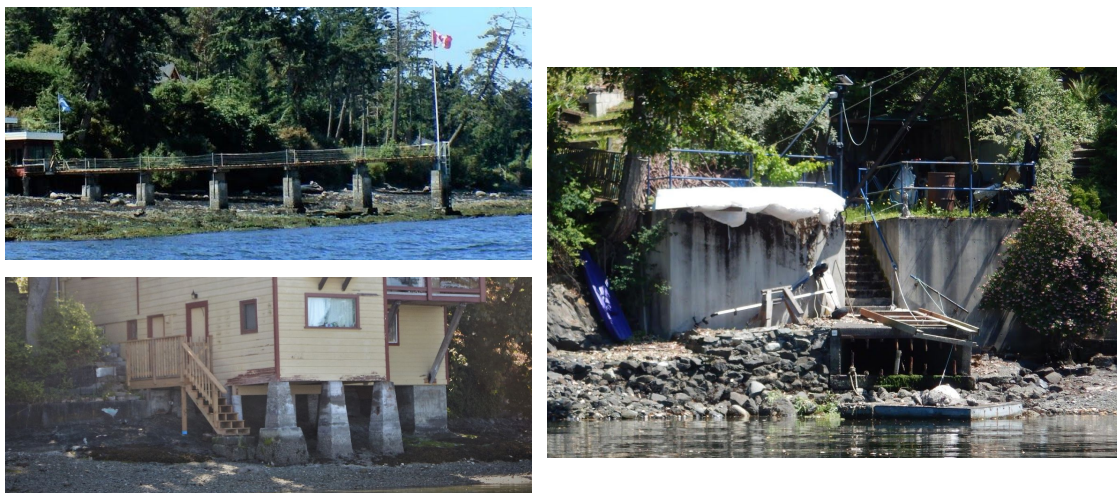
*Development in the intertidal zone.*

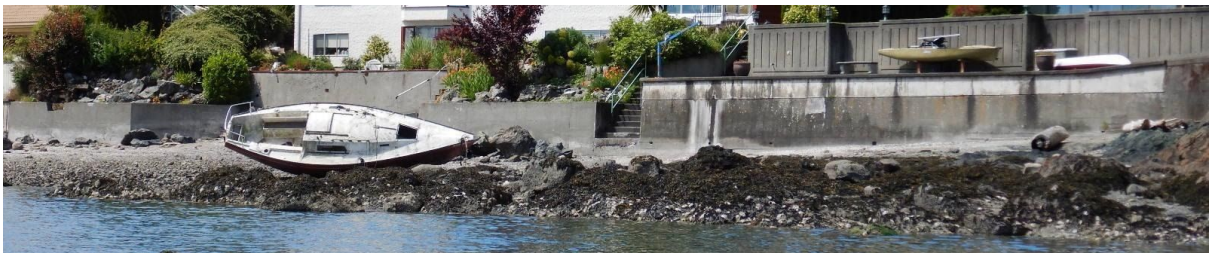
- Seawalls covered 5.4 km (39%) of the survey area
- 60% of units contains at least 1 seawall
- It is notable that Roberts Bay in Sidney had the highest percentage of seawall coverage of the survey areas with 73% modified.
- The average base elevation of seawalls compared to the HWM in the study area was 0m. The average top elevation was 2 meters.
- 50% of seawalls appear to be in moderate condition, 27% in poor condition and 23% in good condition.

*Extensive sea walls along the Peninsula shoreline*

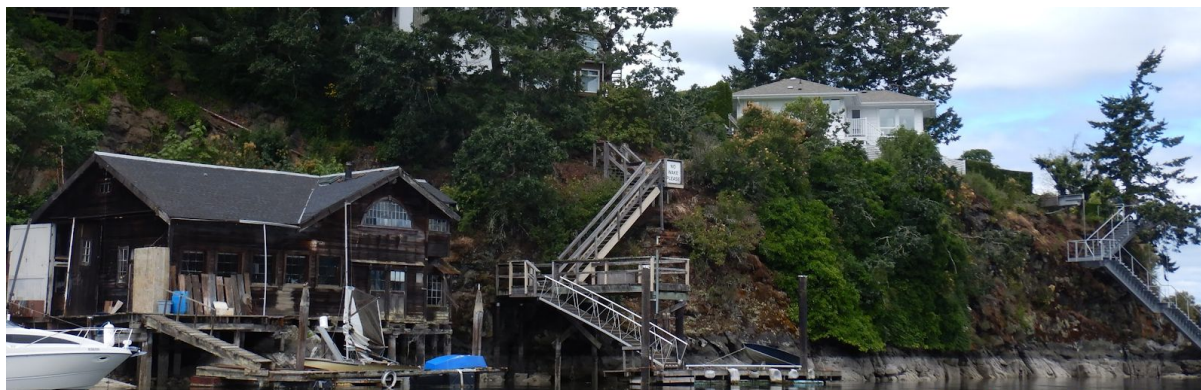
Of the 65 new structures observed, 46 (70%) of these were found in North Saanich. New visible structures in this area include houses, docks/floats, stairs, decks, wharves, boathouses and sheds.

*Other man-made structures and new visible structures in the nearshore*

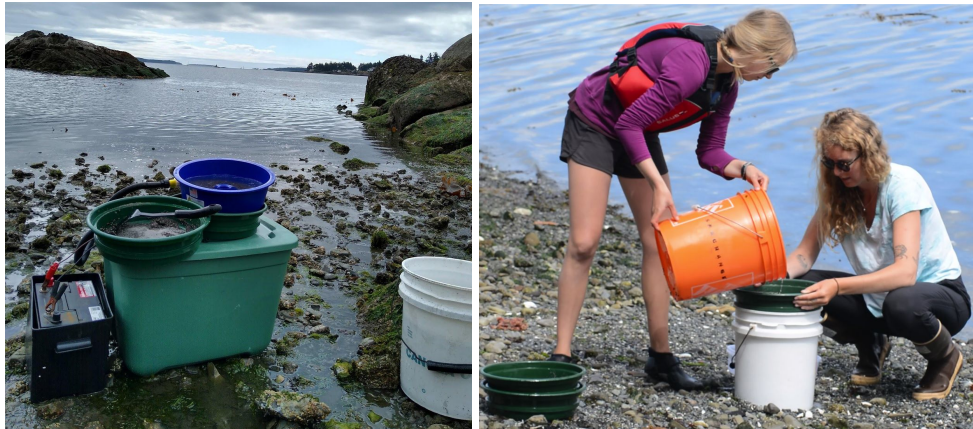
*Forage fish beach seining field set-up*

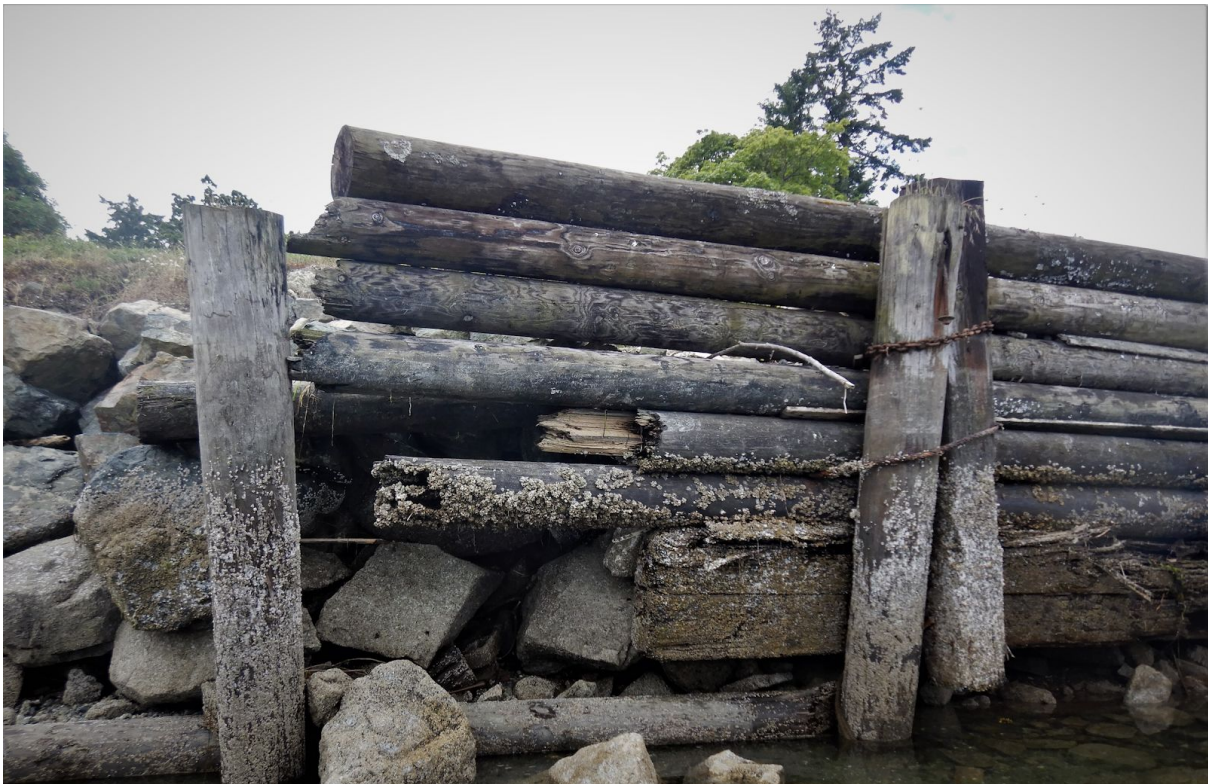
*Example of a creosote-treated log polluting feature and a sea wall in poor condition.*

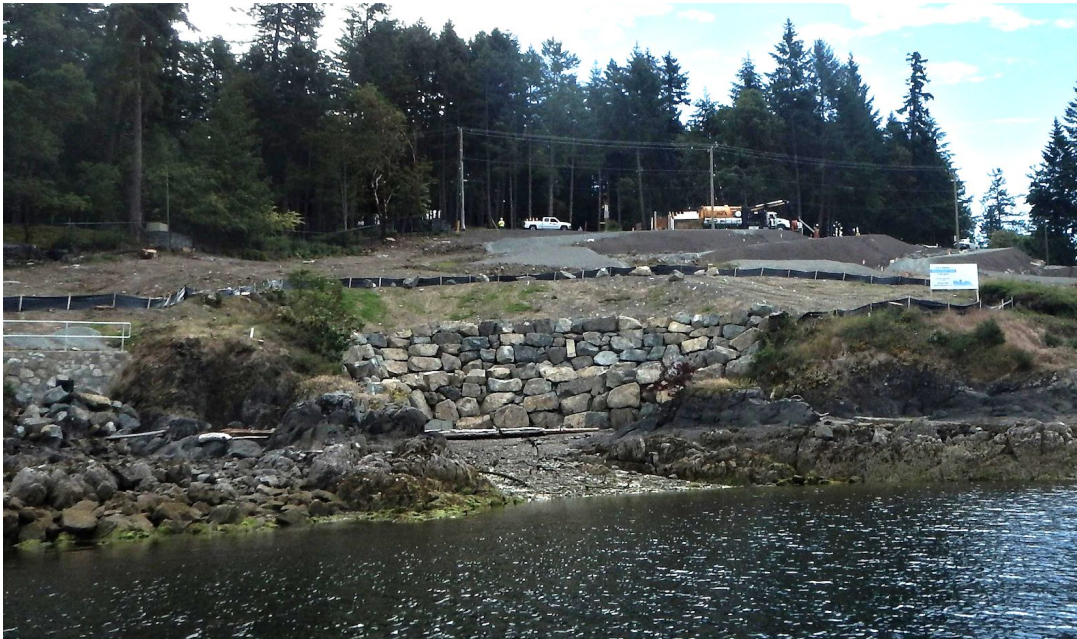
A property on Lands End Road has been clear cut, with scarce vegetation remaining on site. The lot is to be divided into 4 simple fee lots. Below the clear cut are two pocket beaches, which had potential for forage fish spawning. The addition of an 8m tall seawall at one of the beaches has altered the habitat suitability (see photo below). Without overhanging riparian vegetation to provide bank stabilization and shade, this shore unit will lose significant ecological value.

*Newly clear cut site on Lands End Road*
