Resilient Estuaries of the Salish Sea

Taking Action:
Restoration, Conservation, and Education

**Year 1 Summary Report
2023-2024**

SEACHANGE
MARINE CONSERVATION SOCIETY

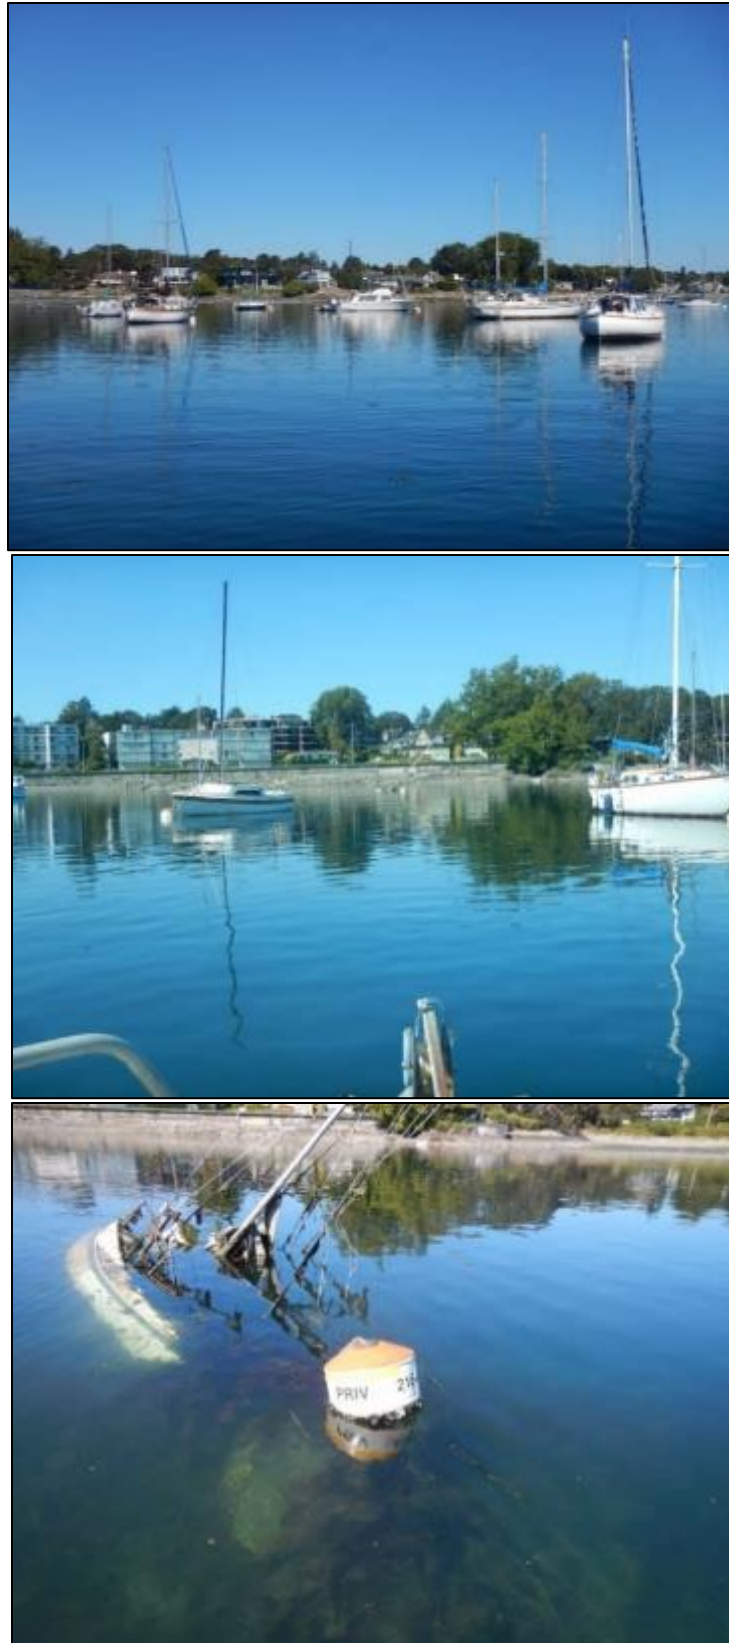
Figure 3. Oak Bay shoreline and transient anchored boats as well as derelict vessels. Photos by S. Anthony.

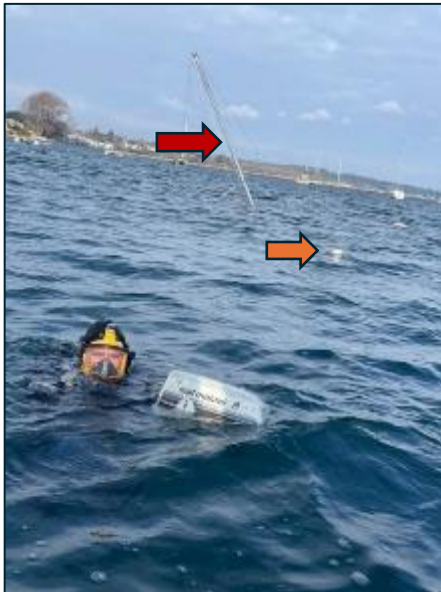
Figure 5. Oak Bay Debris Removal Event (Jan/Feb). Diver Joshua Prael with a motorboat engine cover in foreground, a marker buoy attached to debris or a basket filled with debris (orange arrow), and mast of a sunken vessel (red arrow). We were not able to remove this sunken vessel. Photo from J. Lisaingo.

Divers collected items in baskets tied to buoys (or buoys directly tied to the debris item, if large). The *Collective Effort* crane barge lifted the items from the seafloor, and an excavator moved the debris from to a dumpster that was placed at Cattle Point. A bin removal company took the debris to the Hartland Landfill for proper recycling or disposal, as appropriate (Figure 5-10). **2.4 tonnes of debris was removed** during this cleanup. The debris included sails, masts, rope, ghost gear (crab traps), clothing, and appliances. Due to the volume of material, we only covered about 30% of the area we wanted, and therefore planned to return to collect more at another time.

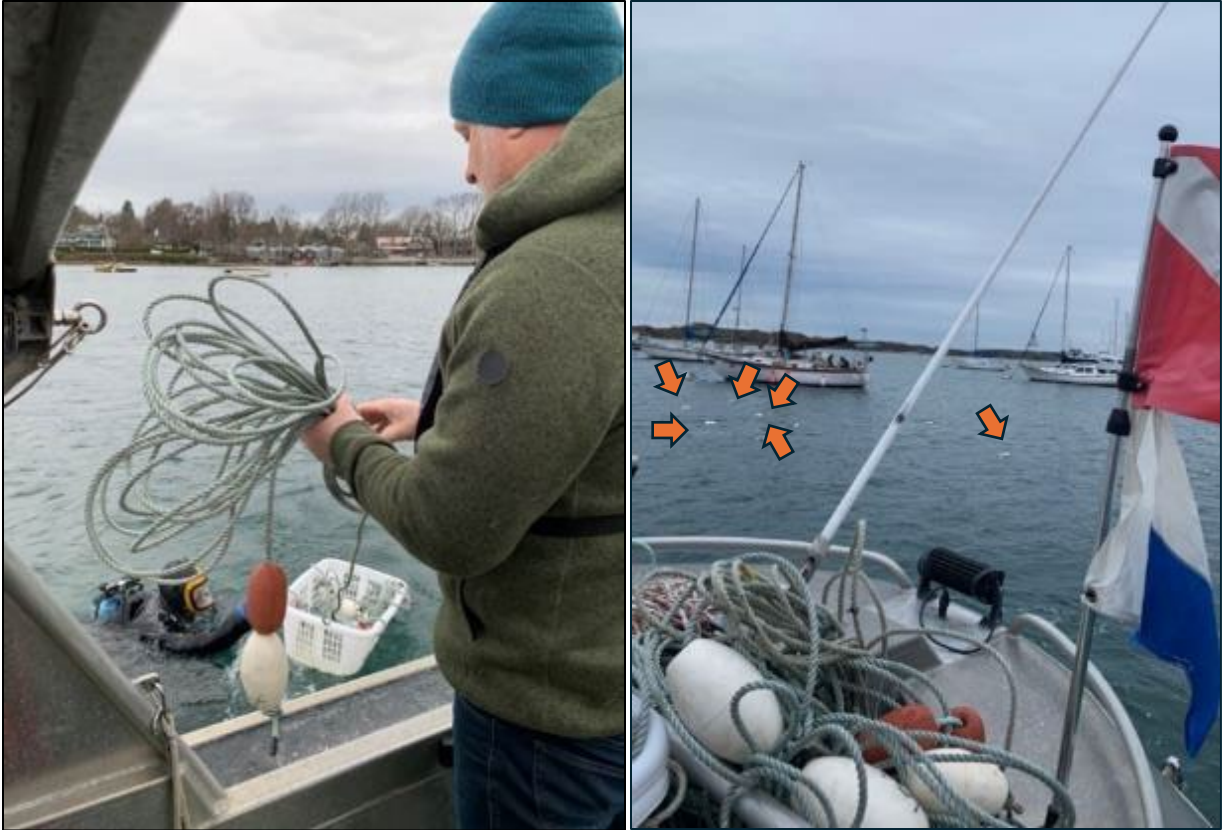
Figure 6. Oak Bay Debris Removal Event (Jan/Feb): Debris removal process, taken from the deck of the *Klanawa*. Left: Justin Bland (diver) brings a basket attached to a float down to the seafloor to fill with debris; Jamie Smith (on the boat) is in communication with the diver, and if more baskets or floats are required, he sends them down. Right: the marker buoys (orange arrows) are left behind when the divers come out of the water; later the crew returns on the *Collective Effort* and lifts the items and baskets on deck, sorts them into super sacks, and brings it to the trash bin of shore. Photos from S. Anthony.

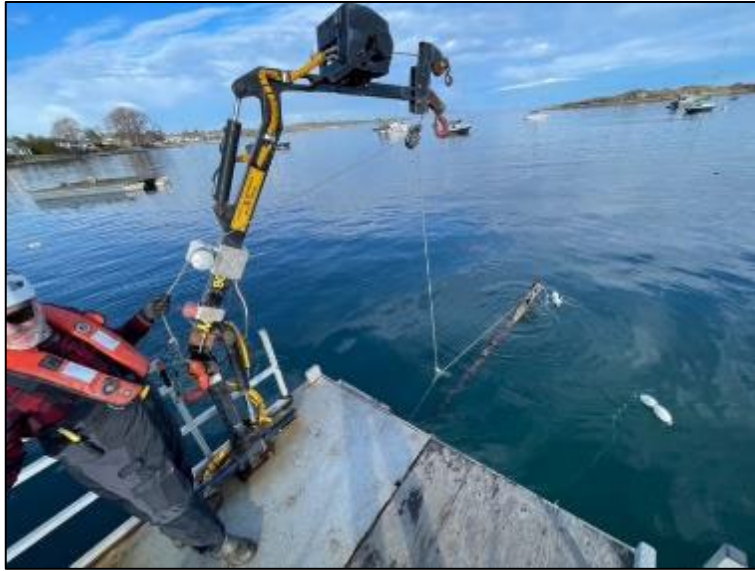
Figure 7. Oak Bay Debris Removal Event (Jan/Feb). Two examples of the many sailboat masts collected from the seafloor. Photos by J. Lisaingo.

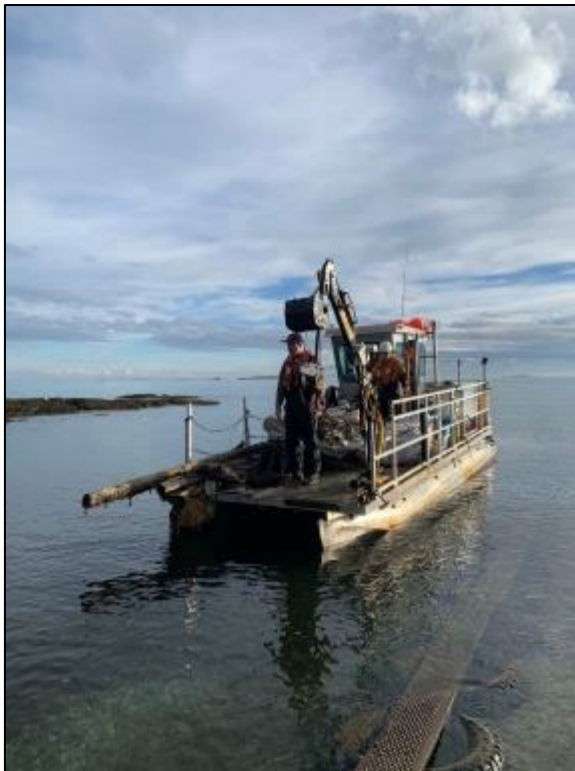
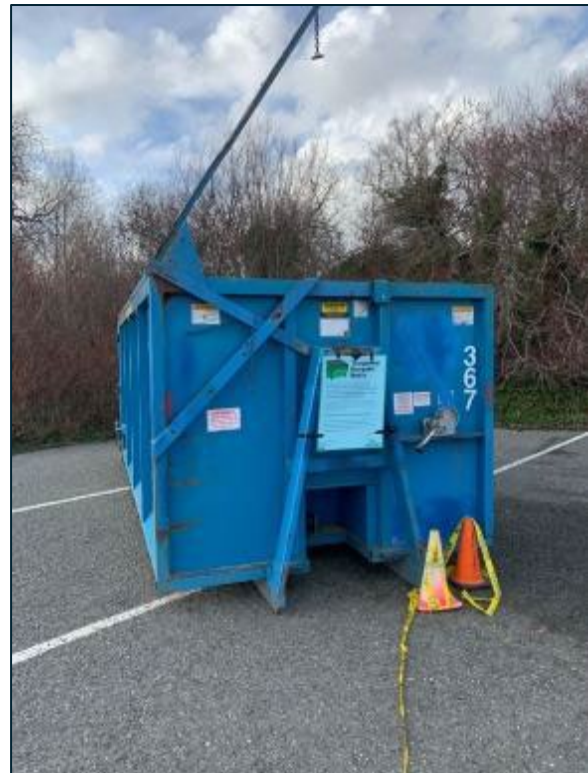
Figure 8. Oak Bay Debris Removal Event (Jan/Feb): Left: the *Collective Effort* coming to shore at the Cattle Point boat ramp, Right: the trash bin with informational signage at Cattle Point. Photos by S. Anthony.

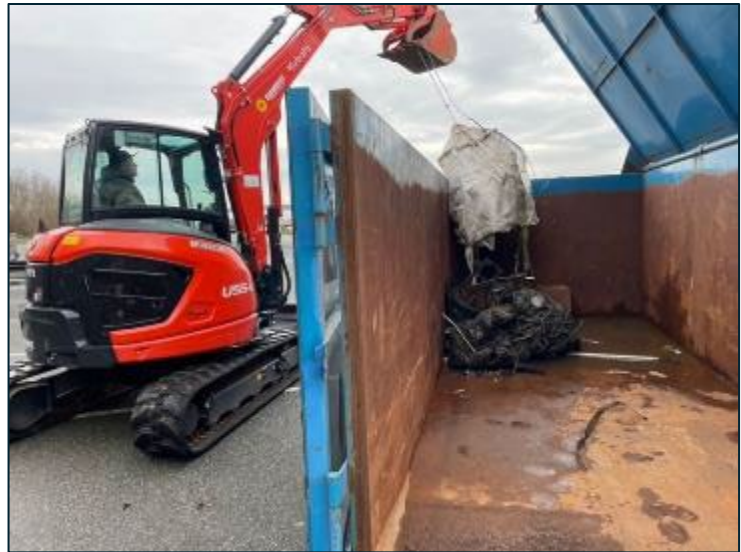
Figure 9. Oak Bay Debris Removal Event (Jan/Feb). Left: Aboard the vessel *Collective Effort*, Viki Kolatkova (left) and Jamie Smith (right) moving hoisted debris into the super sacks. Right: dumping the debris from the sacks into a trash bin on land, transferred from the *Collective Effort* with an excavator. Photos from J. Lisaingo.

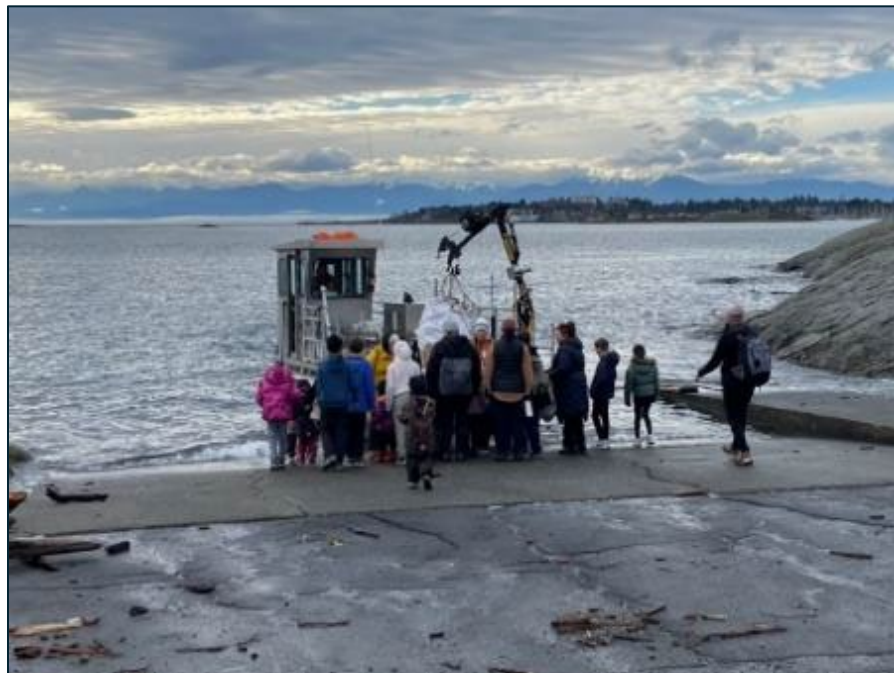
Figure 10. Oak Bay Debris Removal Event (Jan/Feb). The *Collective Effort* bringing the trash bags on shore at Cattle Point boat ramp, where the trash bin and excavator were parked. Viki Kolatkova and Jamie Smith spoke to visiting families, sharing their knowledge and experience of debris removal, educating them about the problem with ocean trash. Photo by J. Lisaingo.

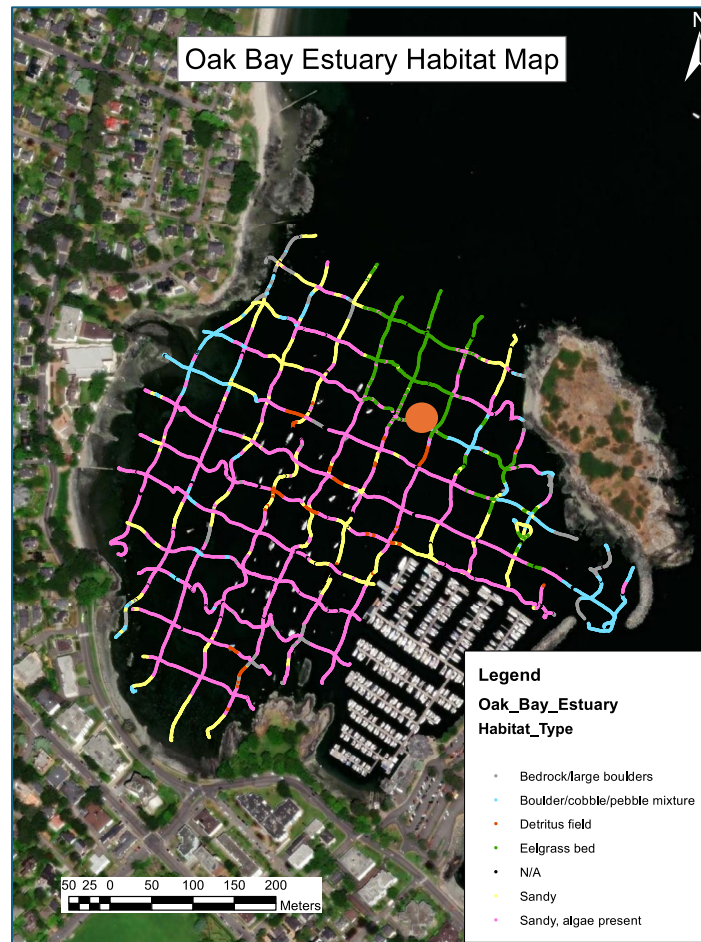
Figure 11. Oak Bay Habitat Map with an orange dot in the location of the sunken vessel in the eelgrass bed.

Location: Oak Bay, Bowker Creek Estuary (South and East); cleaning up more of the transient mooring area and removing debris left behind from the sailboat raised from the eelgrass bed (Figure 11).

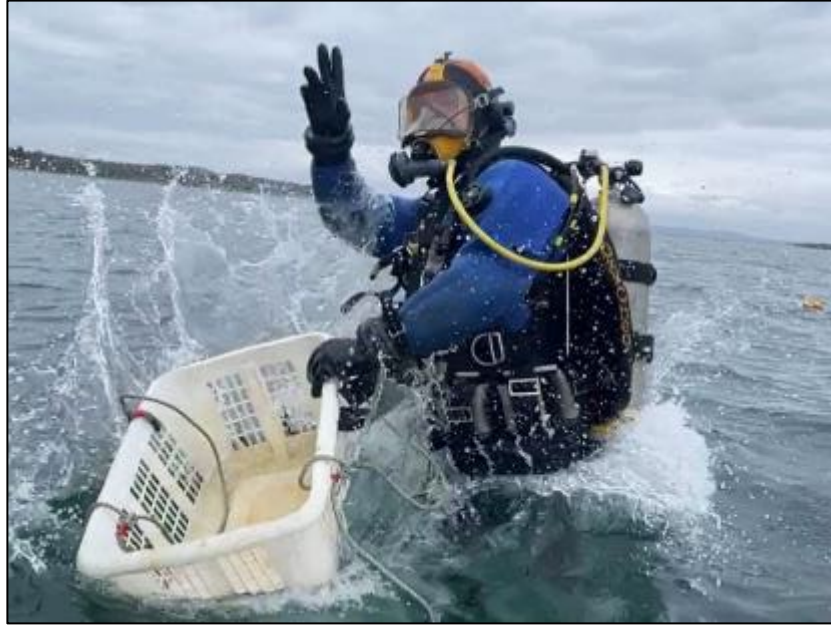
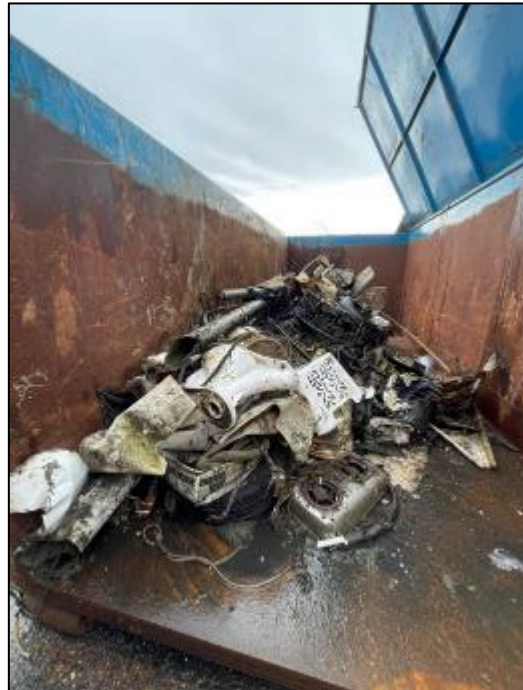
Figure 12. Oak Bay Debris Removal Event (Mar). Top: Diver Landon Maybaum dropping into the water with basket. Bottom-left: debris from the seafloor in Oak Bay on the deck of the *Collective Effort*. Bottom-right: debris in the trash bin at Cattle Point. Photos by J. Smith.

Divers collected items in baskets tied to buoys (or buoys directly tied to the debris item, if large). The *Collective Effort* crane lifted the items from the seafloor, and excavator moved the debris from the *CE* to a dumpster, and a bin removal company took the debris to Hartland Landfill (Figures 12 and 13). **1.51 tonnes of debris** were removed during this event. The debris was made up of materials left behind by the raised boat, crab traps, plastic toys, and cans and bottles. The area left bare by the raised derelict sailboat and the debris cleanup and is an ideal candidate for an eelgrass transplant. Follow-up will include community education on the issue of debris in the estuary, which will be part of some “dock talks” at the Oak Bay Marina that are in the planning stage for summer 2024.

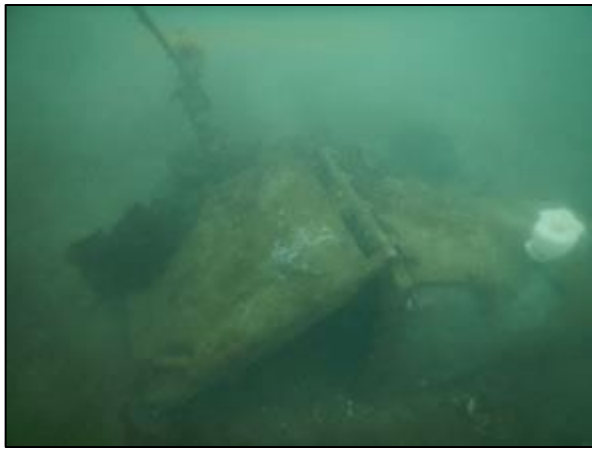
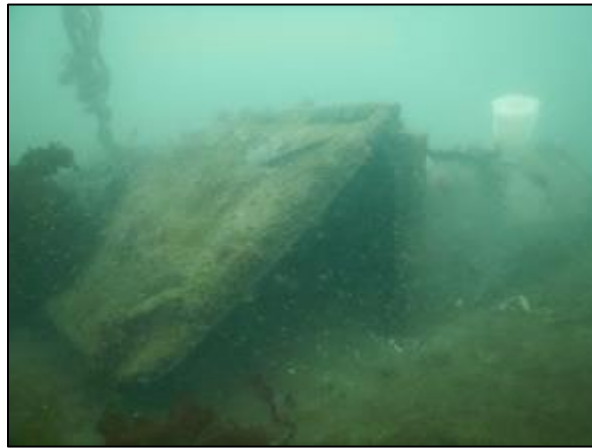
Figure 13. Oak Bay Debris Removal Event (Mar): assorted underwater photos of debris. Photos from divers V. Kolatkova and L. Maybaum.

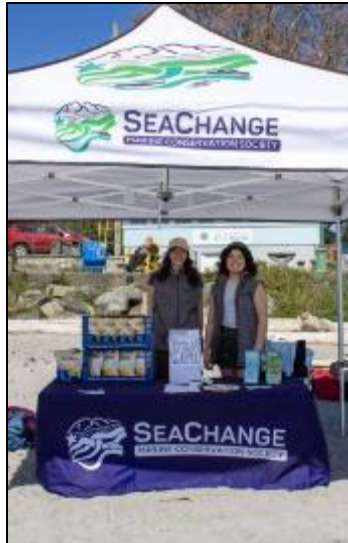
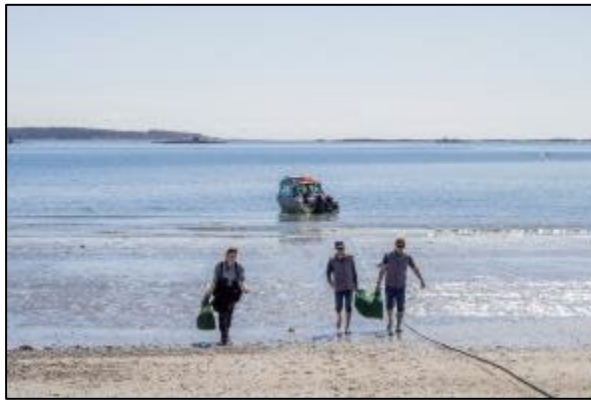
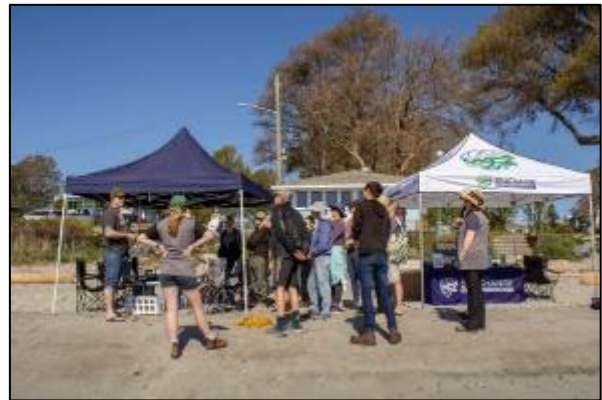
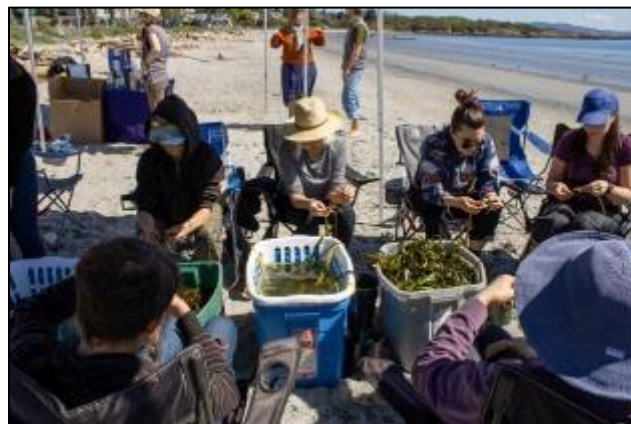
Figure 15. Oak Bay Eelgrass Transplant Event Staging Area at Willows Beach. Top: table with information on SeaChange and RESS; Middle-left: Divers (l-r) Viki Kolatkova, Justin Bland, and Jamie Smith bringing bags of eelgrass from the donor site to the beach for volunteers to bind for transplant; Middle-right: Jamie Smith (l) leading the volunteer orientation and giving eelgrass shoot binding instructions to the volunteers; Bottom: volunteers binding eelgrass shoots to washers and twine for transplant.

Divers collected 1,000 shoots from the donor site and kept them submerged in seawater until they were attached to washers and bound together by 15 volunteers and then stored in seawater until the dive team could plant them in their new site (Figures 15-17). The divers took video of the site before the transplant (<https://youtu.be/h84Plmg7loc>) and after the transplant (<https://youtu.be/xtrfsJ-1eyyl>). The transplant covered 66 m² and the density of the plantings was ~15 shoots/m². The monitoring plan for this area is outlined in Section 3.

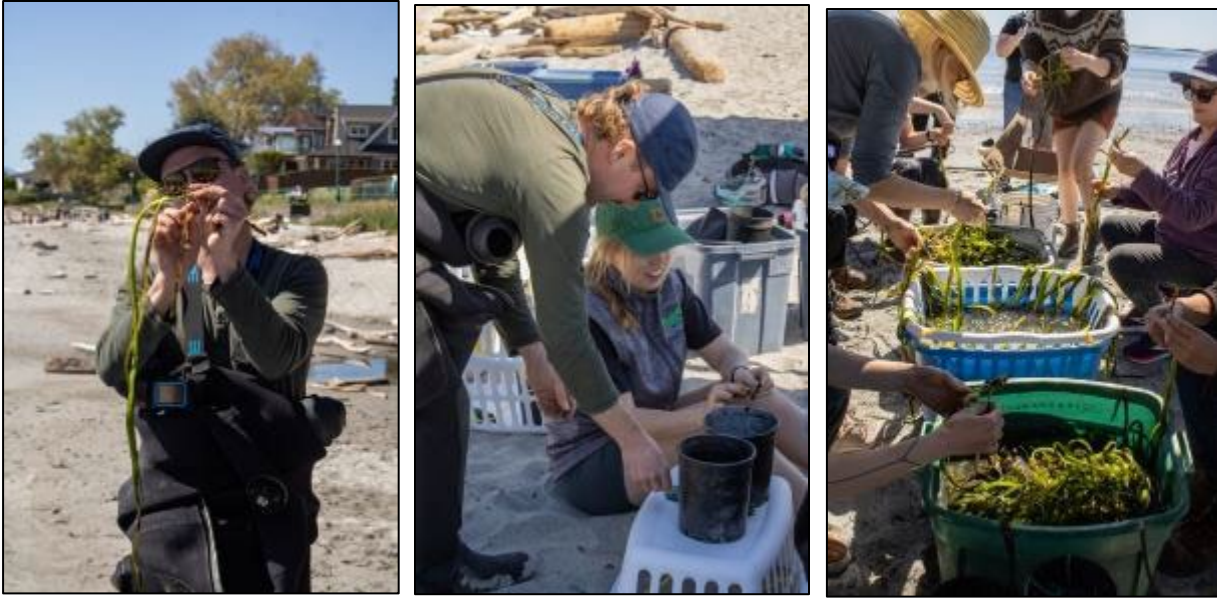
Figure 16. Oak Bay Eelgrass Transplant. Left and middle: Justin Bland instructing volunteers on proper eelgrass shoot binding technique; Right: volunteers binding eelgrass shoots.

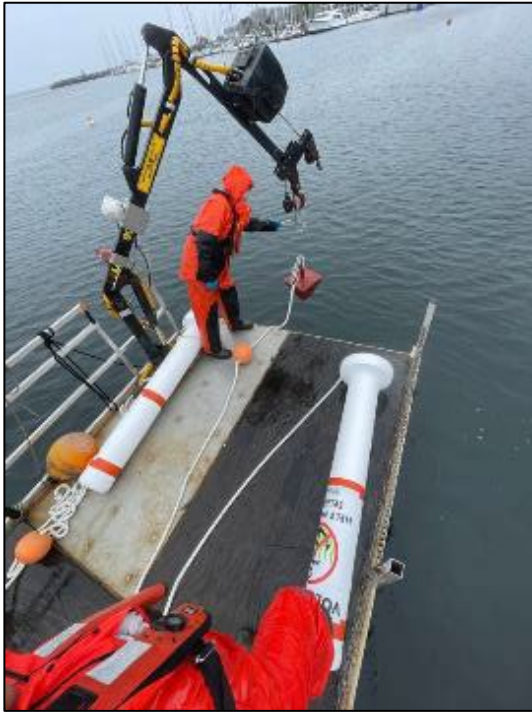
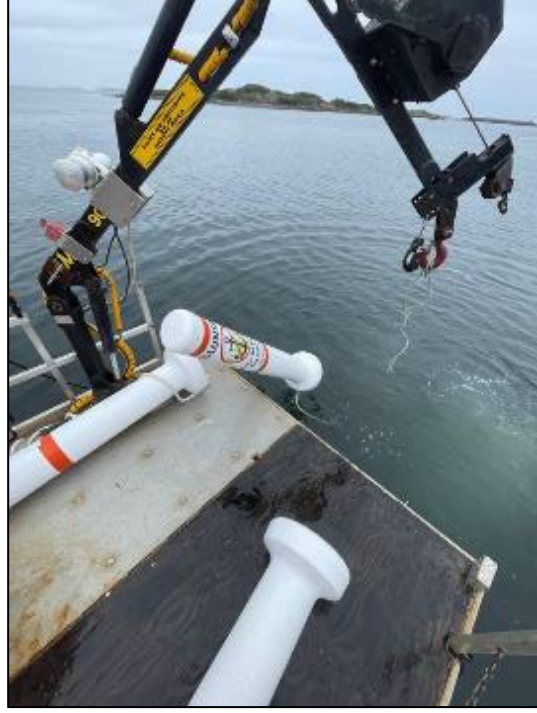
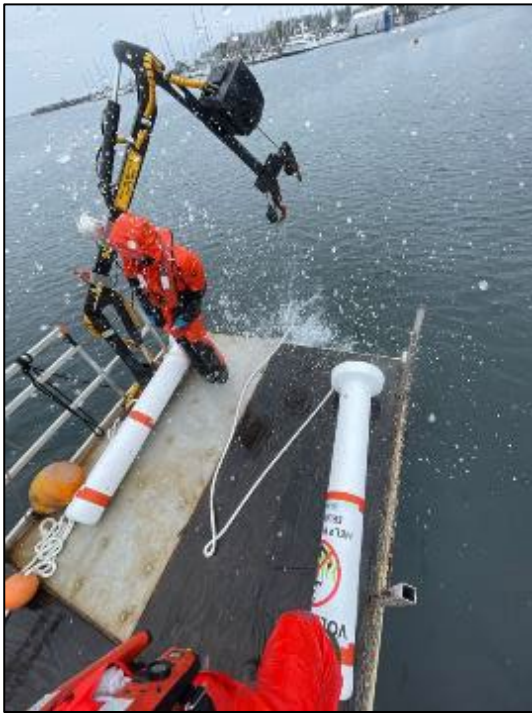
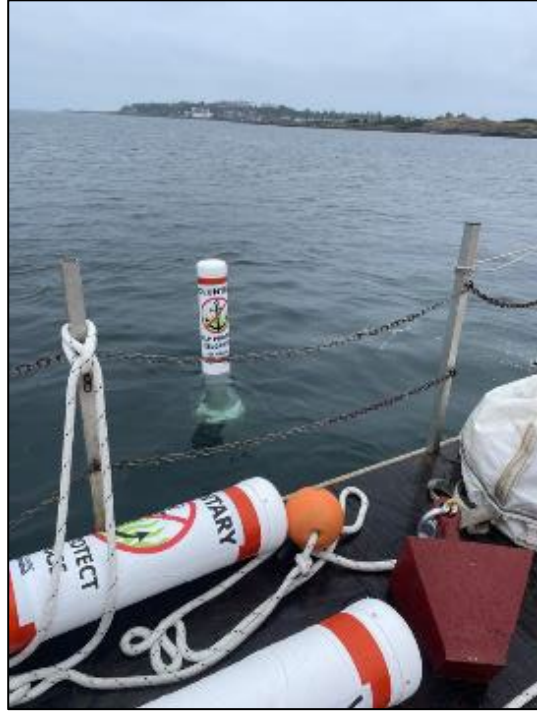
Figure 19. Deployment of the “Voluntary No Anchor Zone” buoys. A crane on board the *Collective Effort* drops the anchor block into the sea. The buoy is attached to the mooring block with a mid-line buoy system, which keeps the line from scouring the seafloor. Photos by J. Smith.

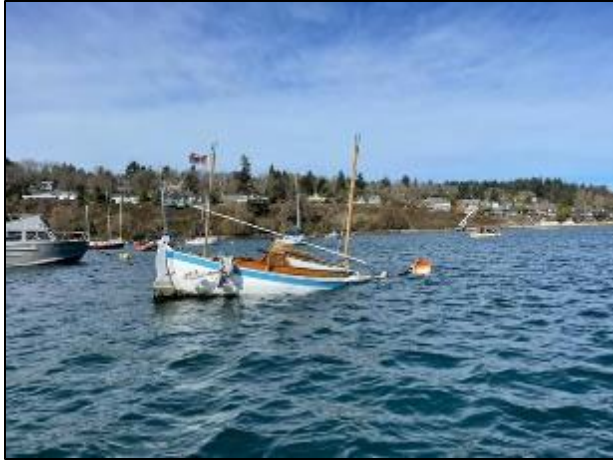
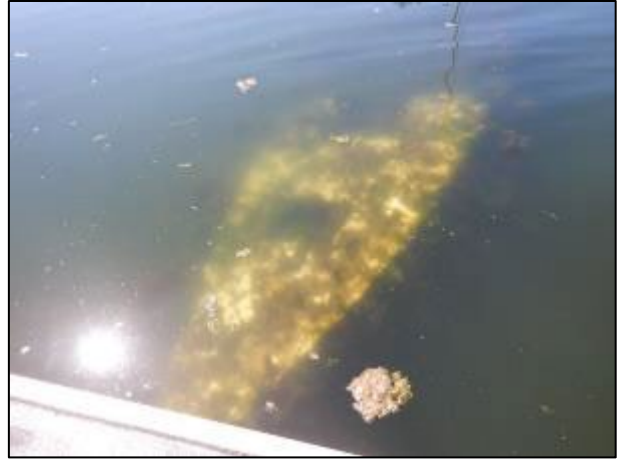
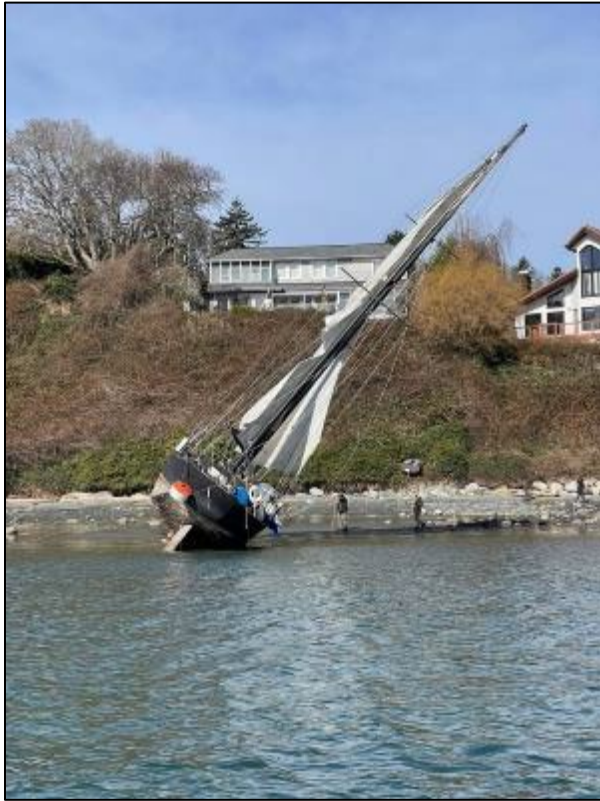
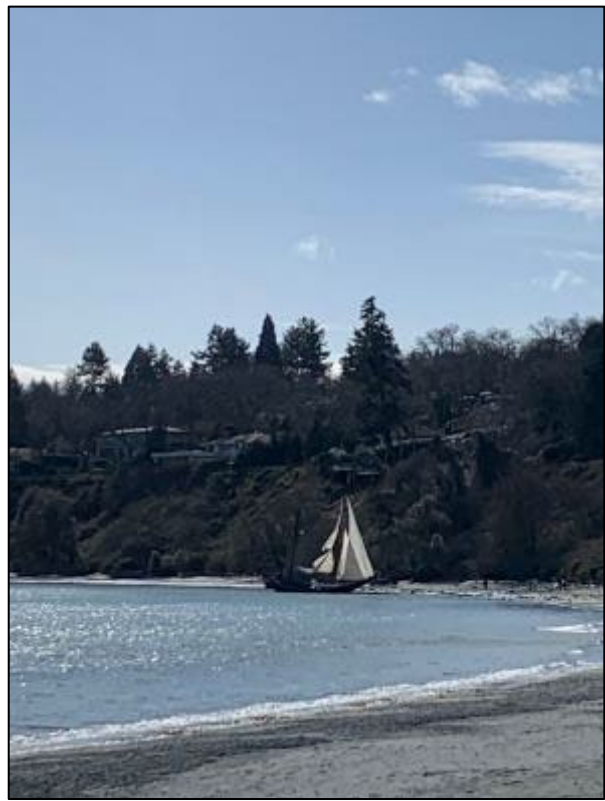
Figure 23. Examples of Cadboro Bay abandoned and derelict vessels. Top-left: A half-submerged sailboat still attached to a mooring. Top-right: Submerged and alga-covered abandoned vessel which we almost hit with the vessel *Klanawa*. Bottom-left and right: sailboat washed up on shore, later removed by the owner with the assistance of the Cadboro Bay Dead Boats Society. Photos: S. Anthony (top) and Eric Dahli (bottom).

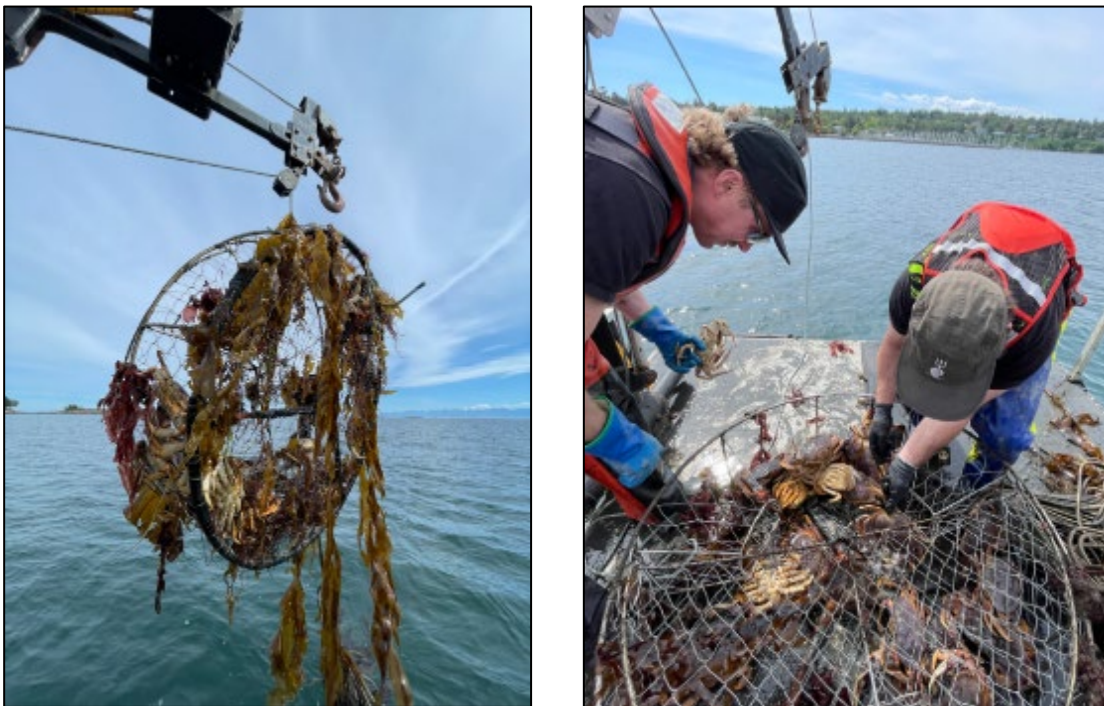
Figure 25. Cadboro Bay ghost gear removal. Left: Abandoned crab trap with live crabs trapped inside. Right: Justin Bland and Joshua Prahl removing live crabs trapped in an abandoned crab trap.

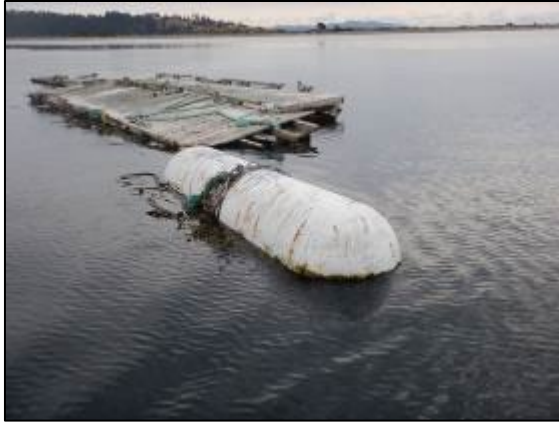
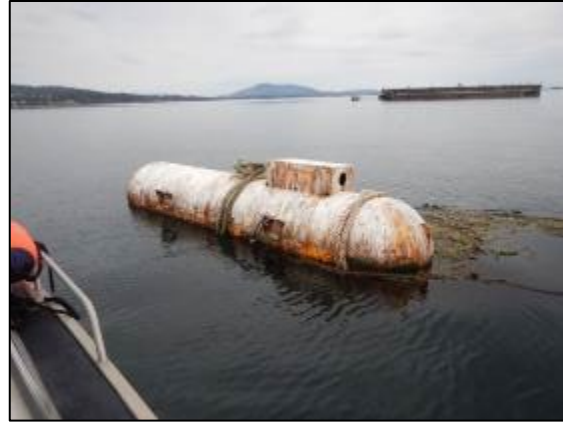
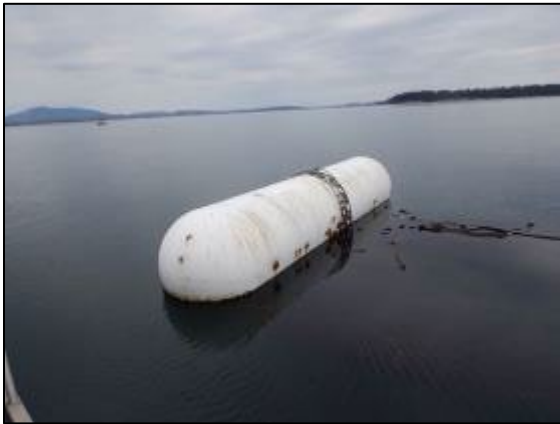
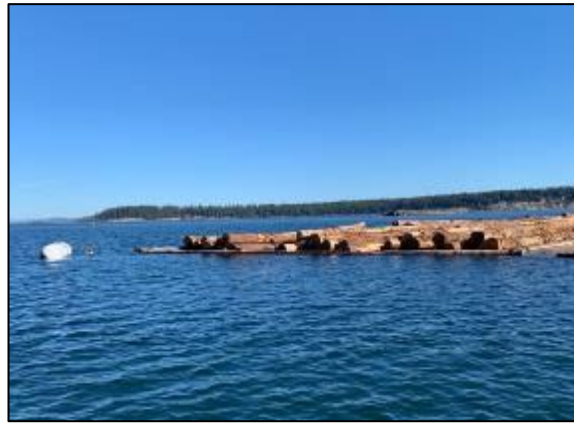
Figure 30. Large mooring buoys in Saanichton Bay. Top-left: small, dilapidated barge (with dead baby seal on it) attached to a water or gas-tank mooring “buoy”. Top-right: Mooring “buoy” in the foreground, large, moored barge in background. Bottom-left: another mooring “buoy”. Bottom-right: a log boom that was temporarily moored in the bay near the centre of the bay, towards the southeastern side. Photos from S. Anthony.

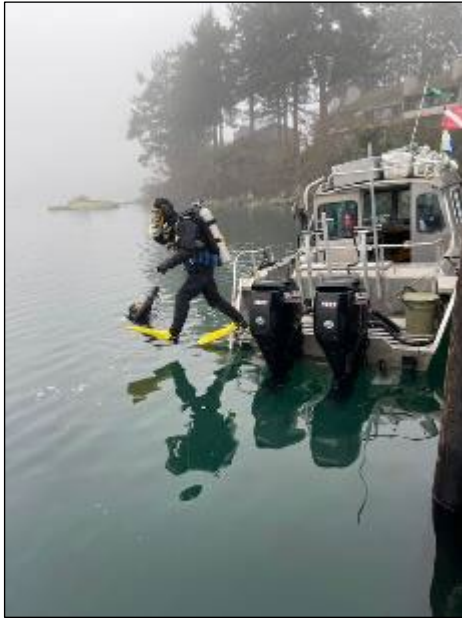
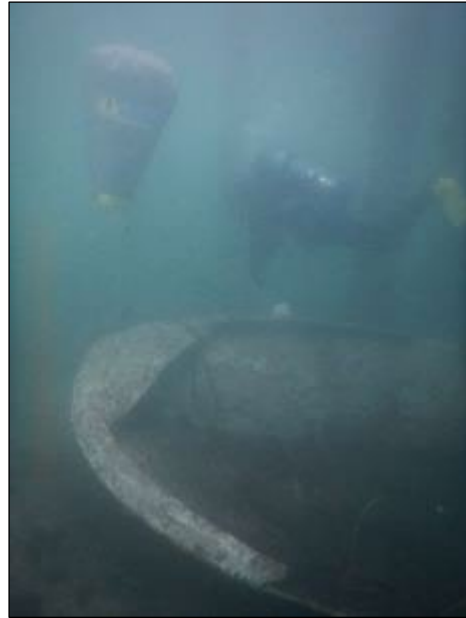
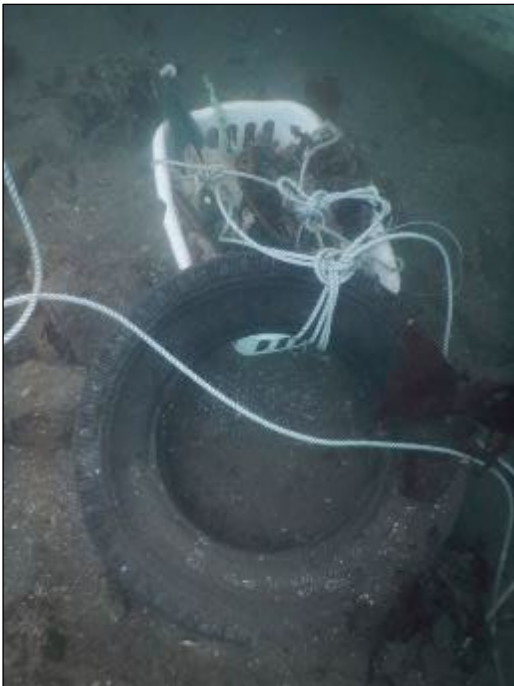
Figure 32. Saanichton Bay debris removal. Top-left: Joshua Prah and Viki Kolatkova in the water, diving from the *Klanawa*, moored at James Island Wharf. Top-right: lift bags used to move a dinghy from the seafloor. Bottom-left and bottom-right: baskets filled with debris and lines attached directly to debris (a tire and abandoned crab trap). Photos: S. Malcolm (top-left) and V. Kolatkova (underwater).

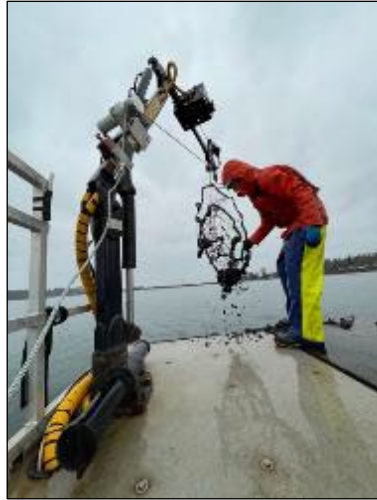
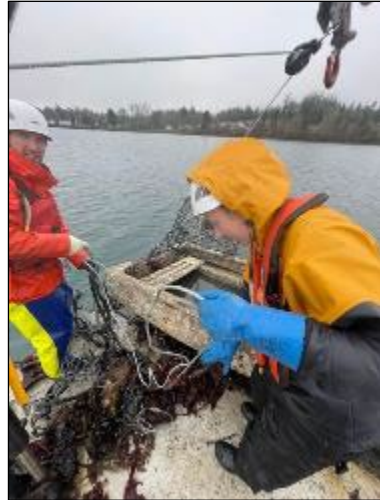
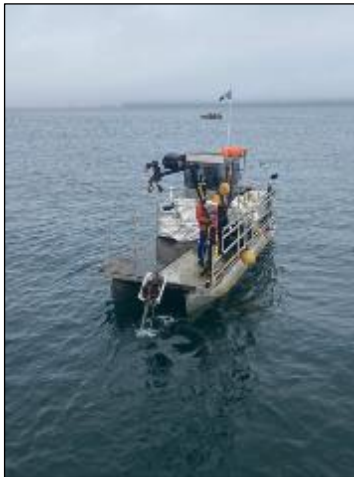
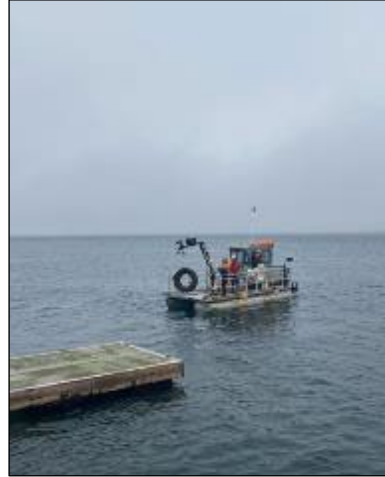
Figure 33. Saanichton Bay debris removal. Top: Joshua Prah and Viki Kolatkova pulling items onto the *Collective Effort*. Middle: Pulling debris from baskets and a tire onto the *Collective Effort* (crew: Jamie Smith, Viki Kolatkova, Joshua Prah). Photos: J. Smith, J. Lisaingo, S. Anthony, S. Malcolm.

Divers collected items in baskets tied to buoys (or buoys directly tied to the debris item, if large). The *Collective Effort* crane lifted the items from the seafloor, and a crane truck removed the super bags of debris and brought them to Hartland Landfill (Figures 12 and 13). Approximately 0.5 tonnes of debris was collected and disposed of. The debris included a dinghy, truck tire, and lots of crab traps; a large boat had to be left behind because it was too large and heavy for our team to remove (Figures 32 and 33; short videos: <https://youtube.com/shorts/Uip9okuiftE>; <https://youtube.com/shorts/cHlxZuGjSLM>). There are no immediate plans for further actions in the Bay or follow-up monitoring while we wait for direction from the S7ÁUTW_Fisheries department.

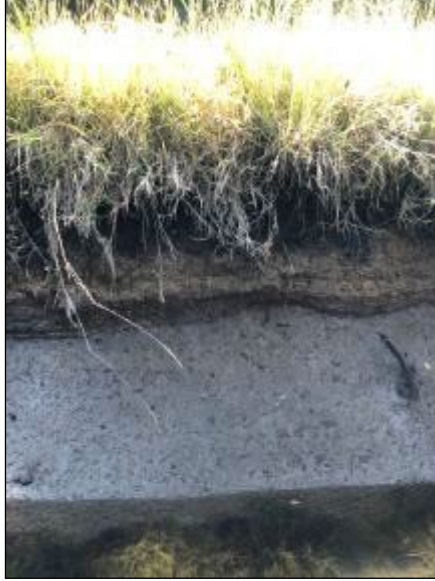
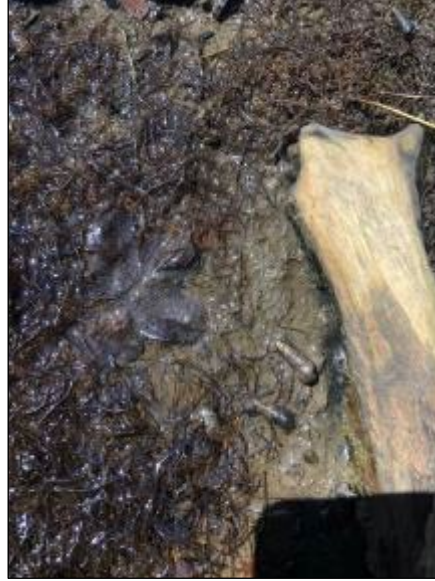
Figure 36. View Royal Park tidal marsh. Left: muddy sediment eroded to marsh plant line. Right: muddy substrate with the highly abundant non-indigenous mud snails, *Batillaria attramentaria*. Photos by S. Anthony.

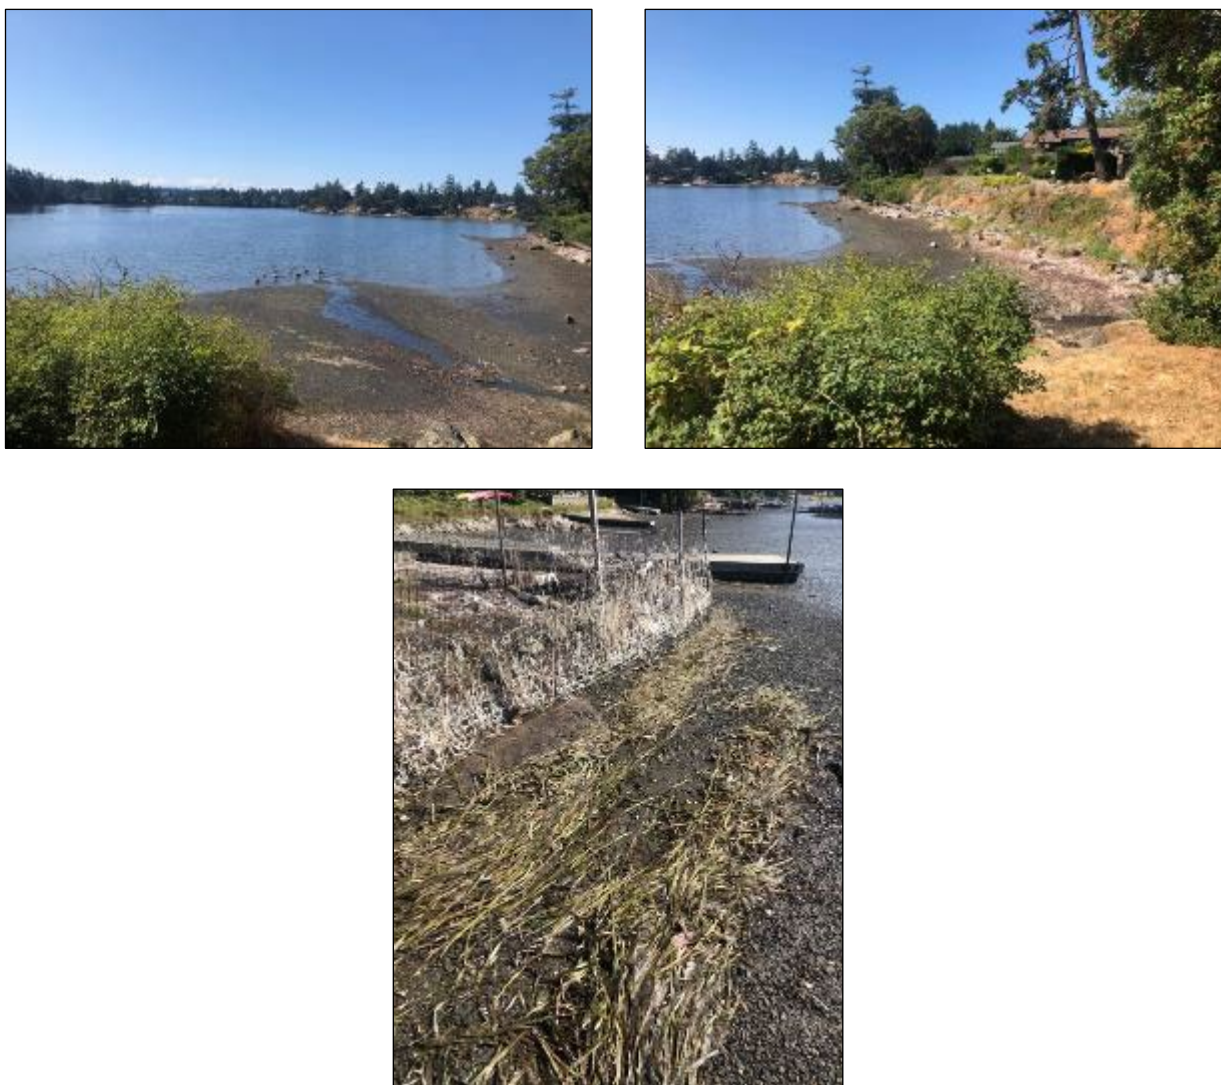
Figure 37. Portage Inlet Site Photos. Top-left and right: Canada geese at the mouth of Hospital Creek. Bottom: wadding fence with bare substrate (with beach wrack) and marsh plants in the goose exclusion area in Hospital Creek. Photos: S. Anthony.

Portage Inlet is at the very head of the Gorge Waterway that runs up from Victoria Harbour. It is a very sheltered inlet that is behind a tidal waterfall at the Tillicum Rd bridge, making access challenging for surveys but also restricting water exchange (Figure 34). Three waterbodies empty into Portage Inlet: Craigflower Creek, Hospital Creek and Colquitz River (Figure 34). These are significant waterbodies that drain a large area, some of which is highly urbanized in the lower reaches, but the upper reach is more natural, with some agricultural land use (Figure 35). There is very little mixing and flushing in the inlet and the influence of freshwater is high, making the estuary's water quality poor. Shoreline modification, urban run-off, sewage, and Canada Goose excrement and herbivory leading to erosion all contribute to the low biodiversity, poor sediment quality, and high nutrient and bacterial concentrations in the inlet (Figure 36). There have already been successful restoration activities (by Peninsula Streams Society and Guardians of Our Salish Estuaries): riparian planting and goose exclusion fencing ("waddle fences") at the mouth of Hospital Creek have stabilised shorelines and deterred herbivory, likely improving water quality through filtration (Figure 37).

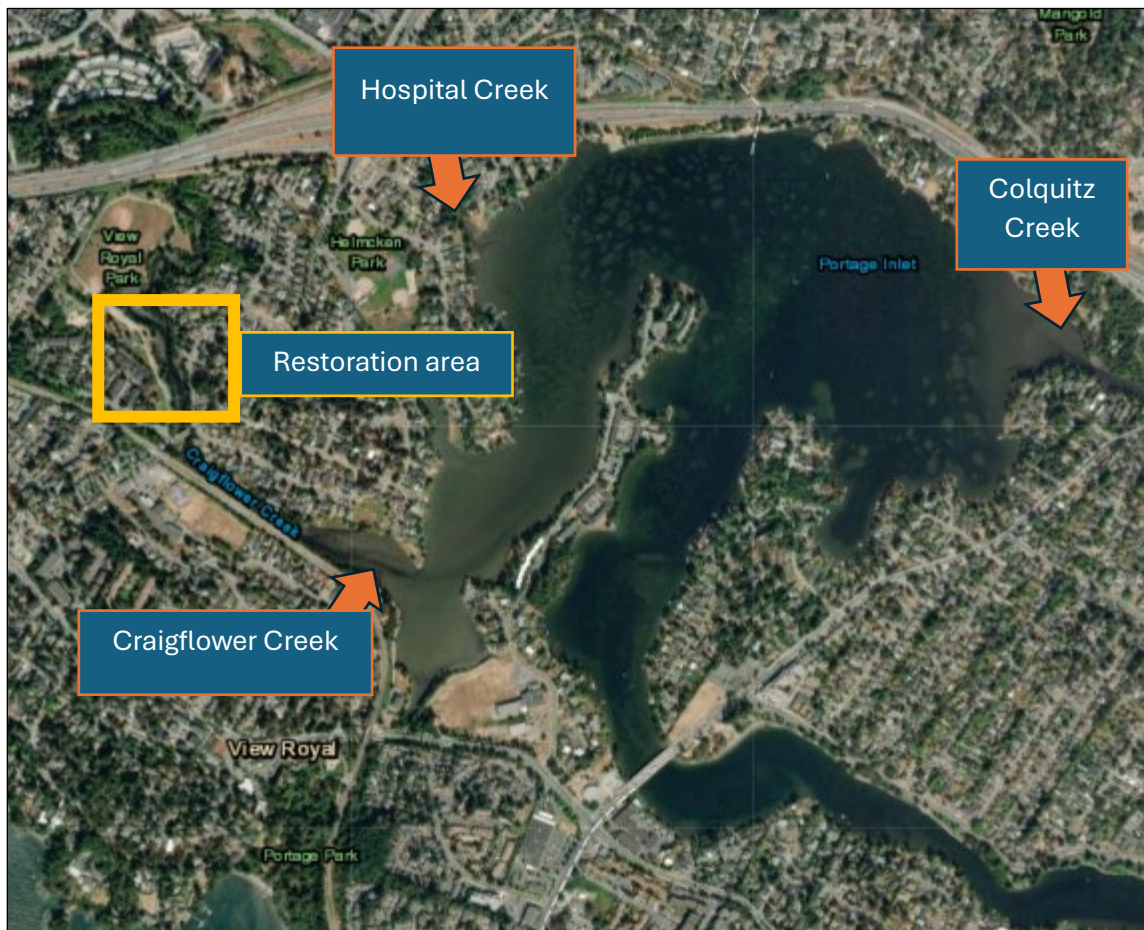
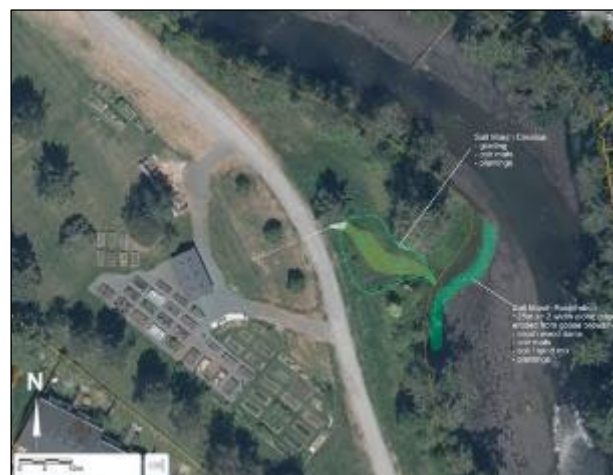
Figure 38. Portage Inlet aerial maps. Top: Portage Inlet with the three freshwater inputs and restoration area labelled. Bottom-left: close-up of restoration area. Bottom-right: restoration plans from Swell Consulting.

Location: View Royal Park, westside of Craigflower Creek, about 100m north of the parking lot. The planned restoration involves planting of indigenous species and soil deposition/dredging at View Royal Park (Figure 38). The work was partially completed by the end of March 2024, where we built wattle fences (Figure 39) and established some test plots with different sediment mixtures at a high tidal height (Figure 40), that gave us the mixture of sand and sediment that is most effective at allowing the marsh plants to establish at this particular site (see the before and after images (Figure 41)). Kyle Armstrong (Peninsula Streams and Shorelines, Executive Director) is leading the project and their funding comes from the World Wildlife Fund. The consulting firm Swell has been hired as consulting biologists on the project and the plants have been seeded and are established with Streamside Native Plants, Nat's Nursery, and Satinflower Nursery. The plan is to dredge a drainage channel, build up the shoreline, and maintain the present wattle fence. The plants will be in the newly established shore and bushes towards the storm-drain entrance. SeaChange is funding the seeding and planting of 1,550 native plants and will provide in-kind labour support for the work.
