Resilient Estuaries of the Salish Sea

Taking Action:
Restoration, Conservation, and Education

**Year 1 Summary Report
2023-2024**

SEACHANGE
MARINE CONSERVATION SOCIETY

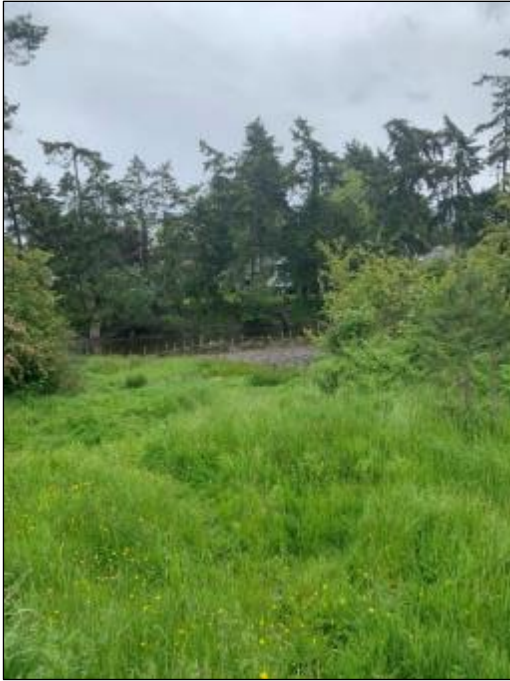
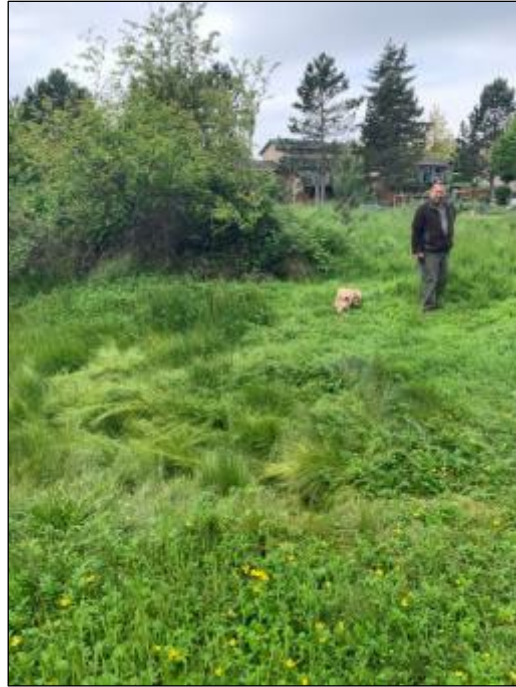
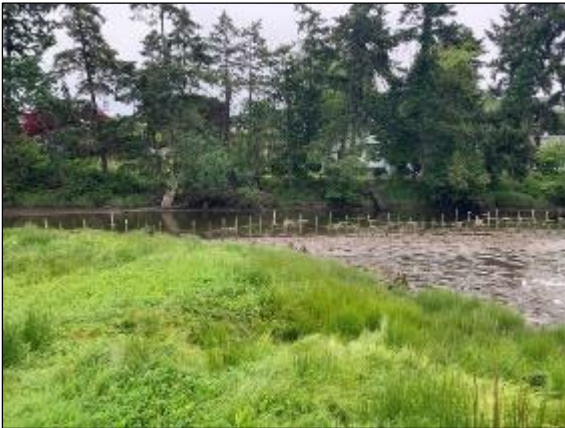
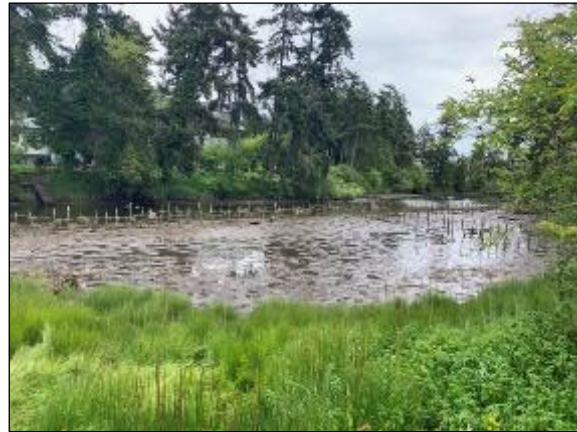
Figure 39. More view of View Royal Marsh restoration location, May 2024. Top-left: View of the marsh from the pathway, with creek channels visible as channels in the vegetation. Top-right: View of the creek channels. Bottom-left: north end of waddling fence in the marsh. Bottom-right: the remaining waddling fencing to the southern side and a fence bisecting the marsh area. Photos by S. Anthony.

Location: View Royal Park, westside of Craigflower Creek, about 100m north of the parking lot. The planned restoration involves planting of indigenous species and soil deposition/dredging at View Royal Park (Figure 38). The work was partially completed by the end of March 2024, where we built wattle fences (Figure 39) and established some test plots with different sediment mixtures at a high tidal height (Figure 40), that gave us the mixture of sand and sediment that is most effective at allowing the marsh plants to establish at this particular site (see the before and after images (Figure 41)). Kyle Armstrong (Peninsula Streams and Shorelines, Executive Director) is leading the project and their funding comes from the World Wildlife Fund. The consulting firm Swell has been hired as consulting biologists on the project and the plants have been seeded and are established with Streamside Native Plants, Nat's Nursery, and Satinflower Nursery. The plan is to dredge a drainage channel, build up the shoreline, and maintain the present wattle fence. The plants will be in the newly established shore and bushes towards the storm-drain entrance. SeaChange is funding the seeding and planting of 1,550 native plants and will provide in-kind labour support for the work.

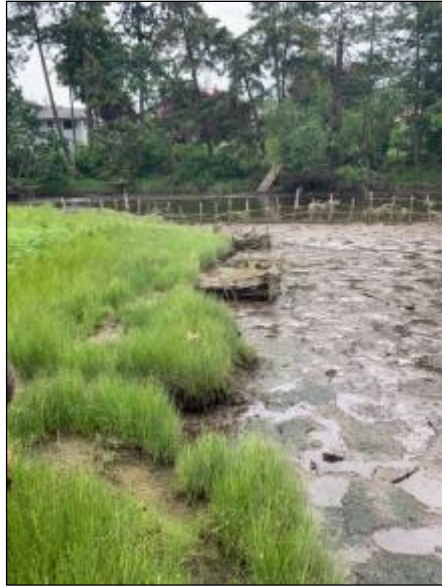
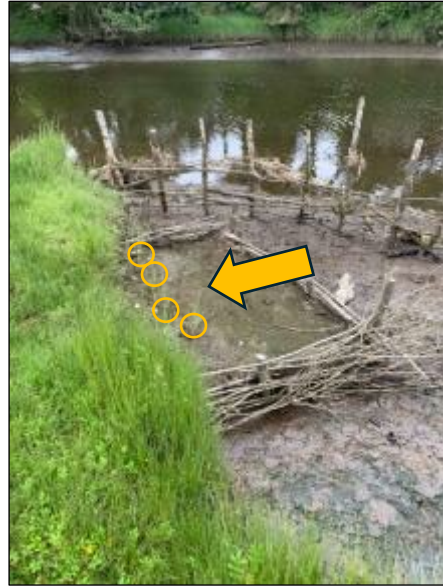
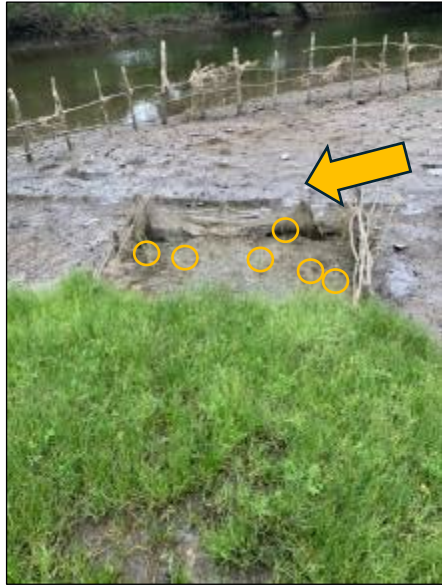
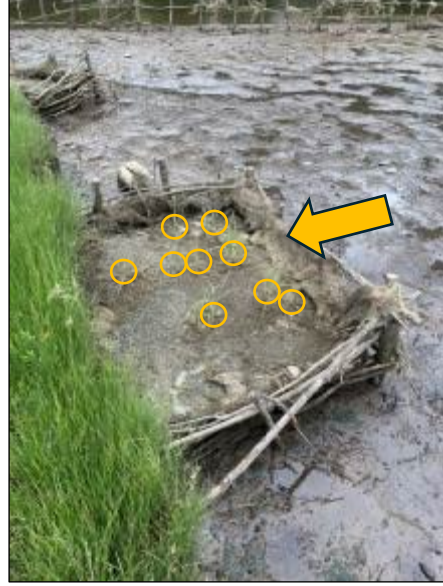
Figure 40. View Royal Park sediment testing plots, May 2024. The three plots were along the northern shoreline of the tidal marsh “muck” area (top-left) and the low (top-right), medium (bottom-left), and high (bottom-right) -concentration of sand in the sediment with *Carex lyngbyei* (Lyngby’s sedge) planted within. The number of surviving plants (after winter and spring) were higher in the higher sand-to-soil concentration sediment bed (plants circled in orange, lower right photo). Photos by S. Anthony.

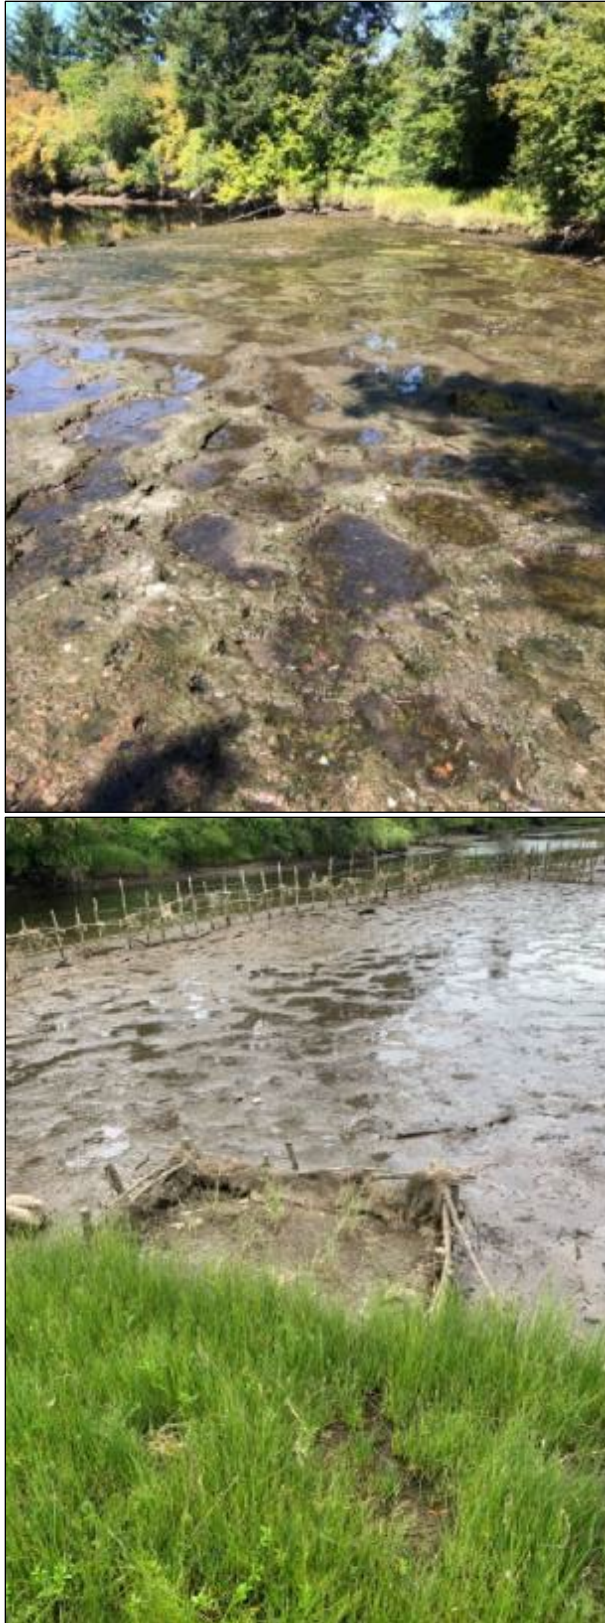
Figure 41. View Royal Marsh in July 2023 (left) and after test plots and waddling fencing have been there for six months May 2024 (right). Photos by S. Anthony.

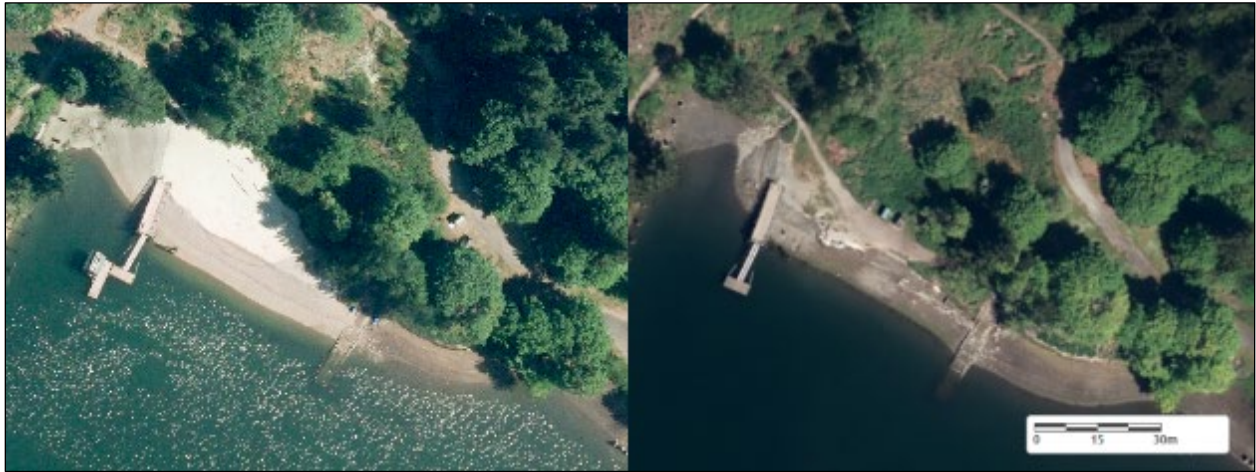
Figure 44. Aerial photo of Tod Inlet, northern shoreline. Left: after shoreline/beach enhancement in 2019. Right: before the enhancement (2015). Photos from CRD Mapping Atlas.

A previously completed restoration of the shoreline, which included beach nourishment with sediments and shell hash, was successful (Figure 44). The shell-hash deposit not only increased the larval settlement of pacific oysters, but also the Olympia oyster (*Ostrea lurida*), a “Species of Special Concern” https://www.canada.ca/en/environment-climate-change/services/species-risk-public-registry/cosewic-assessments-status-reports/olympia-oyster-2011.html#_cas).

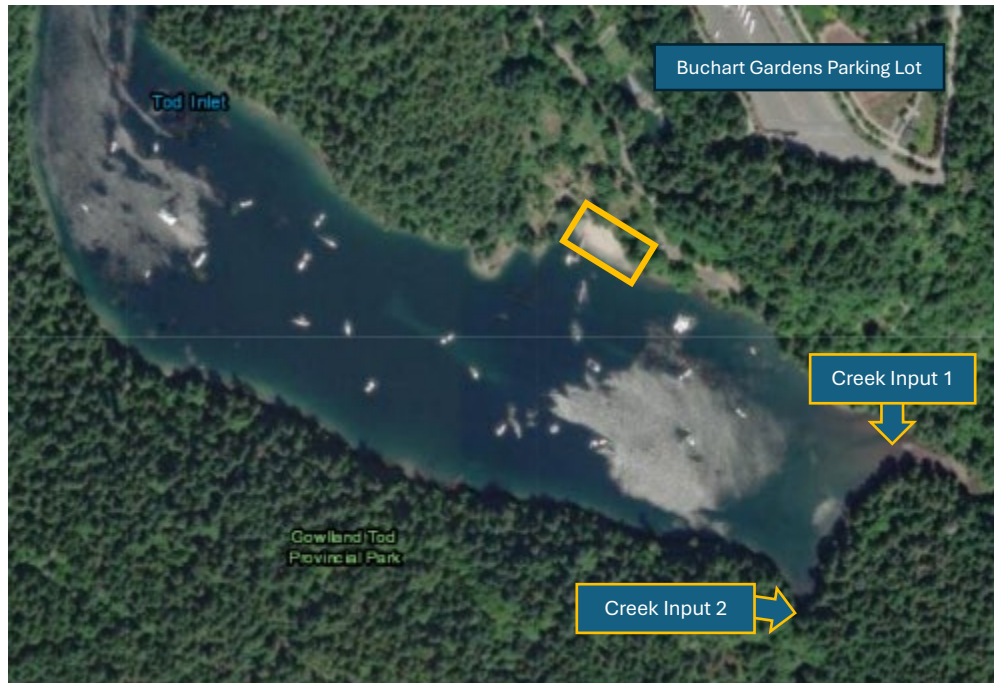
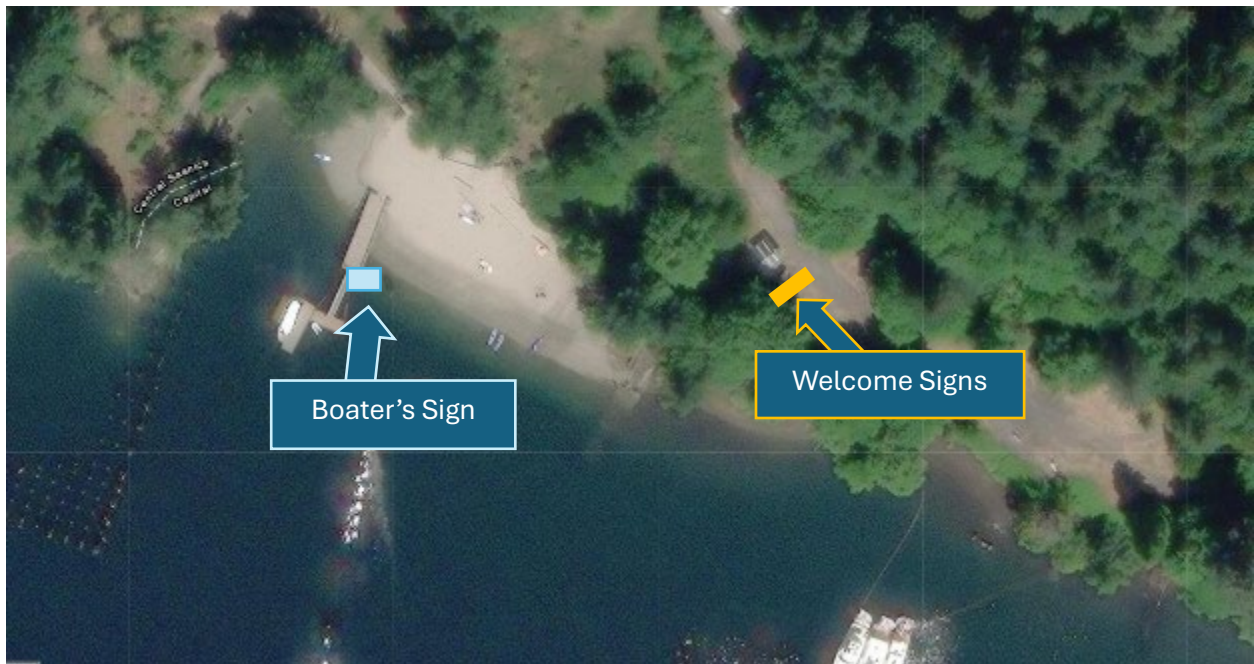
Figure 47. Aerial Map of Tod Inlet. Top: aerial image of the inlet filled with anchored boats (about 25-30) and restoration site (outlined in orange) Bottom: close-up aerial image with locations of the Welcome Signs and Boater's Sign.
