Resilient Estuaries of the Salish Sea

Baseline Assessments and Ground-truthing

**Preliminary Year 1 Summary Report
2023-2024**

SEACHANGE
MARINE CONSERVATION SOCIETY

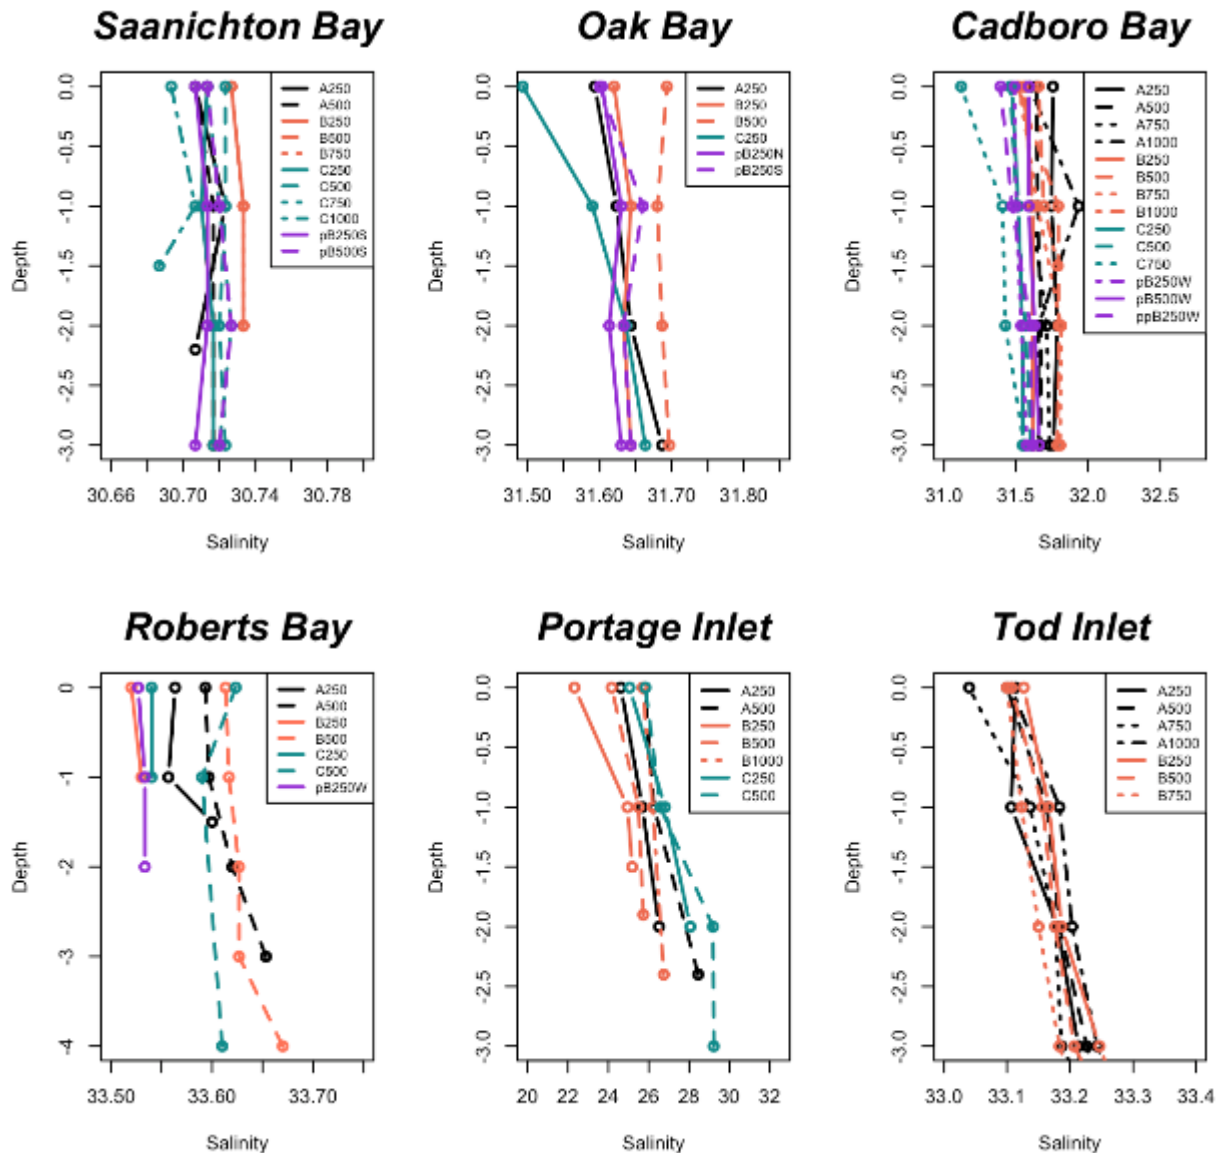
Figure 2. Salinity (ppt) profiles of the Area 1 estuaries, depth is in metres. The x-axis ranges differ between plots and the datapoints are the mean of three replicate measurements (error bars omitted as they are negligible).

The salinity range in five of the six Area 1 estuaries was between 30 ppt and 33 ppt, with Portage Inlet being an exception (see Figure 2). Portage Inlet, which is at the end of the 8.5 km Gorge Waterway, has a lower salinity range of 22-30 ppt, indicating that there is very little exchange with the open ocean. This could lead to higher concentrations of waste, nutrients, and contaminants, potentially leading to hypoxic conditions in the area. The high salinity values in Tod Inlet may be due to the closed nature of the inlet, however the reason for the high salinity in Roberts Bay is unclear and may indicate less freshwater input than the other estuaries. It must be noted that the Portage Inlet dataset was collected in mid-November 2023 (unlike the other locations which were mid-October), after the fall rainy weather had begun (over 250 mm of rain between sampling times) so this likely affected the comparison with the other estuaries.

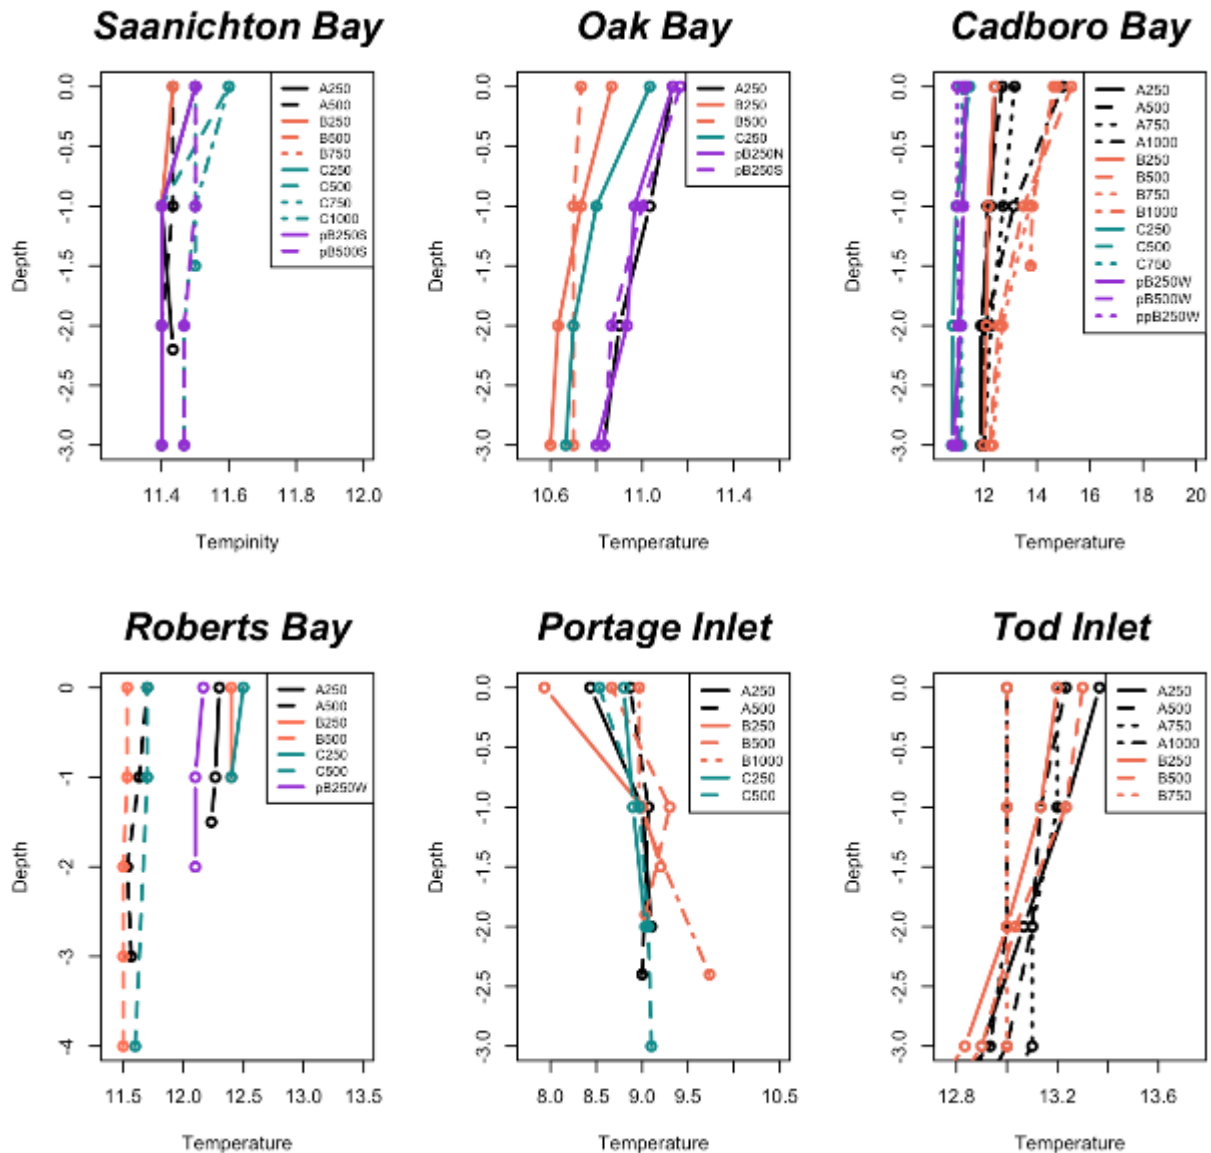
Figure 4: Temperature (in degrees Celsius) profiles of Area 1 estuaries, depth in metres. Temperature (x-axis) ranges differ between plots and the datapoints are the mean of three replicate measurements (error bars omitted as they are negligible).

The temperatures in Tod Inlet and Cadboro Bay were higher than this average, while they were lower in Portage Inlet (Figure 4). Leading up to the sampling days, the weather had been dry and warm, and therefore the temperature of the surface water will be warmer if there is little exchange with the open ocean. The higher temperature in Cadboro Bay could be due to its long and shallow beach/seafloor profile, which makes it an enjoyable place to swim, but also doesn't allow much shading from shoreline plants. Tod Inlet has surprisingly warm water, which could be due to low exchange with cooler water from the open ocean, and the water within Saanichton Inlet being cut off from much cold ocean water input due to the sill at its opening that shrinks

the water depth to less than 100 m. On the other hand, the low temperature water in Portage Inlet is surprising, especially since it gets warmer with depth. The source of the cooler water is unclear, but it could be from a recent input of cold, fresh water. The recent rains in the CRD between mid-October and mid-November 2023, which were over 250 mm, could be the cause of the low temperature and salinity.

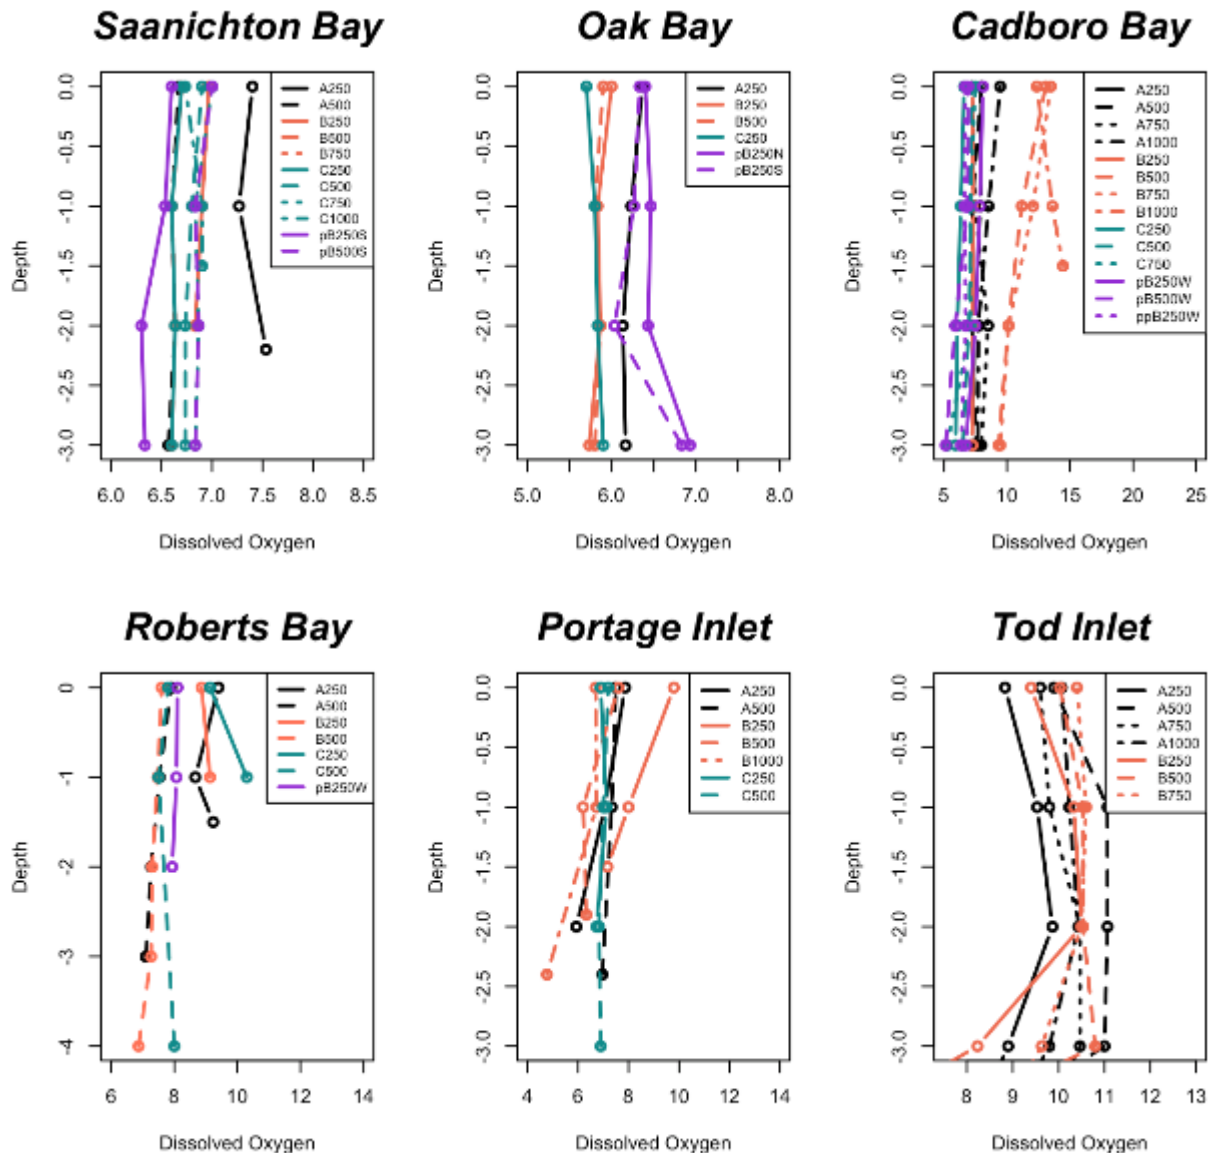
Figure 5: Dissolved oxygen (in mg/mL) profiles of Area 1 estuaries, depth in metres. Dissolved oxygen (x-axis) ranges differ between plots and the datapoints are the mean of three replicate measurements (error bars omitted as they are negligible).

Cadboro Bay has a larger range of oxygen levels than other locations, with one of the lowest and one of the highest values (Figure 5). The low oxygen content in this bay is likely due to low oceanic exchange due to the long and sheltered nature of the bay and a lack of photosynthetic organisms (*Ulva*, *Gracilaria*, and an unknown brown kelp): a higher oxygen concentration near the mouth of the bay, where there is more ocean water exchange, gives evidence that the low oxygen levels do not come from the ocean water. On the other hand, the low oxygen concentration in Portage Inlet is likely a result of eutrophic conditions, which the eelgrass beds cannot replenish with oxygen.

The cause of the sharp decrease in oxygen concentration at depth in Tod Inlet is unclear, but it is the only place that it is seen. The sharp increase in oxygen with depth in Oak Bay pB250N is likely due to the eelgrass bed at that location; the cause for the increase in pB250S is unclear, however there is algal presence in the area (*Ulva* mostly), and with the sheltering at that site, the oxygen could be retained at the bottom.

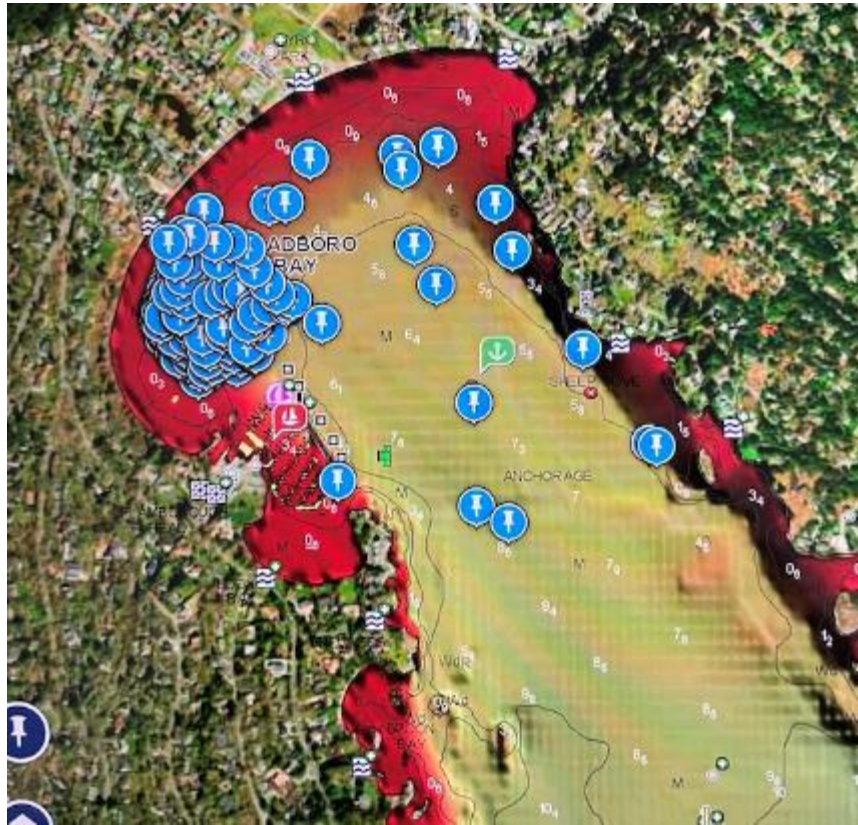
Side Scan Marine Debris Mapping

Interpretation: Lots of debris, especially in the region of the liveboards. The area away from the liveboards has ghost gear that is endangering the wildlife that is present (confirmed by tow camera video).

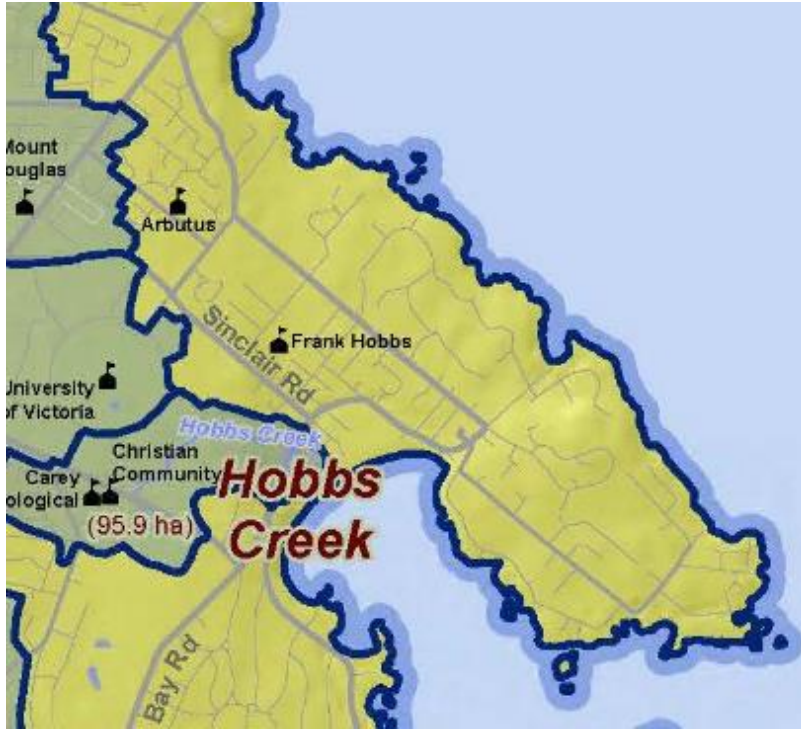
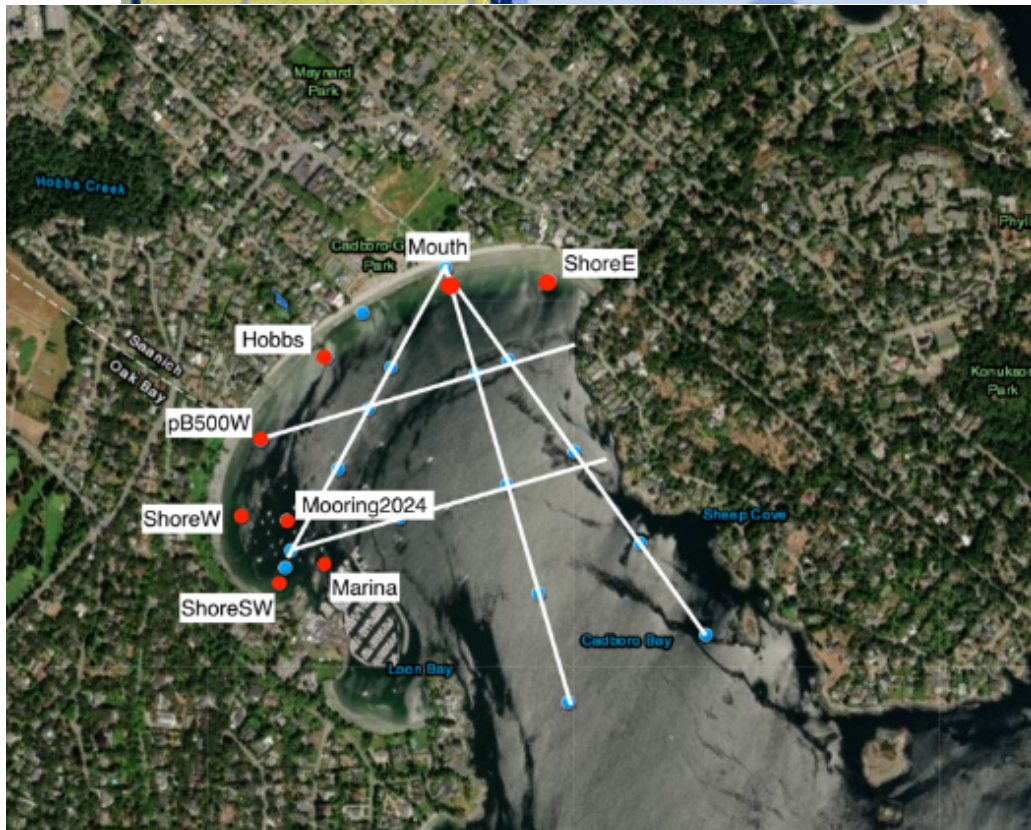
Resampling for bacterial sources would have to be along the shoreline, and away from the shoreline within the area of C750 (the high levels from the October sampling event). Red dots are the new sites: Mooring2024, Marina, ShoreSW, ShoreW, pB500W*, Hobbs, Mouth, ShoreE, B500* (*returned sites). We will take salinity, temperature, and oxygen measurements at the nine new sites and the original 14, plus nitrate, phosphate, and bacterial samples from the seven new and two old sites previously mentioned.

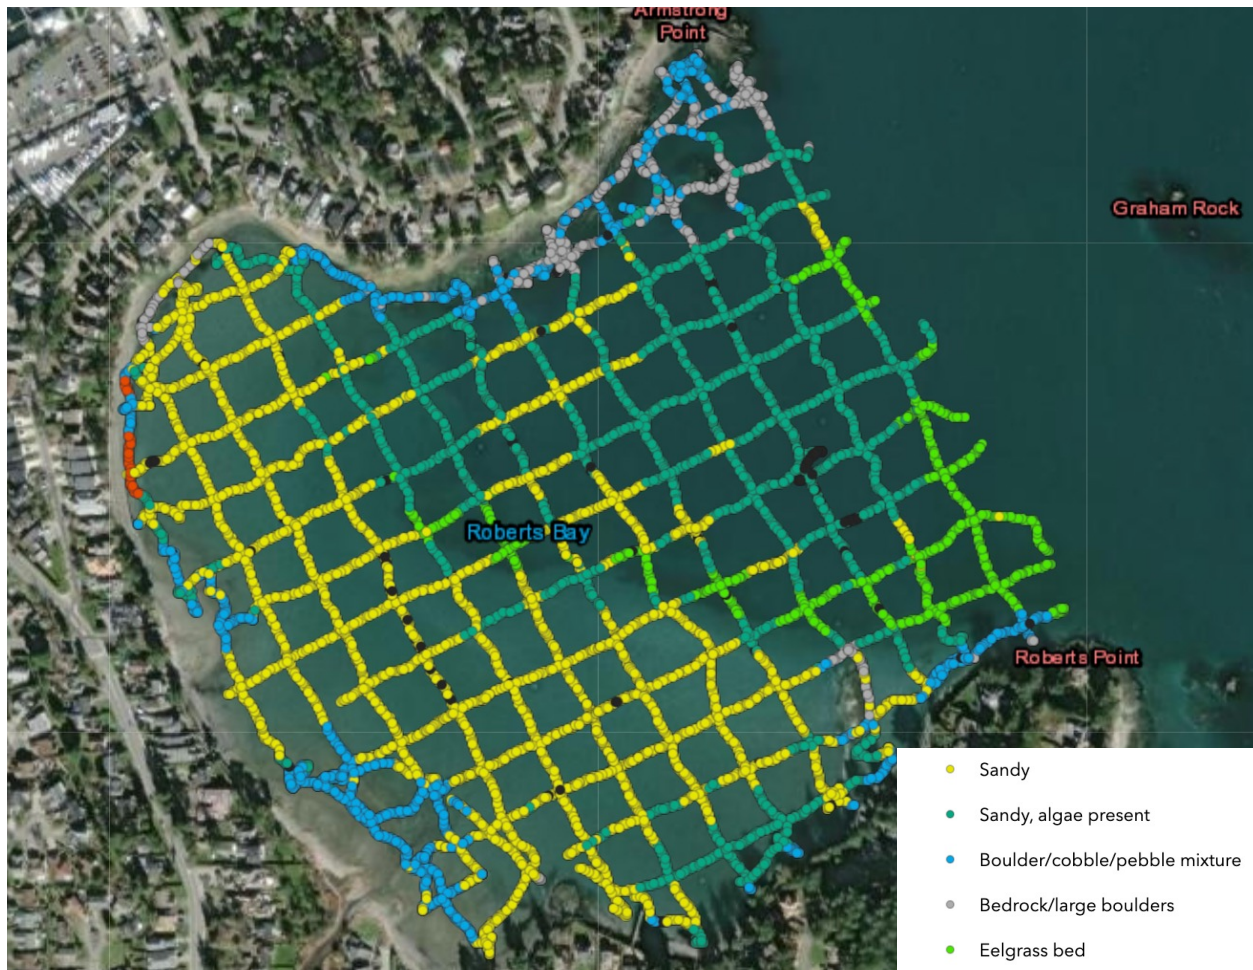
Habitat Mapping

Interpretation: The eelgrass bed within the bay is in a band, which will help with shoreline erosion towards the creek area, especially with the thicker (but undetermined) eelgrass beds towards the outside of the bay. These eelgrass beds are essential not only for habitat but for shoreline protection from waves and tidal currents. The extensive areas free of alga may be due to the time of year (mapping was done in January) or other influences preventing the growth and expansion of eelgrass. The preservation and space for expansion of the eelgrass will be essential for protecting the marsh at Mermaid Creek, and if allowed to expand, may even help the area from the effects of sea level rise.

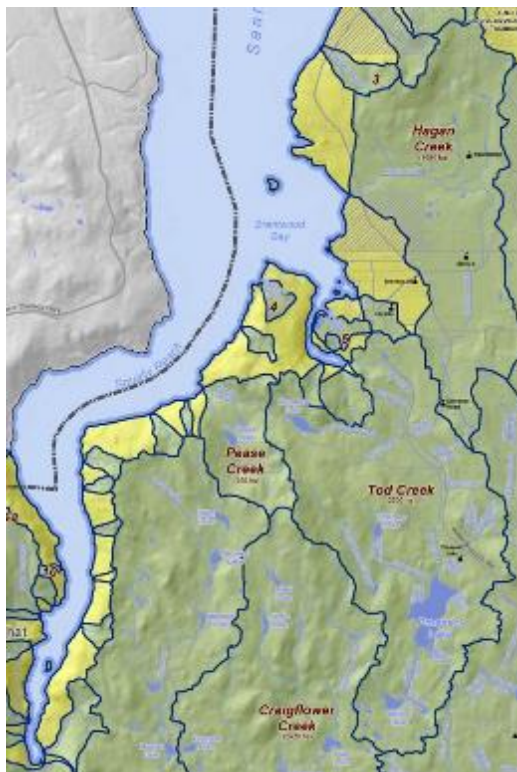
Yellow: direct drainage into the ocean

5 : Butchart Creek

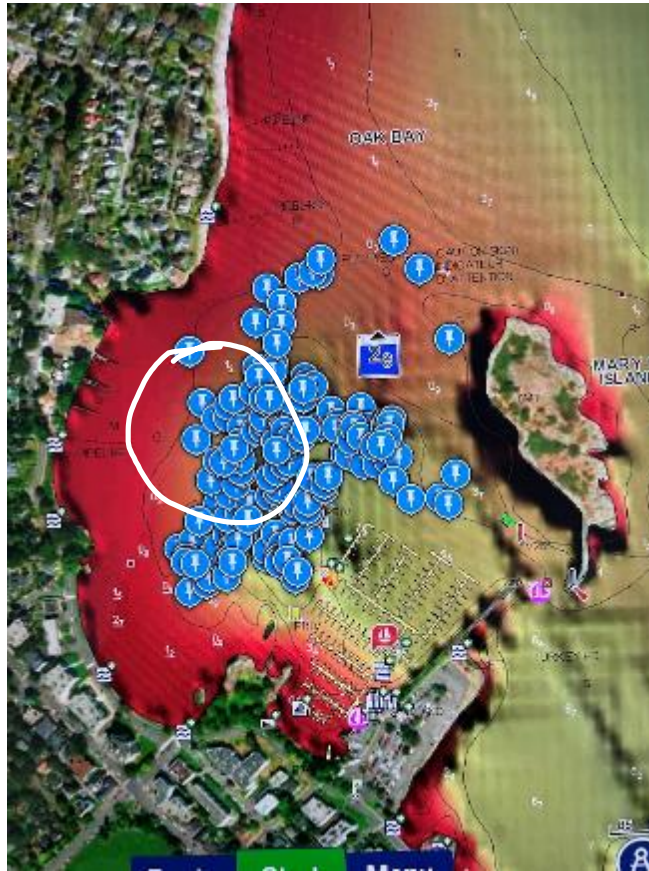
Debris points from sidescanning. One-hundred fifty-six items (some of them are clusters, some are large like boats). This does not include the boats that are sticking out from the water (two as of October 2023). There was no scanning in the marina.

Interpretation: There is good evidence that cleanup is necessary here. The debris is spread around the subtidal region with soft sediment: areas that do not show debris are in the “waterway” along Mary Tod Island, and near a rocky mound (with marker sign) where boats do not anchor. The raw data of the sizes and shapes of the objects tell us that on top of the two boats with masts poking out of the water, there are at least three others on the seafloor. There is also two what have been tentatively identified as mooring blocks which are not attached to buoys.

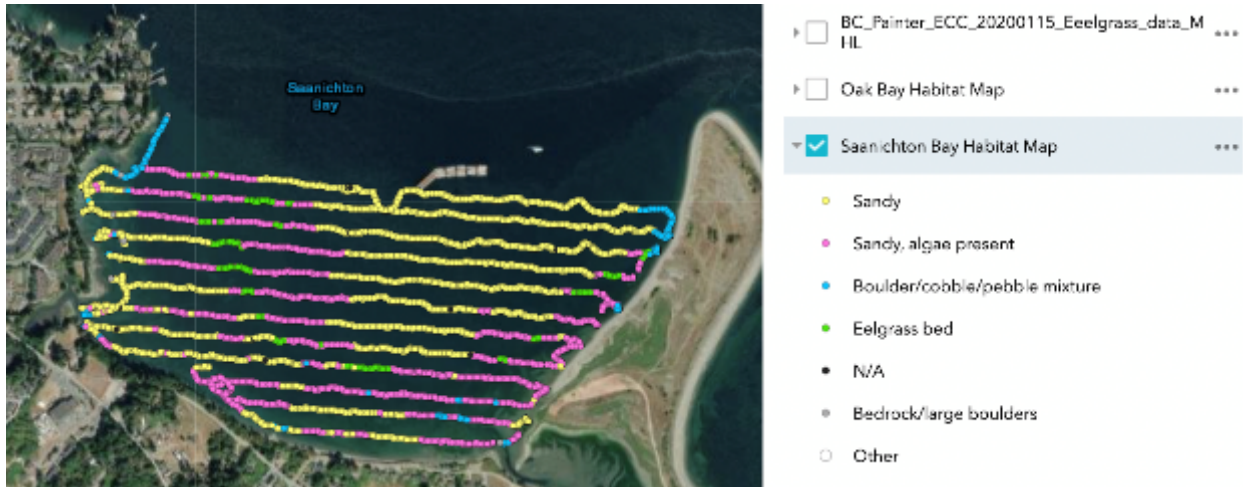
Habitat Diversity

Interpretation: Although incomplete, there are scattered eelgrass beds along the shore. From comments, I heard that eelgrass was commonly thick along the spit (TAYUT). This map is the winter extent of eelgrass, and further detailed eelgrass mapping would give a more fine-scale eelgrass bed area. However, the presence mostly in the Western side of the bay (near the mouth of Tetayut Creek) is a positive sign that pollution input from land may not have as large an impact on the beds as predicted. The question is what may be impacting the Eastern side of the bay, depleting the eelgrass below known levels.

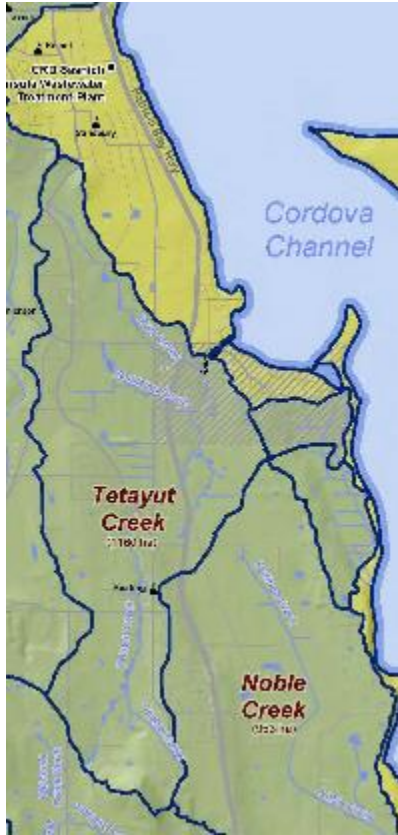
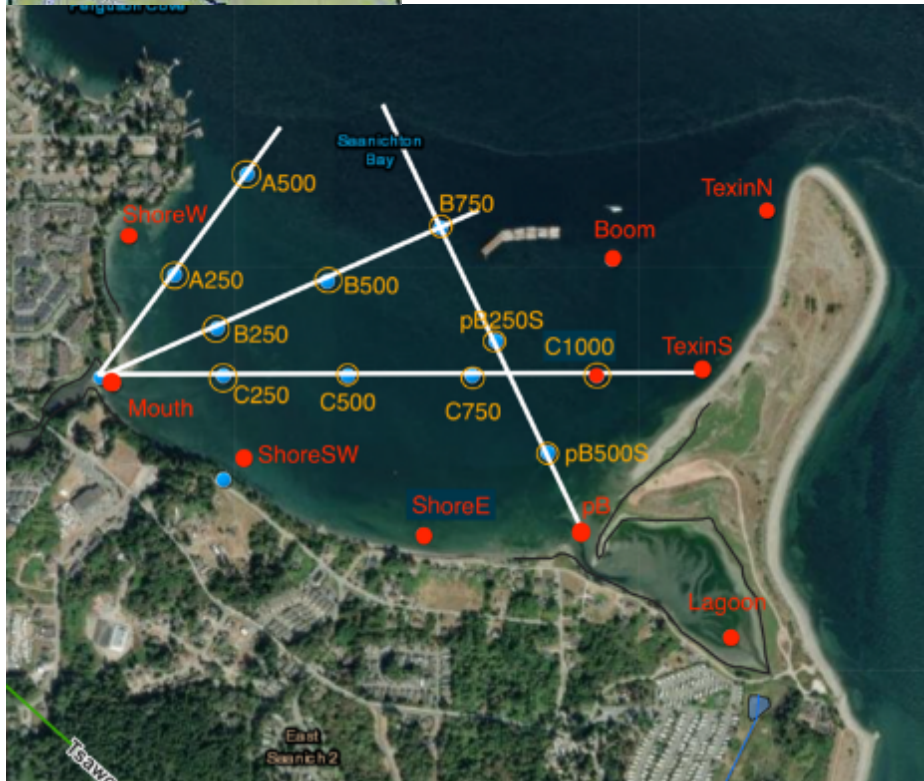
Site name	Lat	Long
ShoreW	48.597331	123.390062
Mouth	48.594379	123.390534
ShoreSW	48.593215	123.387058
ShoreS	48.591909	123.381822
Lagoon	48.589922	123.373711
TexinS	48.595032	123.374097
TexinN	48.597614	123.372896
Boom	48.597132	123.377273
pB	48.591796	123.377917

We think these areas, along with some of the original sampling sites, should be (re)sampled at different times of year and before and after rainfall. These new sampling sites are designed to identify sources of nutrient loads if present. If there is a higher concentration of nutrients and bacteria at “Mouth” and “Lagoon” are higher than the “Shore” sites, we can deduce that the nutrient loads are from inland watersheds.

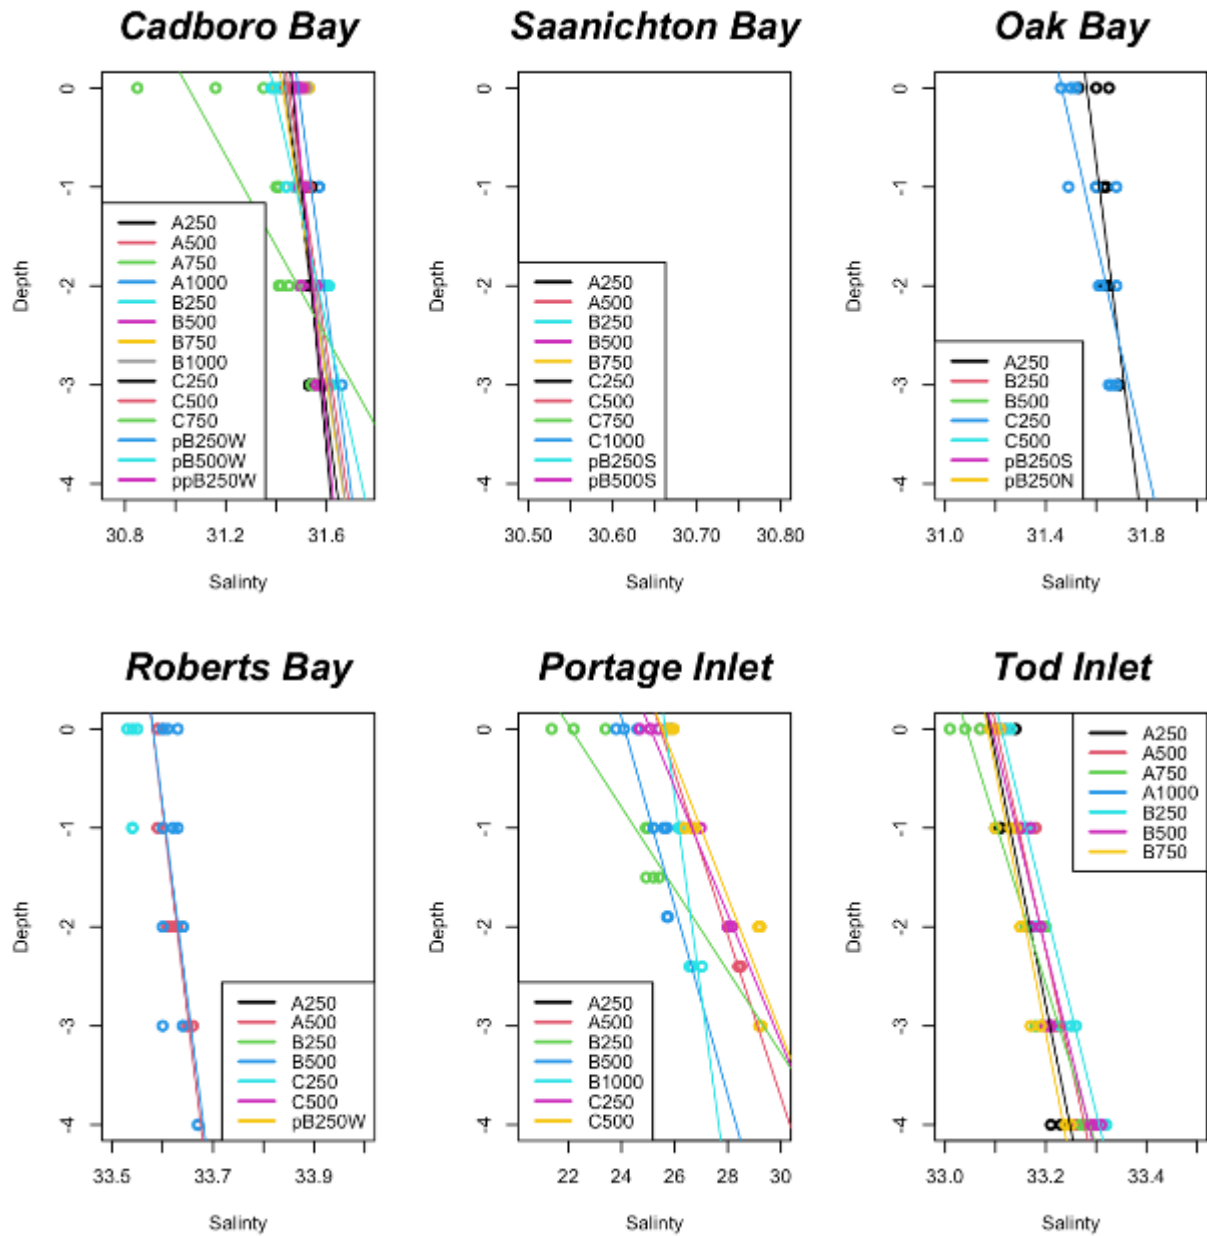
Figure 3-6: The regression lines for the salinity profiles of the sites with the Area 1 estuaries where the slope was significantly different from zero (horizontal).
