2013-2015 Final Report

Salish Sea Nearshore Conservation Project

Prepared for:
Pacific Salmon Foundation
Recreational Fisheries Conservation Partnerships Program
Environment Canada (EcoAction)

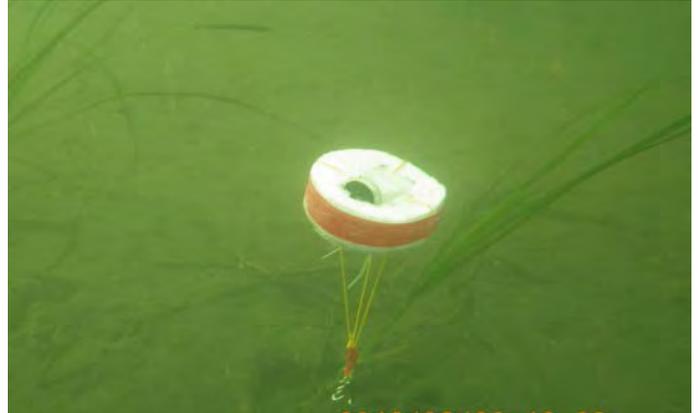
Cattermole Slough, Squamish Estuary

HOBO water monitoring units were installed in six sites: Genoa Bay (installed February 2015), Cattermole Slough, and Stawamus Reserve in the Squamish Estuary, Tillicum Bay in the Sechelt Inlet and Gallagher Bay and Long Harbour in Salt Spring Island. These units monitor water temperatures and light availability over one year. They were installed within the transplanted beds at the same height as the average eelgrass shoot. Information has been downloaded from each unit after six months in the water. Most likely it will take at least two years of monitoring before changes in water temperature and light availability over time can be accurately measured within and between sites. This data is stored with SeaChange and is available upon request.

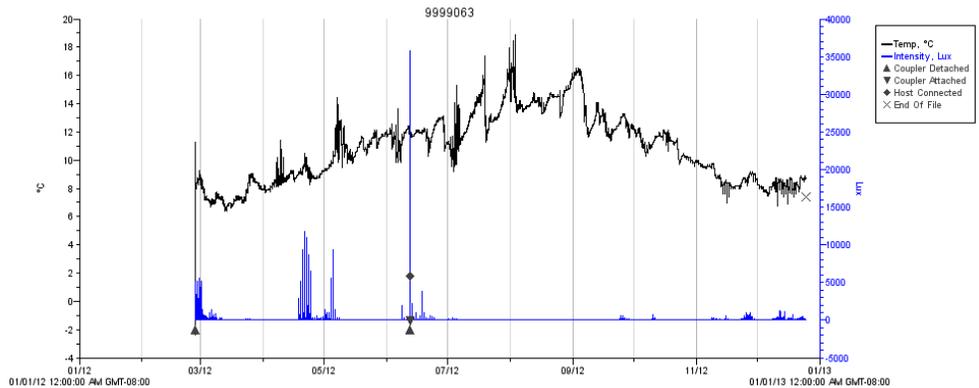
Stawamus Reserve, Squamish Estuary

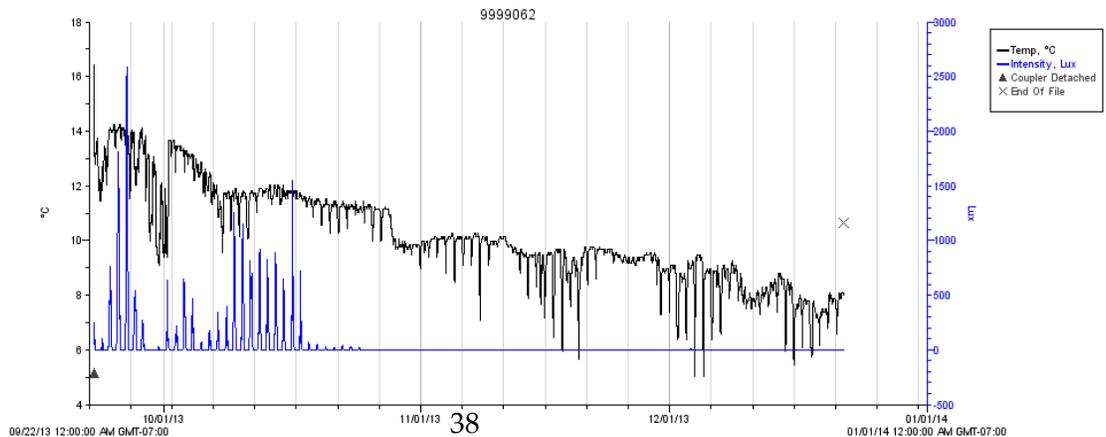
Tillicum Bay, Sechelt Inlet

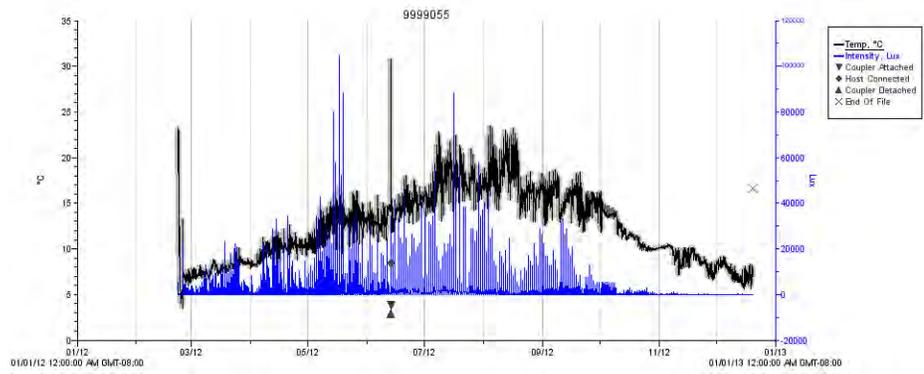
Gallagher Bay, Salt Spring Island

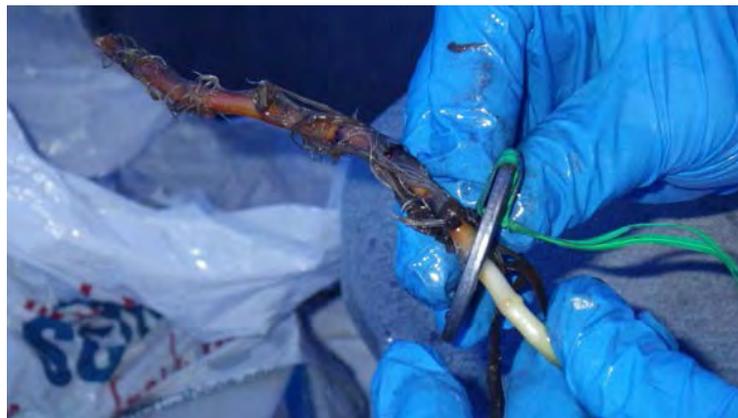
Tying anchors onto eelgrass shoots prior to transplant

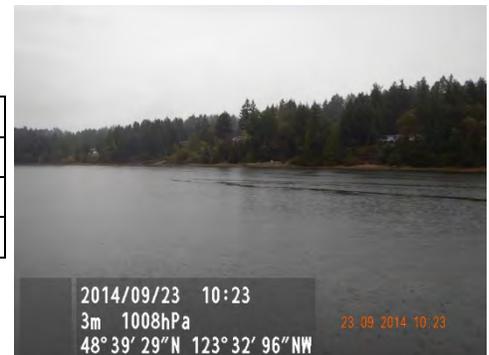
#/0.25 m ²	Length (cm)	Width (mm)	Area (m ²)
Minimum	8	30	4	66.4
Maximum	19	69	9	
Average	12.5	52	6.4

Native eelgrass located in 8-11' depth. Transplant of 664 shoots Sept. 22, 2014 to fill in gap. Abundance of *Ulva spp.* present. Nine Brentwood College students and two instructors assisted with transplant. When the site was monitored in February, there was evidence eelgrass shoots had been disturbed by juvenile crabs (~10% damage). Where not disturbed, shoots appear healthy and growing. Site will continue to be monitored over the spring to observe growth and further bioturbation from crabs or impacts from other activities. This might be a suitable site to test adaptive management strategy, such as a metal grid (rebar) form to attach eelgrass rhizomes, which might limit crab disturbance.

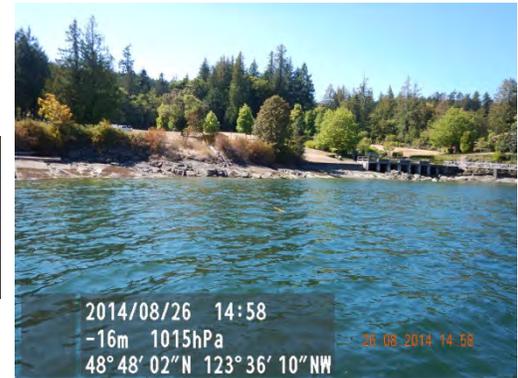
#/0.25 m ²	Length (cm)	Width (mm)	Area (m ²)
Minimum	5	30	4	122.5
Maximum	17	70	7	
Average	10.2	51.6	5.7

One thousand two hundred and twenty-five shoots were transplanted August 26, 2014 to fill a gap between two native eelgrass beds. While monitoring the site, the depth sounder indicated several schools of fish travelling nearby (species unknown). Some disturbance by crabs were observed, but the native and transplant beds appear very similar (see below). Recommendation is to monitor the site again in late spring and transplant more shoots if monitoring results indicate successful growth and expansion.

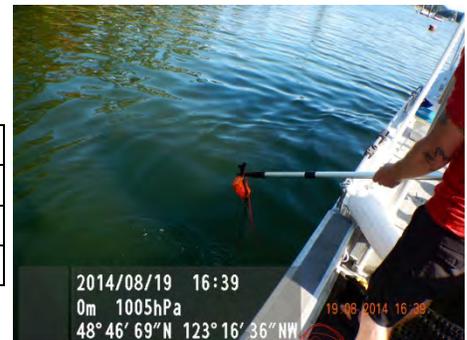
#/0.25 m ²	Length (cm)	Width (mm)	Area (m ²)
Minimum	5	57	6	80
Maximum	19	80	10	
Average	10.2	71.3	7.5

Eight hundred shoots were transplanted August 19th, 2014 at a 9'-11' depth gradient. Ten community volunteers assisted with tying anchors to the plants. Approximately 75% of the shoots survived. The shoots on the shallow end of the site are doing better than in the deeper end. In the middle of the site, there seems to be disturbance, possibly from crabs, as anchors without shoots were observed on the surface of the sediment (not buried). Recommendation is to consider planting additional shoots on the southern end of the site – up to

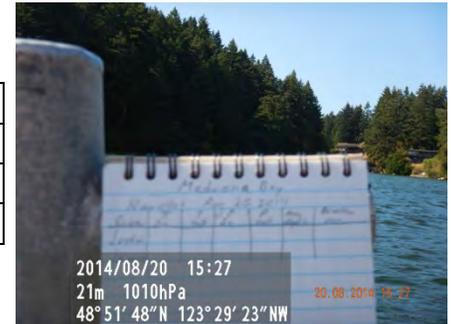
#/0.25 m ²	Length (cm)	Width (mm)	Area (m ²)
Minimum	4	14	4	50
Maximum	23	60	6	
Average	9.9	35.6	4.8

Five hundred shoots were transplanted Aug. 21, 2014. When monitored February 15, 2015, 60% survival rate was observed within the patches. Some disturbance noted from crabs and possibly wave energy from northeasterly winds. Native eelgrass beds at this site have ~50% less density than observed during the summer of 2014. Recommendation is to continue to monitor this site with no new transplants planned for spring 2015.

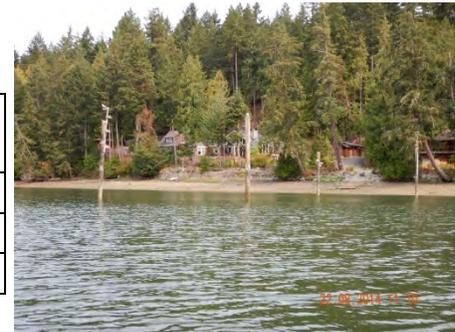
#/0.25 m ²	Length (cm)	Width (mm)	Area (m ²)
Minimum	2	4	3	240
Maximum	10	35	5	
Average	5	24	3.7

A total of 2400 shoots were planted at this site in a protected area between dolphins in Aug. 22, 2014. When monitored on February 18, 2015, 30% survival of all shoots were observed. Data from the Hobo data logger was downloaded (see Section 1.3 above) and the data logger was replaced. Shoots appeared to be re-sprouting after possibly bioturbation by juvenile crabs; an abundance of crabs were noted during the transplant in August. Monitoring will continue during the spring and summer of 2015; if eelgrass recovers, this may be a suitable site for a metal grid-type transplant method to better stabilize the rhizomes and protect them from crab disturbance.

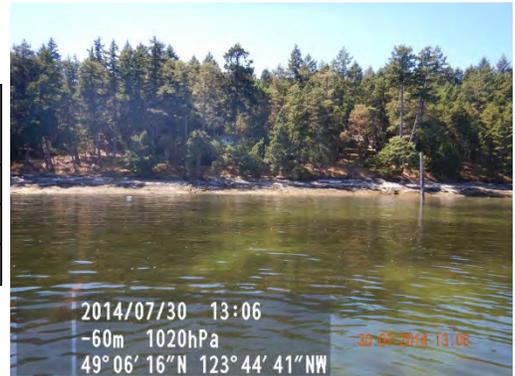
#/0.25 m ²	Length (cm)	Width (mm)	Area (m ²)
Minimum	2	32	5	88.9
Maximum	7	78	9	
Average	5	60.4	6.6

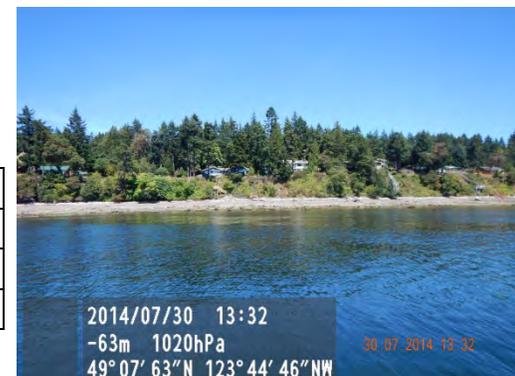
#/0.25 m ²	Length (cm)	Width (mm)	Area (m ²)
Minimum	2	56	6	42.5
Maximum	10	93	10	
Average	5.9	73.9	7.8

Four hundred and twenty-five shoots were transplanted July 31st, 2014. Monitoring indicates the rhizomes are securely anchored in the substrate. Recommendation is to transplant and continue to fill in the gap between the transplant site and the native bed during the summer of 2015.

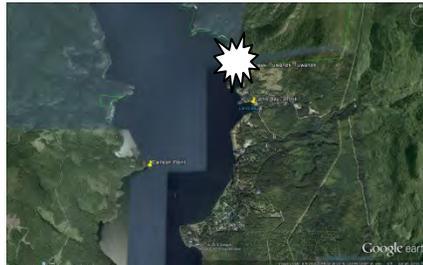
#/0.25 m ²	Length (cm)	Width (mm)	Area (m ²)
Minimum	23	50	3	60
Maximum	53	74	4	
Average	39.5	64.5	3.9

Transplant bed demonstrates advantages of monitoring over several years, as this transplant did not show high densities or area extension over the first year. Six hundred shoots were planted in 2012. The transplants are much denser and are spreading since 2013, when first monitored. Recommendation is to consider increasing the bed with more shoots transplanted to the south of the existing test plot in the summer of 2015.

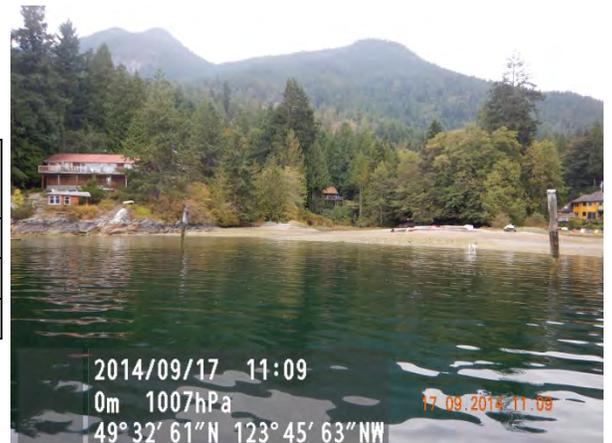
#/0.25 m ²	Length (cm)	Width (mm)	Area (m ²)
Minimum	5	23	3	40
Maximum	10	77	9	
Average	6.9	50.4	4.7

70% of the patches have survived from a transplant of 400 shoots in September, 2014.. Substrate contains wood fibre. Recommendation is to continue monitoring site.

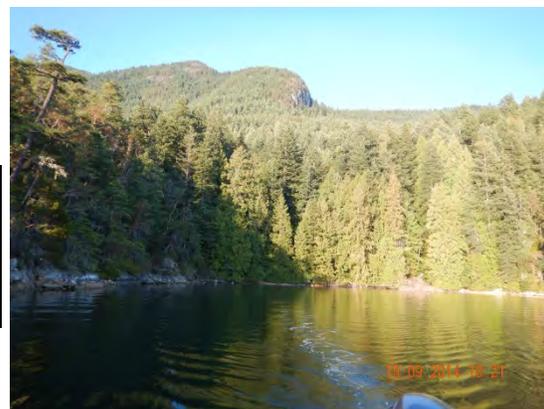
#/0.25 m ²	Length (cm)	Width (mm)	Area (m ²)
Minimum	1	33	3	44
Maximum	13	95	6	
Average	7.4	67.2	5.2

Marine life observed: Kelp, red rock, Dungeness crabs, sea cucumbers, snails, sea stars isopods, and juvenile flat fish. Four hundred forty-four plants installed in September, 2014. Seventy-five percent of patches survived; 5-7' depth is optimal depth range for transplants. On the deeper end the eelgrass seems more gravelly and disturbed, possibly by crabs. Recommendation is to continue monitoring.

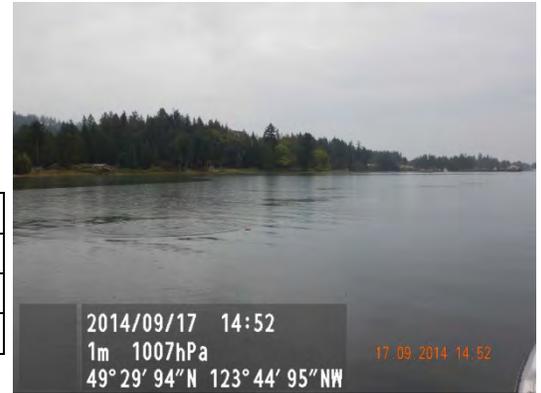
#/0.25 m ²	Length (cm)	Width (mm)	Area (m ²)
Minimum	4	35	3	72
Maximum	25	73	6	
Average	12.4	50.1	4.1

Marine life observed included isopods, moon jellies, sea stars, especially leather stars, flounder, pipe fish, flounder, Dungeness and hermit crabs. Ninety percent of the patches remain of the 719 plants installed in September, 2014. The upper edge (shallow end) is very productive. Recommendation is to consider planting more shoots in the summer of 2015 at this site.

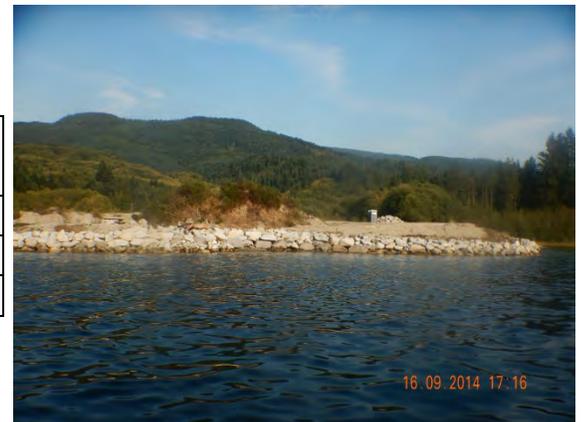
#/0.25 m ²	Length (cm)	Width (mm)	Area (m ²)
Minimum	11	32	4	118
Maximum	76	105	7	
Average	33	66	5.1

Marine life observed: Sea stars, greenlings, horse, kelp, red rock, hermit, and Dungeness crabs, sculpin, pipefish, sea cumpers. Seven hundred seventy-five shoots were planted in 2013 and another 400 shoots in 2014 to fill in a gap between two natural beds caused by a former transfer station. The transplant is successful as the gap is completely filled in. Please view video for evidence of density and growth. Concern remains for planned housing development on shore. There is communication with the developers and a meeting with them will happen in April, 2015 at which time we will discuss the success of

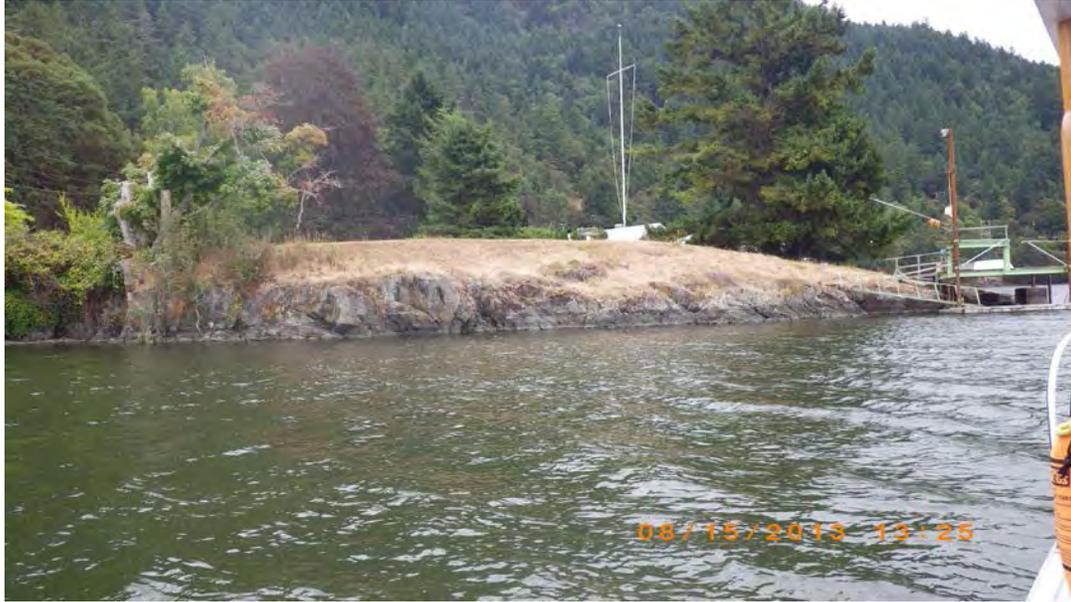
Genoa Bay

Channel transplant site in Cowichan Bay

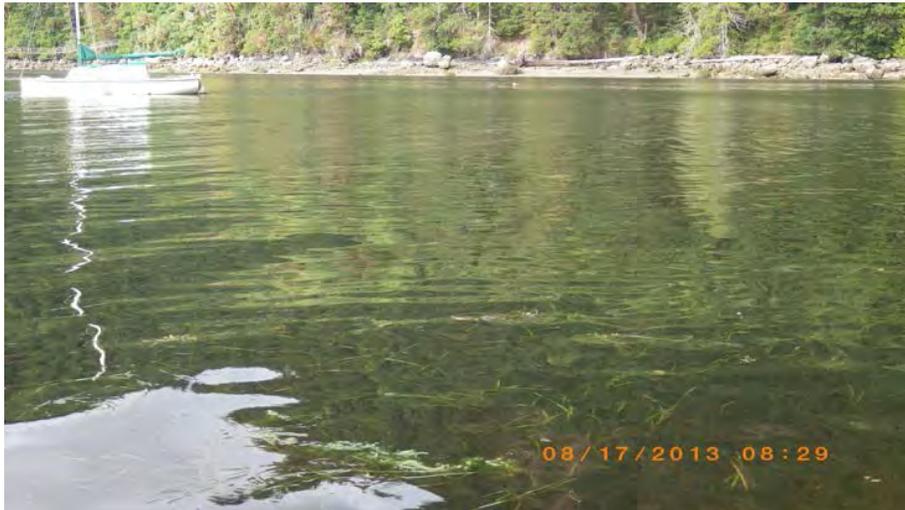
Donor site for Genoa Bay transplant

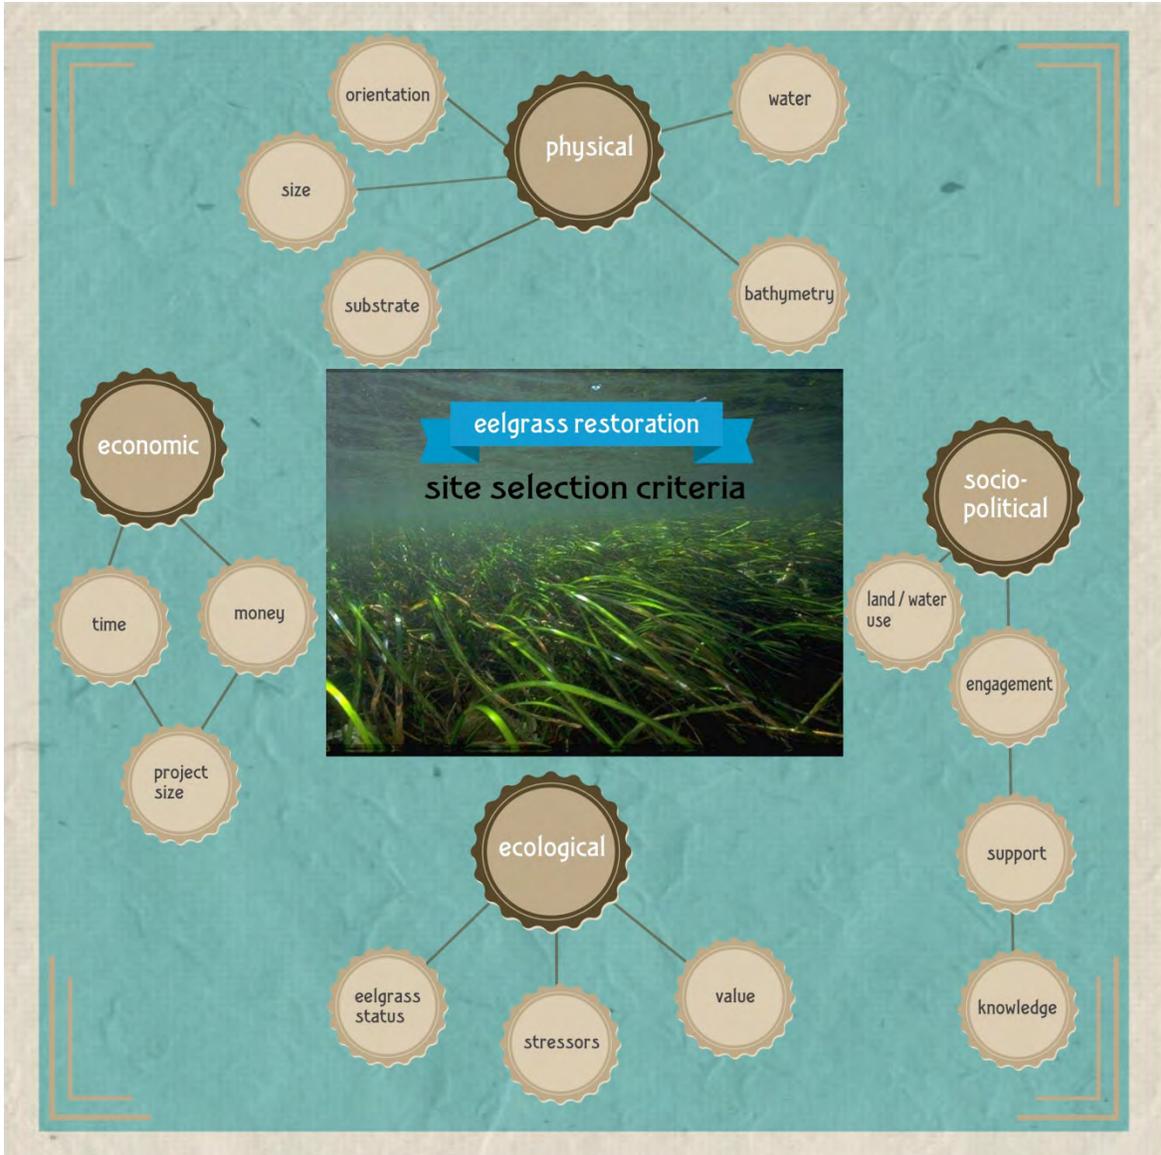
Decision Making Matrix for Eelgrass Restoration Site Selection
Anuradha Rao, R.P.Bio, University of Victoria Environmental Studies
