Salish Sea Nearshore Habitat Recovery Project 2019-2020 Final Report

Submitted by SeaChange Marine Conservation Society Nikki Wright, Executive Director For the Coastal Restoration Fund - Fisheries and Oceans Canada <u>seachange@shaw.ca</u>

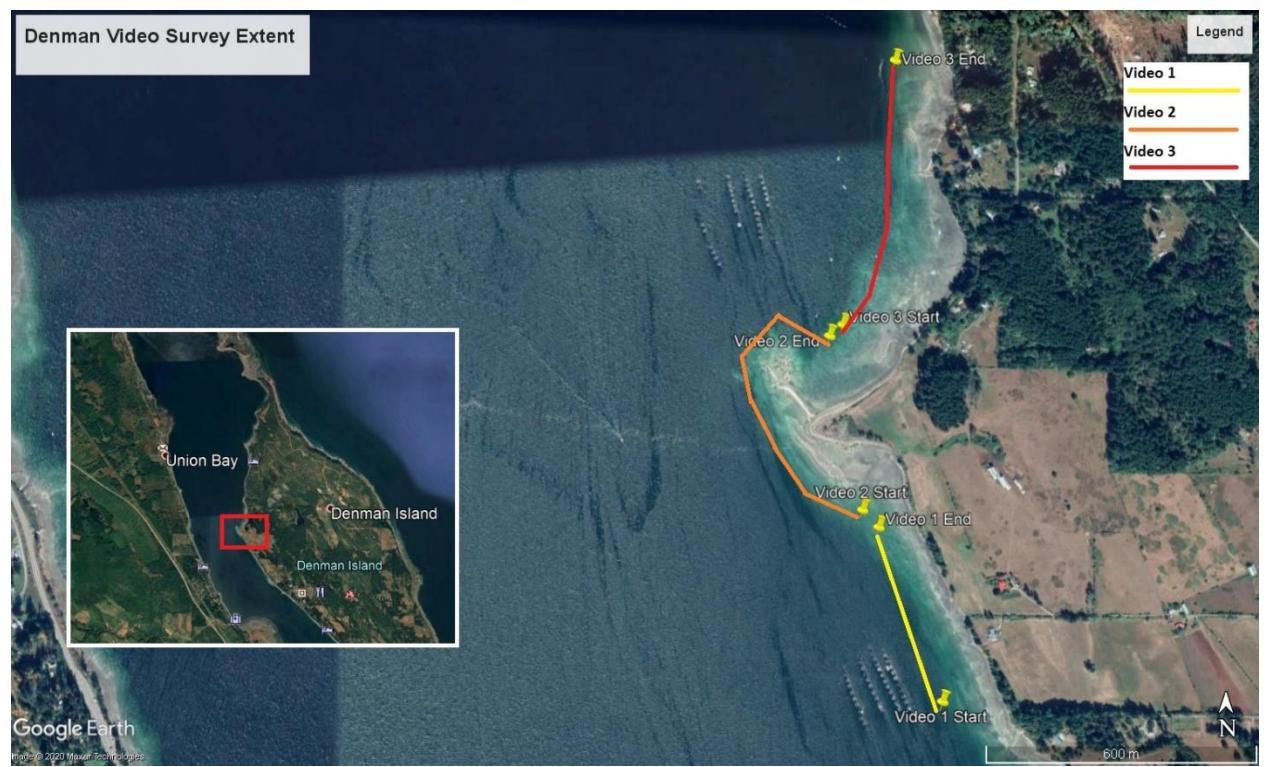
Figure 1. Eastern shore of Denman Island surveyed with underwater video July 23, 2019

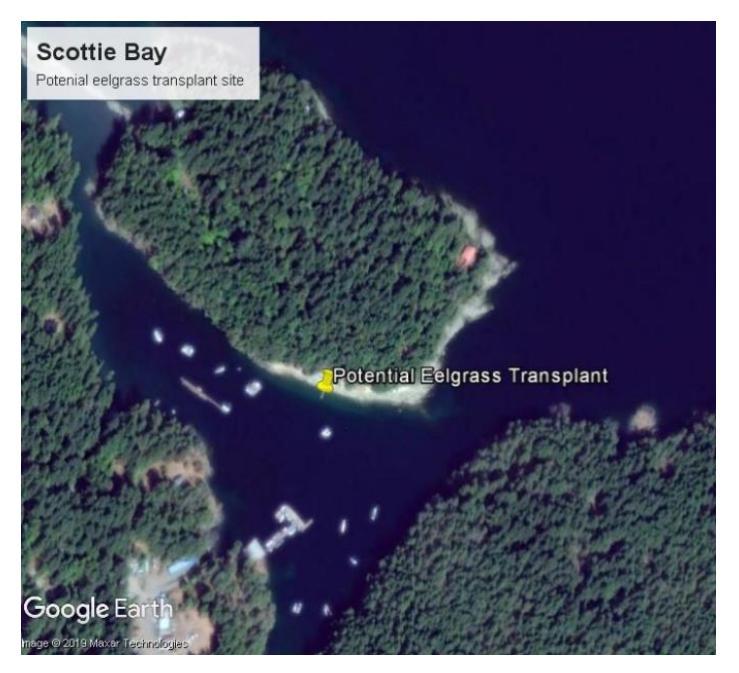
Figure 3. Scottie Bay potential eelgrass restoration site near debris removal site 49°30'48.4" N 124°20'35.9" W

This bay is very protected from wave energy. Since the site is a working shipyard there is much intertidal and underwater debris to be removed. Fetch is 6 km with a northeasterly aspect. No eelgrass is observed on the southwest end of the bay, possibly due to sewage outfalls affecting water quality. Larger derelict boats and barge will need to be removed with a larger barge and crane operation.

Side-scan sonar indicated scattered underwater debris. However the area on the north end of the bay might be suitable for eelgrass transplants. There are two gaps in an otherwise continuous eelgrass bed that could be filled in (49°30'48.4" 124°20'35.9"). Total area for a transplant would be ~ 80m x 5m or ~ 400 shoots. No boat moorages or anchoring were observed in this area of the bay at the time of the survey. The eelgrass habitat here is very healthy and extends about 100m wide at a depth from approximately -2' chart datum to -6'. Donor eelgrass bed is outside the entrance to the bay. Muddy substrate is suitable for eelgrass expansion.

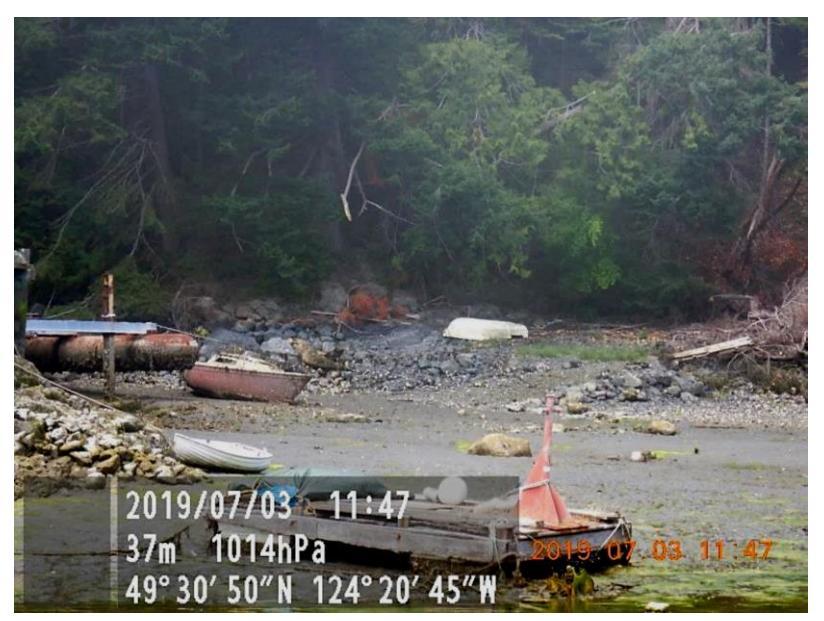
Figure 4. Some of the debris to be removed from Scottie Bay.

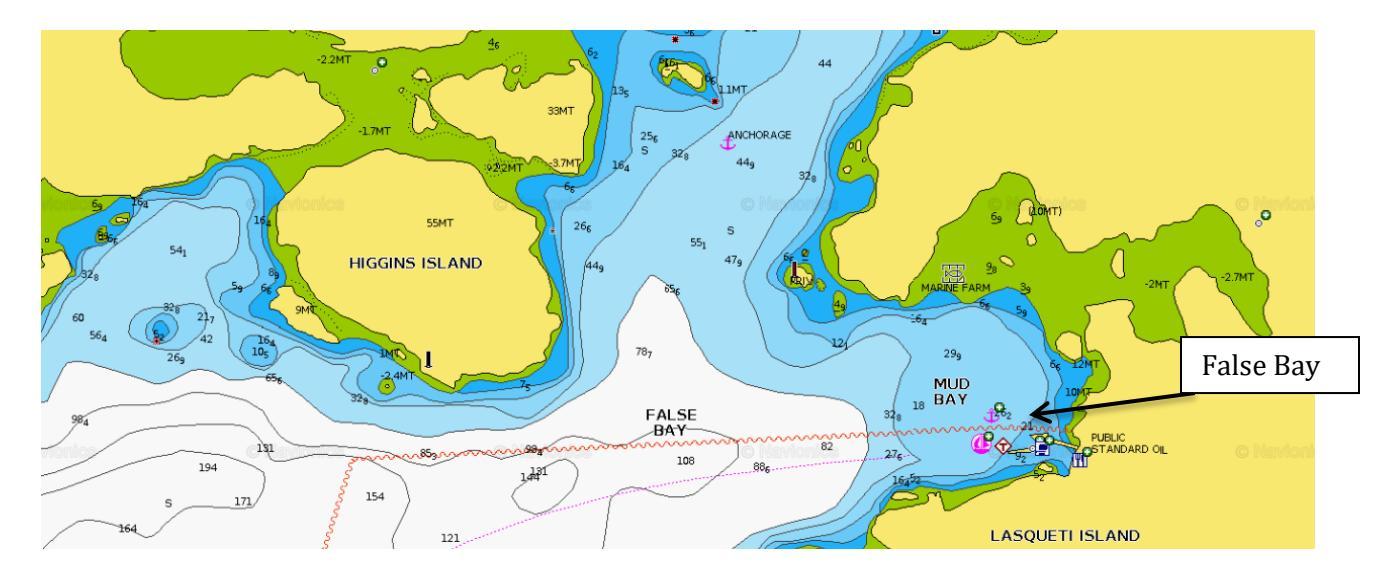
Figure 5. Location of False Bay, near the False Bay ferry dock: 49°494345 N 124°348026 W

Area near the Government ferry dock needs debris removal, especially within the depth of the existing eelgrass habitats. Bottles, batteries, tires and other types of debris were observed near the barge on the south side of the dock.

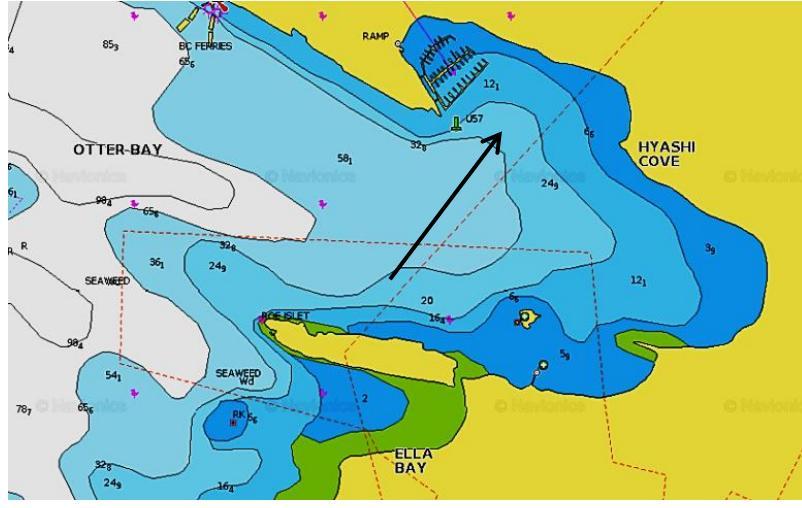
Figure 6. Hyashi Cove: 48°47′46 N 123°18′16″ W

A survey of the presence/absence of eelgrass habitats in this bay was completed for the Islands Trust in 2012, which indicated that most of this bed contained a continuous flat eelgrass habitat, with the exception of most of the northeastern end of the bay. Free divers (divers without the use of SCUBA tanks, who dive holding their breaths) surveyed the bay in July of 2019 and observed there was a larger eelgrass bed in deeper Hyashi Bay

water in the centre and northeastern sections of the bay that was not identified in 2012. There is a gap between the habitat mapped in 2012 and 2019 parallel to shore of about 70m wide.

The sediment is clean mud (devoid of woody debris) and consolidated. The bay has a fetch of 8 km and a westerly exposure. Backshore is residential, cleared and forested land. Beach is possibly a forage fish spawning site. Two boat moorings were observed as well as Canada geese and two river otters.

Eelgrass within the deeper part of the bay is dense and appears healthy with many seeding eelgrass shoots. The blades have a high epiphytic load (microalgae). Depth range for this deeper bed is between -9' to -15'. There were two small patches deeper than 15'.

The bed closer to shore begins at -7' depth and is less dense. There is more U*lva* present (unattached green sea lettuce). Depth range of the shoreward eelgrass bed is between -7' to - 4.5'.

A video was taken of the gap between the two beds. There seemed to be no difference in the sediment between the areas with and without eelgrass. Juvenile Dungeness crabs, sole, tube snout, perch and hooded nudibranchs were observed. No algae were noted within the gap; motile algae and kelp were observed in the shallow bed, possible being washed shoreward from the ferry wake, causing a back eddy.

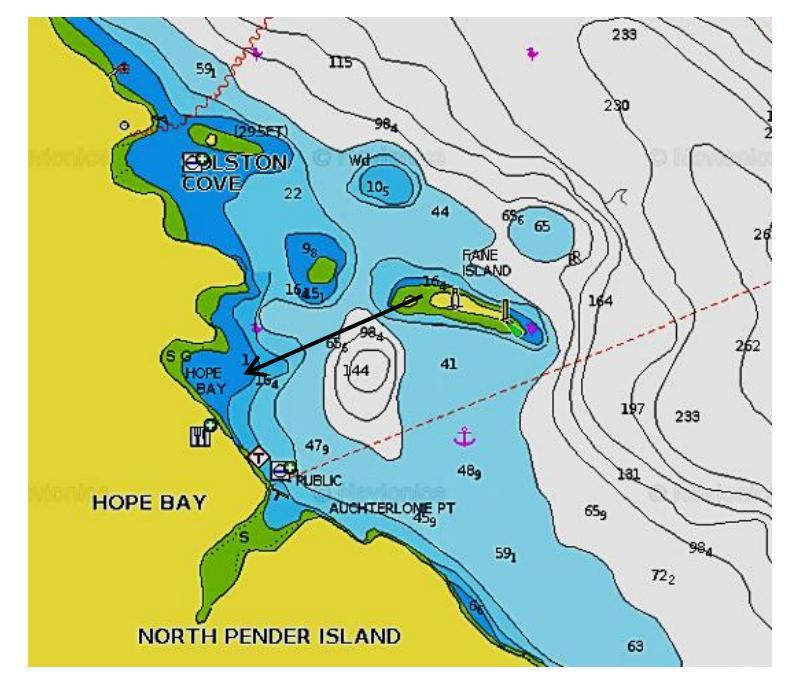
Figure 8. Hope Bay: 48°48'10"N 123°16'31"W

Eelgrass is healthy in Hope Bay. The site has a 6 km fetch with an easterly exposure. There are five residential houses in the backshore. No riparian re-vegetation is needed in front of the bay. There are no mooring buoys at the site. The dock had 6 vessels berthed at the time of the survey. The sediment is unconsolidated mix of sand and shell. A video recording was taken of the area -4 - 5', the depth at which it was observed in Hope Bay. Sand with shell with tufted algae was observed with some rocky areas. Kelp coverage could be attached on rocks or drifting. The area further up the cove is too shallow for eelgrass growth.

Farmland is on the Pt. to the east and a pub to the west, with a road along the head of the embayment. An underwater survey was taken of the three small pocket beaches NW of this site – all three contained healthy eelgrass beds observed lying down because of the strong current.

Recommendation at the time of the survey was to transplant eelgrass within the northwest portion of Hope Bay near the Government dock in an area \sim 5m x 25m (125m²).

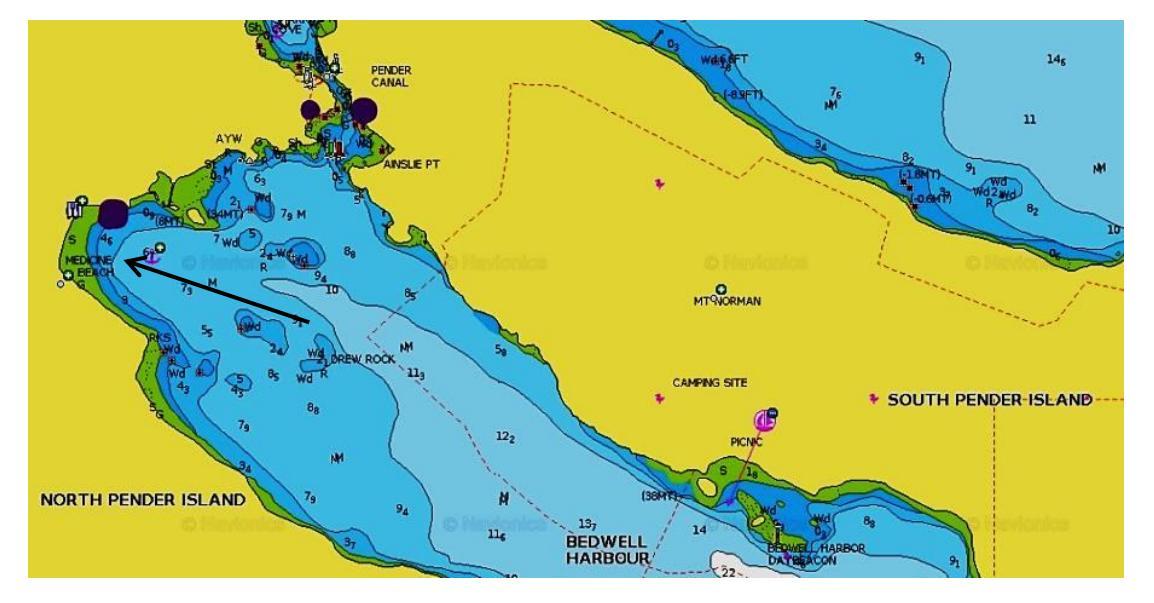
Figure 9. Medicine Beach: 48°45.632 N 123°15.967 W

Clean sandy semi-consolidated substrate with shell fragments (shell hash) in potential restoration site, diatomaceous cover observed on surface of the sandy substrate. Fetch is ~5km. Area does contain underwater woody debris showing evidence of log transfer. Possibly site was

used for temporary log storage. Shore receives wave energy from SE. An area of approximately 130m² could be planted from 3m to 3.4m depth. Restoration site will be situated in lee of bluff southwest of shore for some protection from winter storms. Underwater video taken along 26m transect (3.0m to 3.4m @ 16:00 (4 pm on March 17th) which can be viewed on SLACK site (<u>https://salishsearecovery.slack.com</u>).

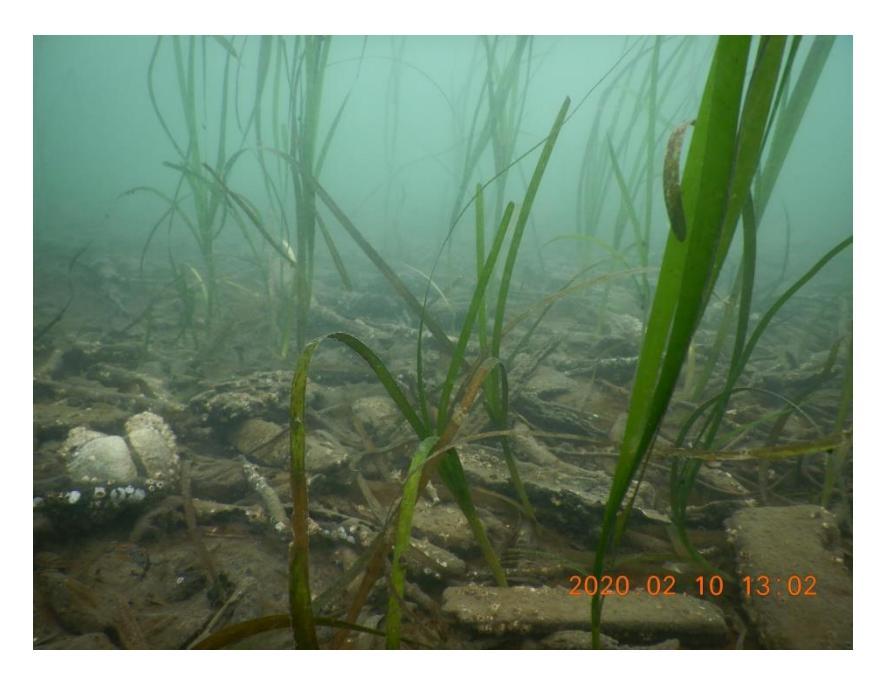
Figure 10 Substrate in Medicine Beach.

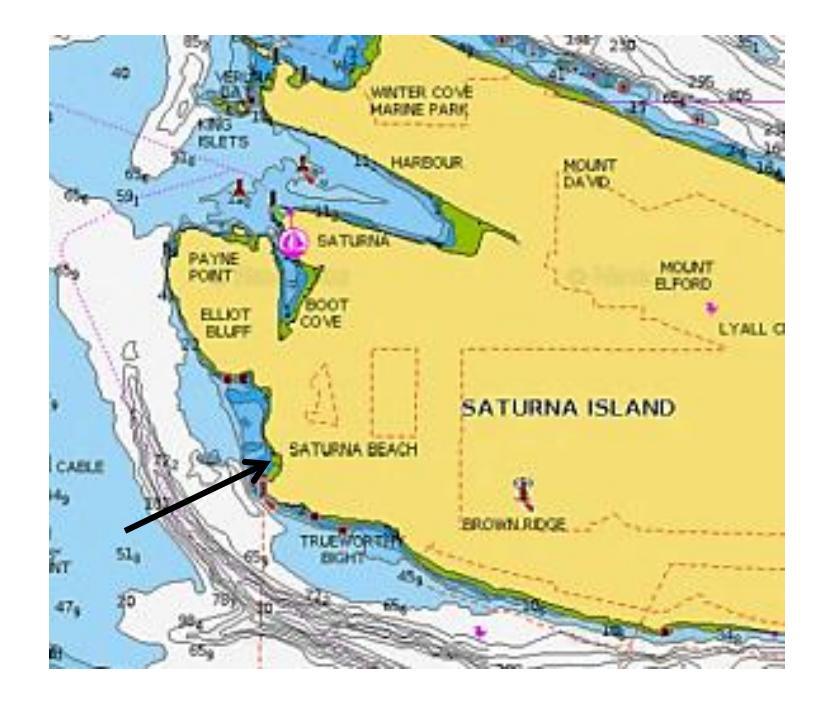
Figure 11. Saturna Beach site: 49° 46'36"N 123°12'05"W

This bay has a 5 km fetch, a westerly exposure and consolidated sand/mud sediment. Depth range for eelgrass is ~0 to -.5'. Flat continuous eelgrass was surveyed for Islands Trust in 2014. The backshore is a mix of cleared and forested areas with a Community Park recreational area facing the beach. There is a private dock on the north end of the shore with a rip rap retaining wall, and a seemingly derelict dock in the centre of the shore. Three mooring buoys are located near the beach, one in eelgrass habitat. One mooring block with a chain attached was located north of the derelict dock and should be removed. In addition, there was a rope from shore to a

mooring block in the eelgrass bed in front of the dilapidated dock. Two wheelbarrows of concrete south of this dock were submerged and also should be removed.

This is a very quiescent site. Seals and seal pups were in the water at the time of the survey. An abundance of juvenile Dungeness crab was present. There is also an abundance of brown kelps and green algae. Depth of eelgrass, a mix of patchy and continuous habitat, grows between ~-3.7' to -4.7' (chart datum). One clear area with clean sediment was observed north of the dilapidated dock (48°46.634'N 123°12.069'W).

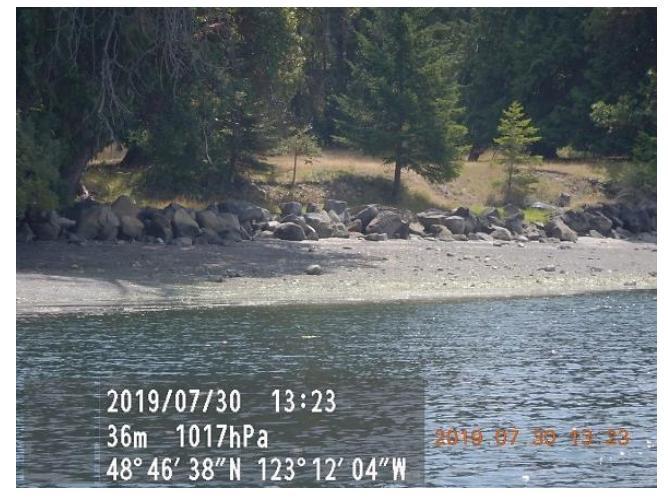
Figure 12. GPS coordinates for Saturna Beach.

SCUBA divers measured an area approximately 6m x 25m at a depth of -5- -7' suitable for an eelgrass transplant which could continue the existing eelgrass towards the SE.

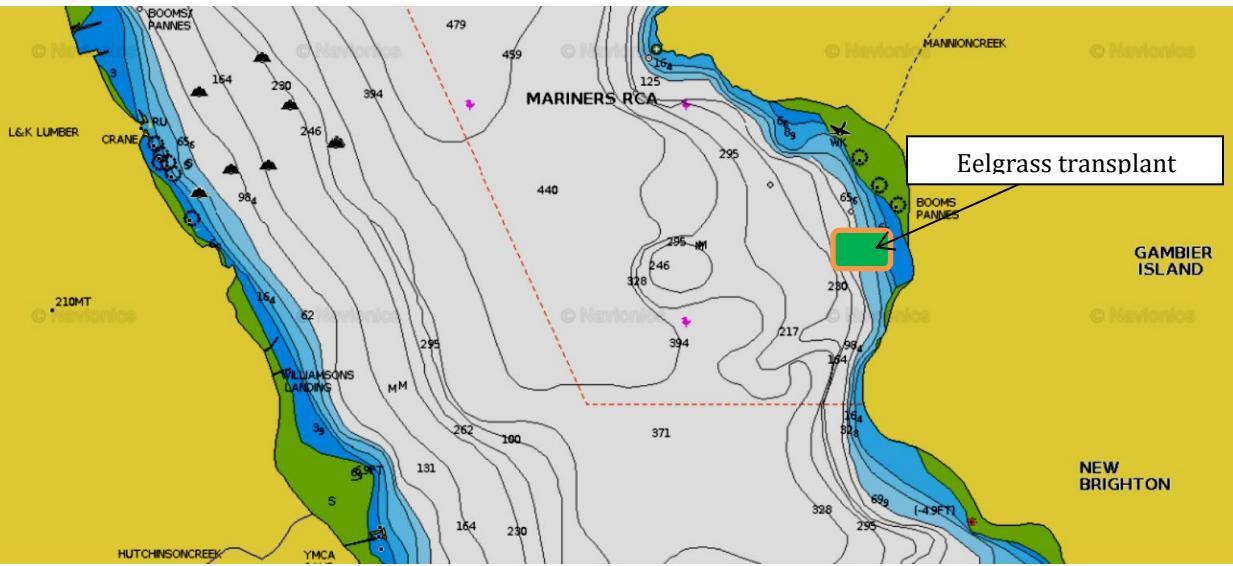
Figure 13. Cotton Bay: 49°46.098 N 123°44.899 W

A salt marsh is located just upland from the mouth of Mannion Creek, where there is a large population of intertidal mussels. No boat moorages or recreational boats anchored in the bay. Fetch is 8.9 km with a south-southwesterly aspect. There is construction on land taking place and a barge transfer site on shore. Some construction of housing is completed on the south end of the barge transfer site. Marine riparian vegetation removal noted.

Eelgrass range is 0 to -9.65' (chart datum). Eelgrass was mapped in 2012 for the Islands Trust. Most of the habitat was characterized as fringing and patchy on the south end of the bay as was observed during this survey. Between the pilings o the south end of the bay there is a large area (7m x 95m) that could be restored. The sediment in this site is clean and consolidated. Juvenile pile perch, juvenile crabs were buried in the sandy sediment, and many cockle and other shellfish siphons were noted. The depth for the restoration is ~-2.7' (chart datum). Coordinates for the transplant site are 49°46.080 N 123°44.845 to 49°46.028 N 123°44.751. There is little evidence on the shore of high wave energy (intact salt marsh with few drift logs on the shore). One underwater and two aerial videos were taken at the site. Potential eelgrass restoration of ~665m².

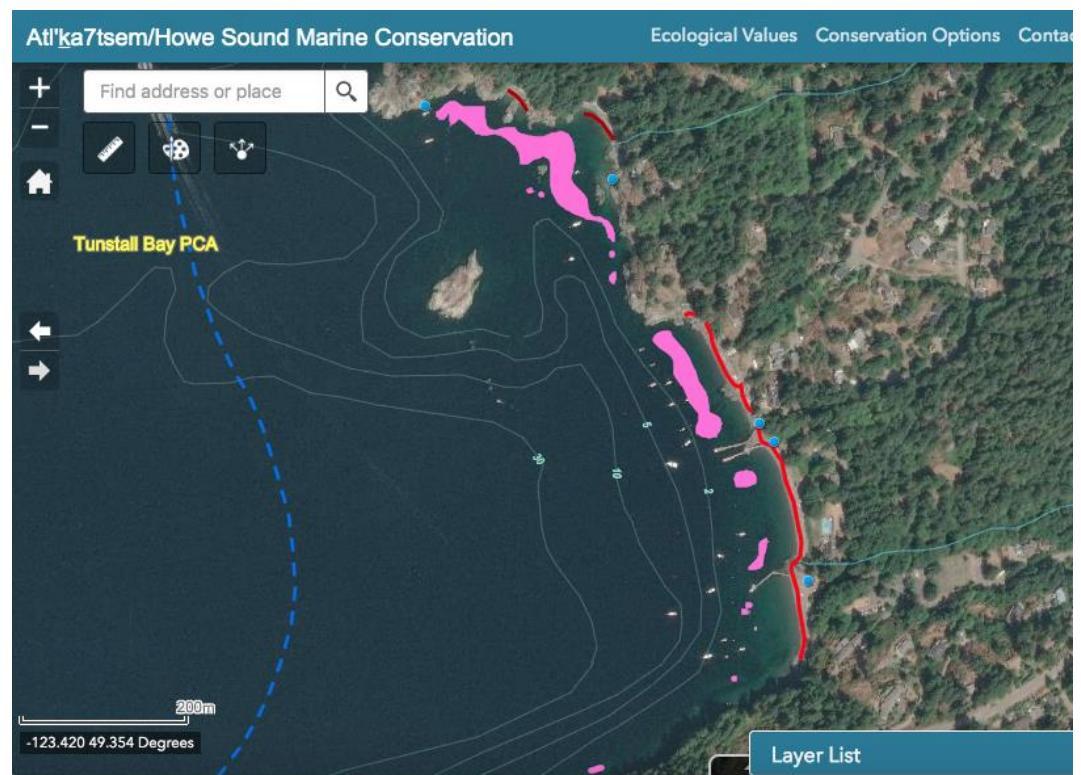
Figure 14. Tunstall Bay: (N 9°21.167' W123°25.38'

Legend: Pink lines = eelgrass distribution, Red and orange lines = forage fish potential spawning beach, blue dot = recreational docks, orange dots = recreational mooring/anchorages, dark blue lines = salmon bearing streams (based on DFO dataset, but sometimes incomplete)

Continuous eelgrass habitat was mapped in 2013 for the Islands Trust. There were eelgrass beds on the N and S end of the shore, less in the centre. (Video film was taken of the eelgrass beds during this field visit). Moorings may be inhibiting eelgrass growth on the S end. There was an increase of drift kelp closer to shore due to change from unconsolidated sand to rock. Visibility was low. Small eelgrass patches are growing on the north side of the wharf at -3' depth. The plants appear tall and thin bladed. In the centre of the bay there are eelgrass patches between two moored boats (N 49° 21.199 W 123° 25.209'). There could be a 10' x 10' area that could support eelgrass. Donor plants could be harvested from the N end or from Pasley Island.

Overall the habitat is less continuous than in 2013. It would be advisable for the two moored

boats in potential eelgrass habitat to be moved to a deeper area. Tunstall Bay Community Association is receptive to altering mooring buoy designs, and community members are keen to contribute to restoration.

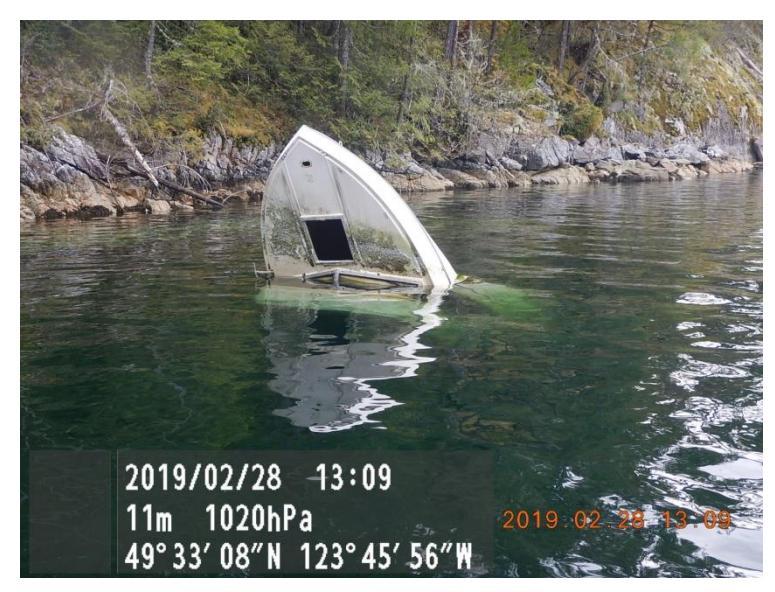
Figure 17. Half sunken runabout will be removed in 2020 to allow space for eelgrass recovery

Debris site mapping was carried out using a side scan sonar within the southwestern portion of Porpoise Bay, at the southern tip of Sechelt Inlet, during August 27th to 31st, 2018, and the southeastern side of Porpoise Bay was mapped for the locations of sunken derelict boats from February 28 to March 2nd, 2019 for later removal by barge and crane.

Debris removal continued in January 2020 over seven days. A total of 2.01 metric tonnes was removed. Please see Regional Coordinator's Report about the

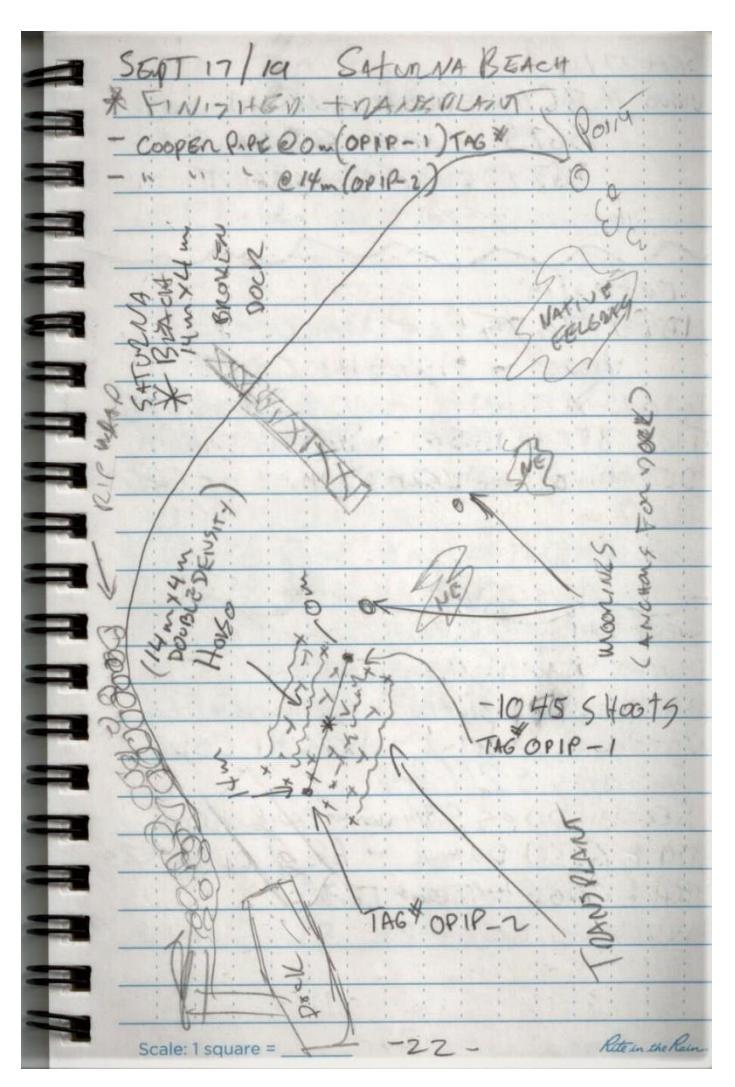
Saturna Beach transplant design drawing. Area transplanted: 14m x 4m. HOBO data logger installed. Monitoring began 6 months after the transplant.

Figure 19. Design drawing of Saturna Beach transplant.

On September 17, 2019, 1045 eelgrass shoots were transplanted by 17 members of the Saturna Ecological Education Centre (SEEC). A HOBO unit was installed. Follow up meetings with the students is planned to report on the success or failure of this transplant and to discuss the monitoring methods and results. Future work with the school is also planned, as it can provide experience and exposure to field biology and ecology that could lead to future career development.

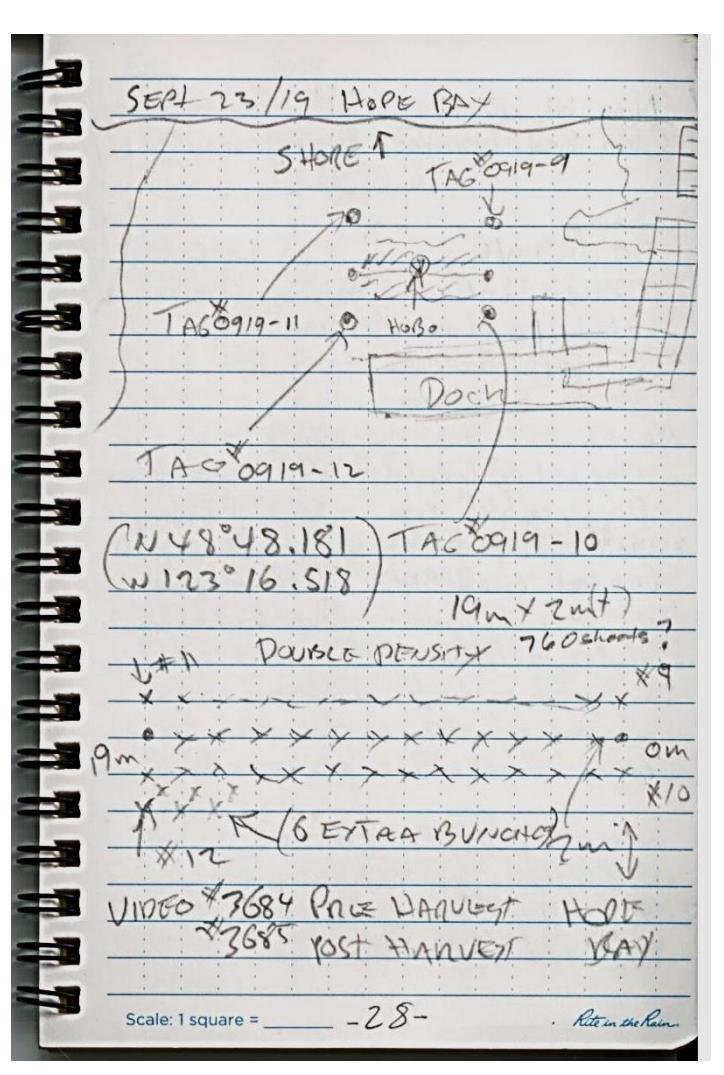
A double density design was used in a 19mx 2m area. Monitoring commenced 6 months after the transplant date. A HOBO unit was installed.

Figure 23. Design drawing for Hope Bay transplant.

On September 21, 2019,860 shoots were transplanted by the same number of volunteers (33) on Pender Island.

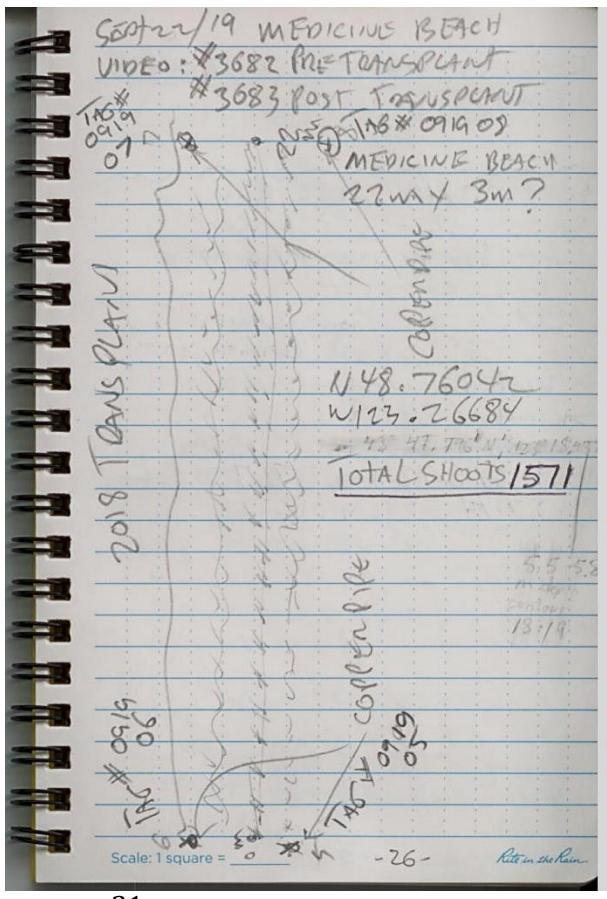
Medicine Beach design for a 22m x 3m transplant area to fill in an area previously planted (1411 shoots in March, 2017). Monitoring continued 6 months after the transplant.

Figure 25. Design drawing of Medicine Beach transplant.

Thirty three community volunteers helped to transplant a total of 1571 eelgrass shoots in a previously transplanted site in front of Medicine Beach.

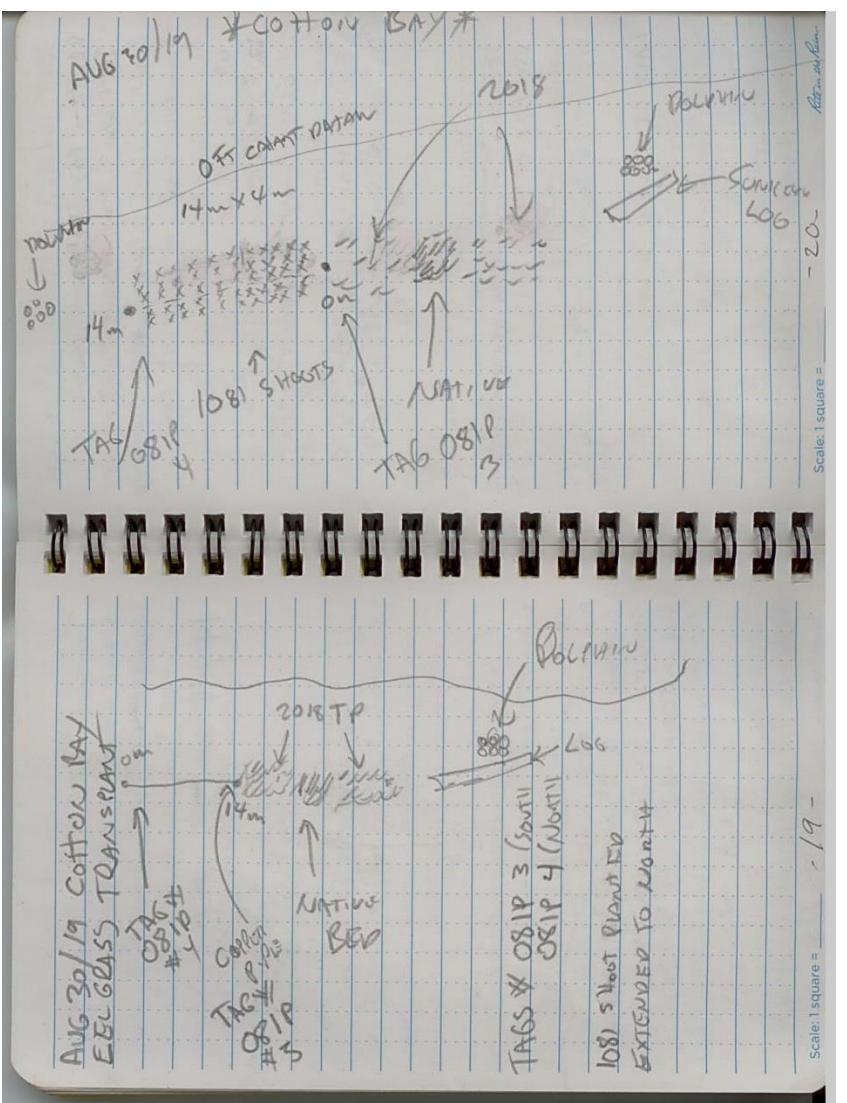
Eelgrass transplant area is 14m x 4m. Monitoring continued 6 months following this installation. HOBO data was downloaded.

Figure 26. Design drawing of Cotton Bay transplant.

A total of 1086 shoots added to an already existing transplant (600 shoots planted in April 2019) on August 29, 2019 by 25 community volunteers.

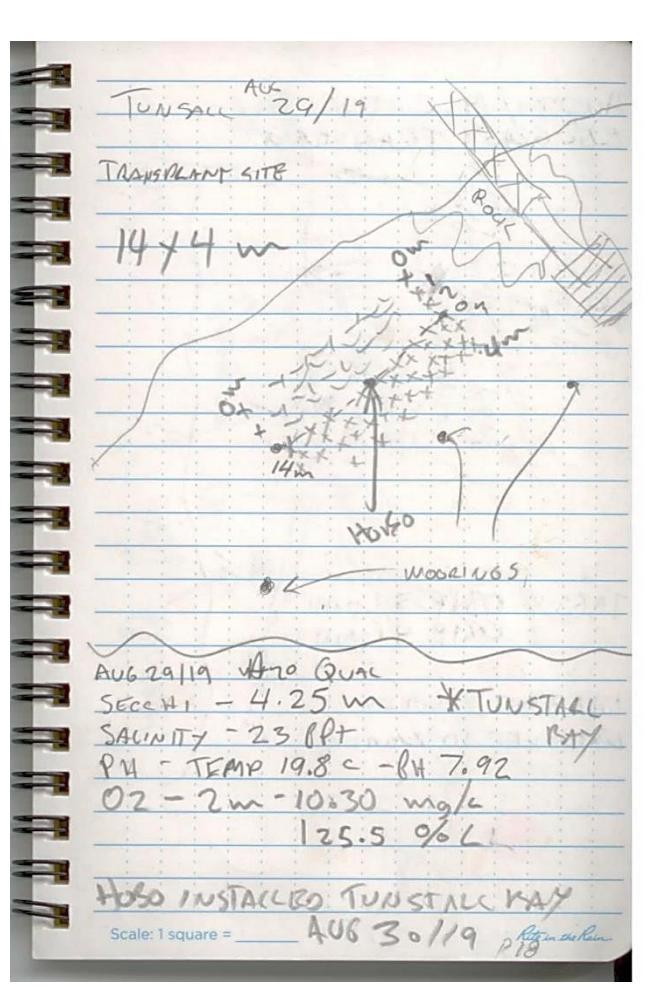
Transplant area is 14m x 4 m. HOBO was installed at the time of the transplant. Monitoring occurred 6 months after installation.

Figure 28. Design drawing of Tunstall Bay transplant.

Community volunteers assisted the transplant of 1081 shoots in Tunstall Bay.
