A Nearshore Marine Habitat Assessment Report of Boat Anchoring Sites within Four Gulf Islands Marine Provincial Parks

Submitted March, 2022 to Ministry of Environment and Climate Change Strategy SeaChange Marine Conservation Society nikki@seachangelife.org

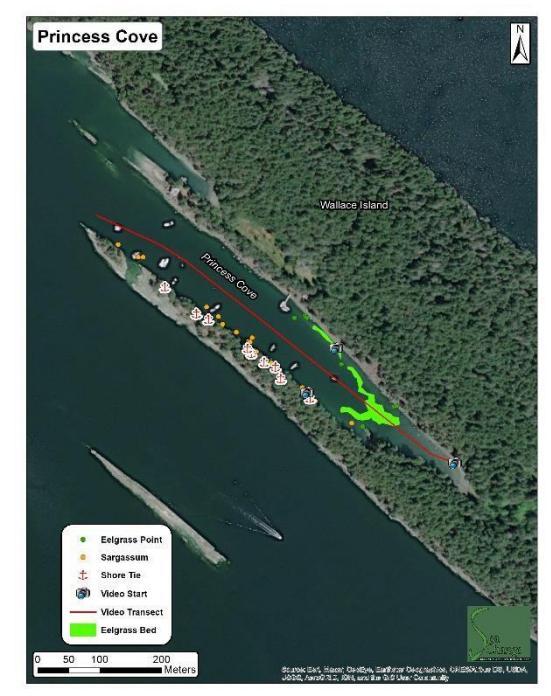
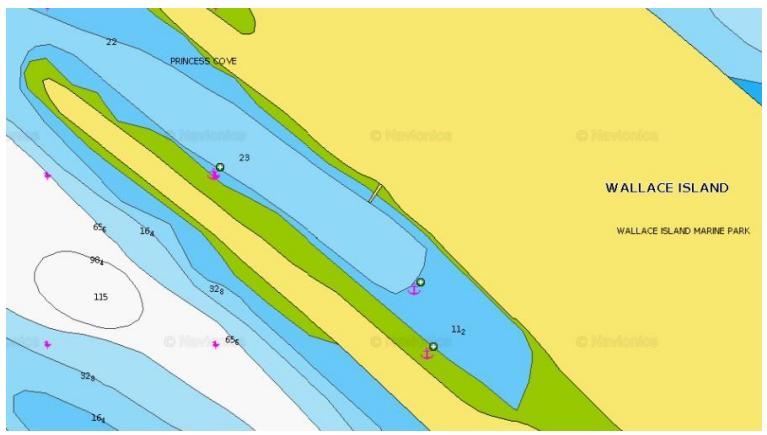
Princess Cove (Wallace Island)

The western side of the Cove is used for stern tying. No eelgrass was observed in this area. *Sargassum* is present on boulders and rocks primarily along this side of the Cove (indicated by the white dots on the Google map).

A small fringing continuous eelgrass meadow is present on the eastern side of the Cove with a narrow depth range of - 4.07m to - 4.7m. A short distance south of this bed is another larger meadow that is continuous and patchy. Depth range is – .8m to –

7.8 m. Some eelgrass blades are over 90cm in height, most likely the ecotype *Z. marina latifolia*.

The beds appear to be healthy. Placement of stern ties into this area is not recommended in order to prevent shading of the current meadow.

- 1. The Cove could benefit from a Voluntary Eelgrass Protection Zone with marked buoys to protect existing eelgrass habitat.
- 2. Install mid-line mooring systems for boats using stern ties.
- 3. Install eelgrass signage at public access points designating location of eelgrass habitats in the Cove and asking for cooperation with debris removal.
- 4. Conduct underwater debris removal.

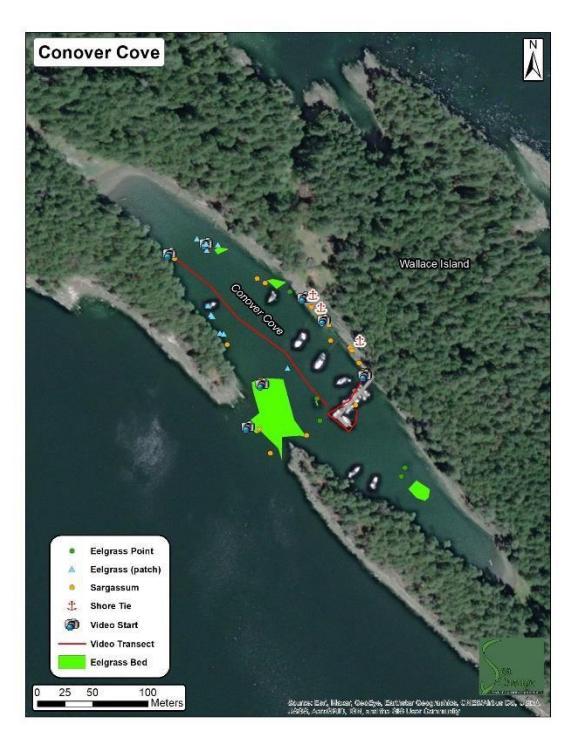
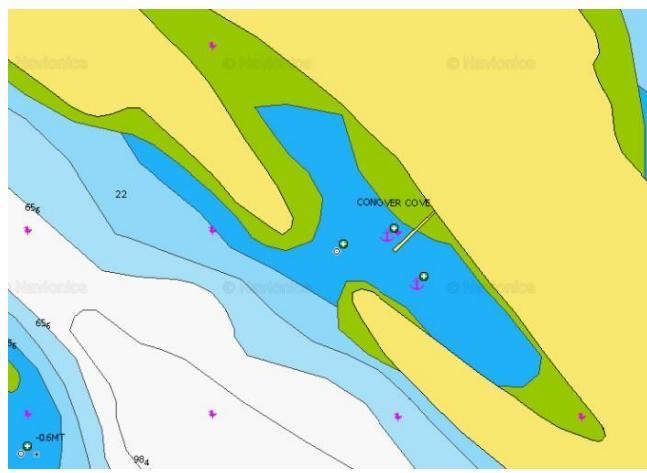
Conover Cove (Wallace Island)

Sediment in the Cove is primarily sandy. Oyster beds are present along the rocky shore. Eelgrass distribution (*Z. marina phillipsi*) to the north and south of the entrance to the Cove is continuous, flat and more dense and extensive than the patchy areas of eelgrass within the Cove.

This site could benefit from debris removal. Bottles, rope, metal pipes, cans and tires were observed near the dock. There is a sunken dinghy in the northeastern area of the Cove at - 6.5m, depth suitable for eelgrass growth.

site, eelgrass was present throughout the Cove, especially in front of the shore ties. It is highly likely that shading by boats and anchoring in depths suitable for eelgrass growth are disturbing seagrass productivity in this bay. Depth gradients (- 4.2m was the lowest point in the centre of the bay) and sediment characteristics are suitable for more productive eelgrass habitats if boat anchoring and moorage are controlled.

- 1. Remove debris from areas surrounding the dock.
- 2. Install signage on the dock re eelgrass presence and its importance with words of encouragement to dispose of garbage appropriately.
- 3. Install mid-line moorage systems for boats using stern ties.

- 4. Re-locate stern ties where conditions for eelgrass growth are not suitable (i.e. depth is beyond 4m).
- 5. Transplant eelgrass using donor plants from healthy beds within the Cove once the number of boats is controlled.

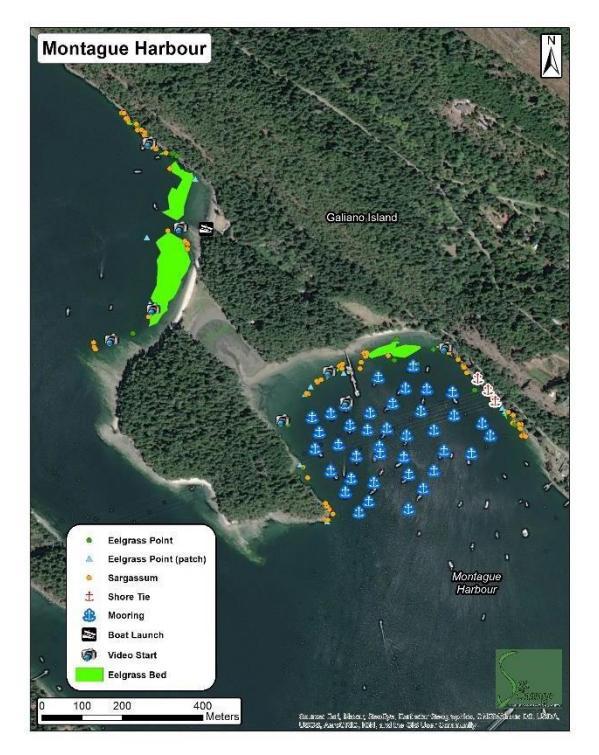
South Bay. Montague Harbour

Thirty-nine mooring buoys and three shore ties were observed in this bay at the time of the survey. There are two flat areas of very patchy eelgrass (Z.marina philippsi) growing in sandy/shell hash sediment in front of the sandy shore, with tufted red algae distributed through the site. The larger bed lies east of the dock and measures approximately 330m² at a depth range of – 3.5m to – 4.6m. A smaller area of patchy eelgrass, approximately 150m² lies west of the dock at a depth between - 0.9m to -2.1m. The eelgrass shoots appear healthy, though very scarce. The conditions for eelgrass productivity are present on the western side of the dock but presently not suitable for eelgrass restoration, as boat anchoring is predominant in this area.

Two very small patches are growing on the eastern shore of the bay on the north and south side of the 3 stern tie locations. This side of the

- 1. Replace the moorings in the shallow areas of the bay with mid-line moorage systems.
- Install multi-boat mooring system in the harbour to accommodate the capacity of the bay to sustain itself and restrict number of boats anchoring out with a Voluntary Eelgrass Protection Zone surrounding the eelgrass habitat in front of the beach.
- 3. Replace ad hoc shore ties with formalized shore ties.
- 4. Install eelgrass signage on the dock, requesting no anchoring in water less than -7m and designating locations of eelgrass beds.

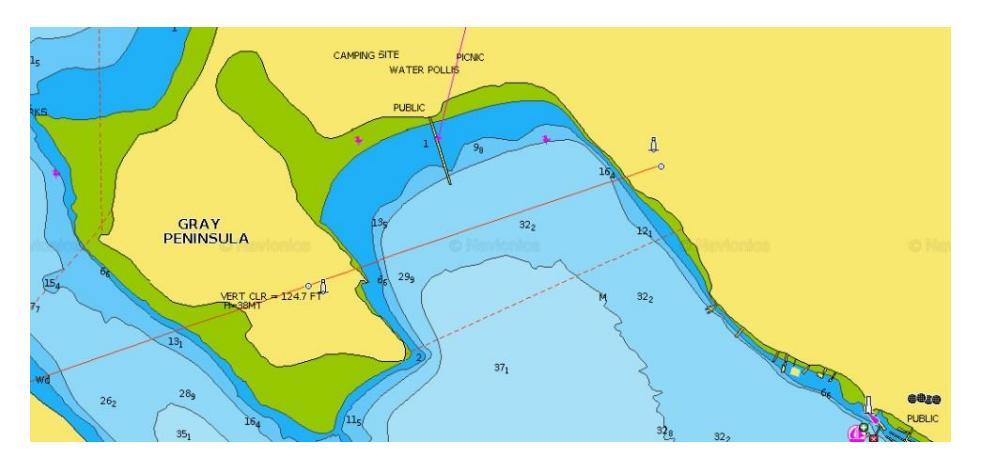
harbour appears to be suitable for stern tying as the seabed drops off suddenly (see Navionics chart below).

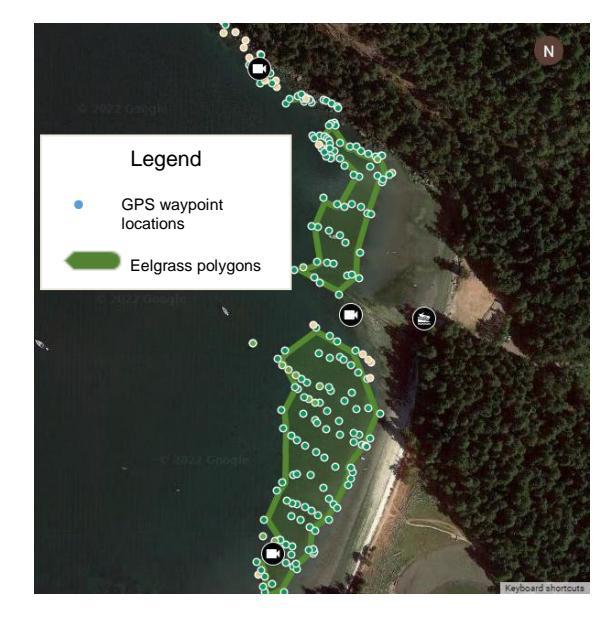
North Bay, Montague Harbour

Dense eelgrass in flat continuous beds is present slightly south of this patchy habitat, forming two distinct polygons. The first polygon ranges from -0.6m to -3.4m and is approximately 290m². A dense population of *Sargassum* was found on the northern

end of the larger second bed. Depth range for eelgrass growing in this more southern part of the bay is -0.3m to -3.5m; the bed is approximately $550m^2$.

- 1. Install informational buoys from the boat launch to the middle of the bay to guide boat traffic in order to avoid damage to existing eelgrass beds at low tide.
- 2. Install eelgrass signage if possible on the dock.

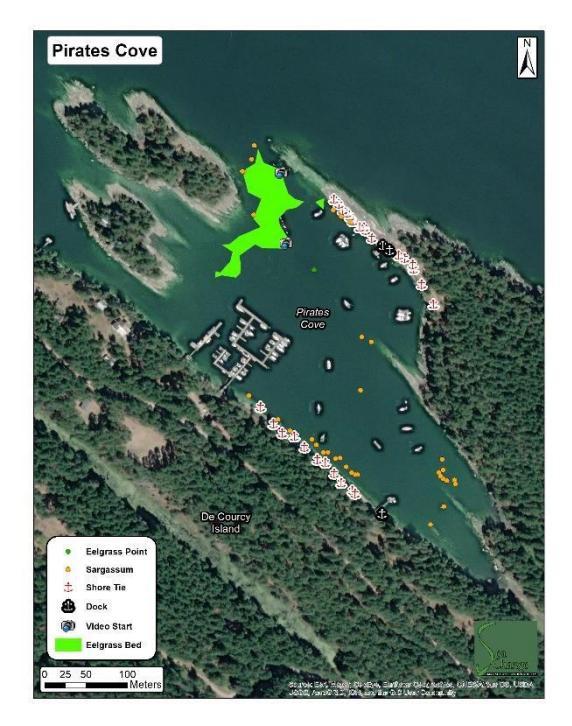
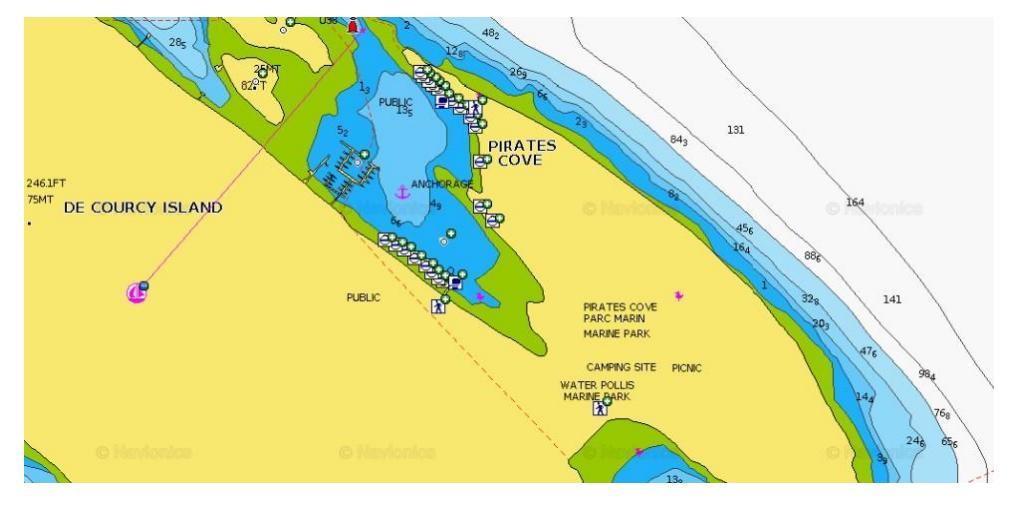
Pirates Cove, De Courcy Island

An extensive, dense, continuous and shallow eelgrass bed, approximately $8,670m^2$ in area, is located in the northwest area, just south of the entrance to the Cove. Depth range is between - 0.1m to - 0.5m.

A smaller patch of eelgrass (approximately $165m^2$) east of this bed is directly in front of the northernmost shore-tying sites, and might be impacted by dragging chains from these stern ties during low tides. Depth range for this habitat is -0.5m to -0.7m.

Both beds have shorter shoots and are most likely *Z. marina phillipisi* ecotype because of the shallower depth in which they are situated. There might be predation by Canada geese, as they were observed during the survey and at low tide periods these birds would have access to

the shoots. As well, due to the shallow depths of this area, boat traffic might be causing damage to the eelgrass, especially during low tides.

- 1. Install a Voluntary Eelgrass Protection Zone to protect the existing shallow eelgrass habitat on the northwestern side of the Cove.
- 2. Install eelgrass signage at the two dinghy docks with maps designating existing eelgrass habitats.
- 3. Install marker buoys to guide boat traffic to and from entrance to Cove to avoid damaging eelgrass during low tides.

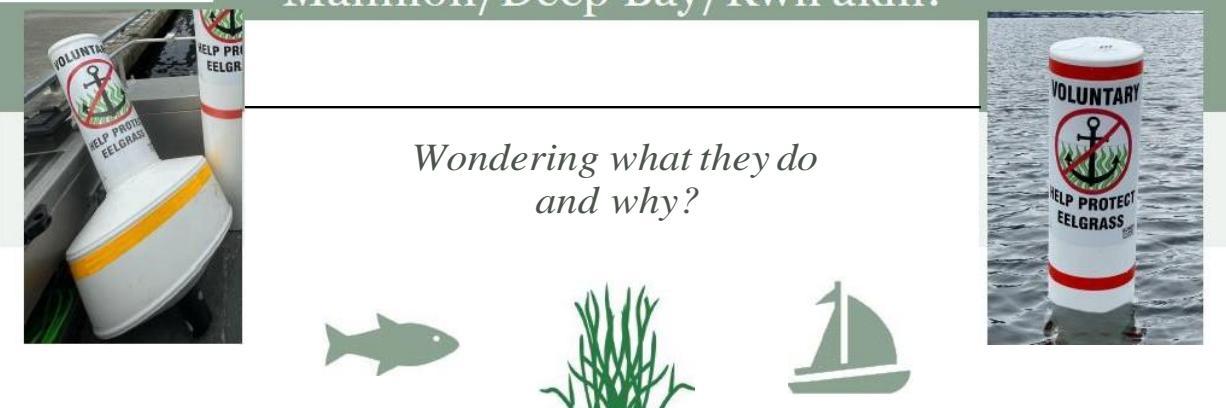
These buoys outline a **Voluntary No-Anchor Zone** to protect eelgrass health in the Salish Sea

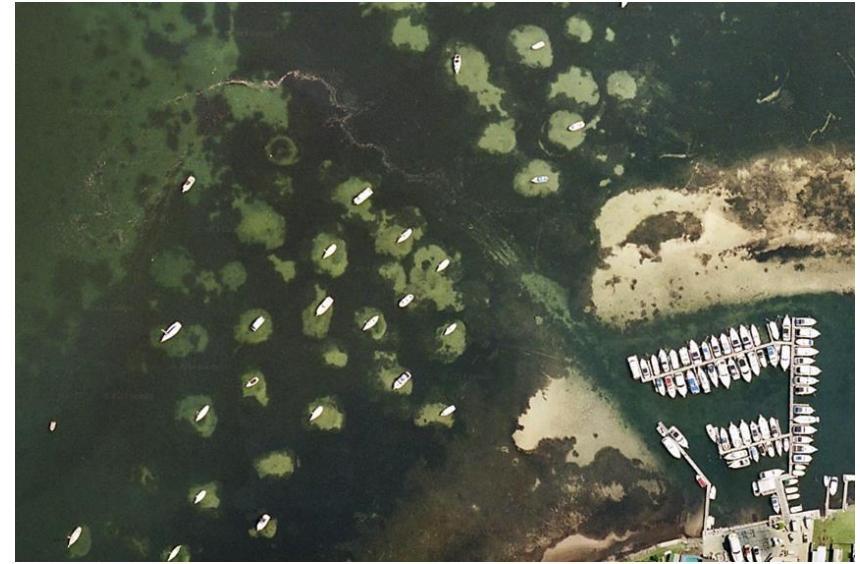
One of the major impacts of traditional mooring systems with chains attached to cement blocks or large re-purposed steel as anchors is the seabed being scoured by chain dragging on the bottom as the boat above moves around from tidal and wave action. The scouring causes gaps in an otherwise contiguous seagrass bed.

Scouring of eelgrass habitats by boat chains

Mooring damage to eelgrass beds can be prevented through the use of mooring systems by a buoy float that holds buoyant rope rather than chain. Replacing existing moorings that are permanently moored in eelgrass habitats can provide the opportunity for eelgrass to recolonize the site, and provide greater habitat connectivity for marine life. Those boats that are temporarily anchored will be encouraged to anchor in deeper waters (-7m) with signage placed on shore.

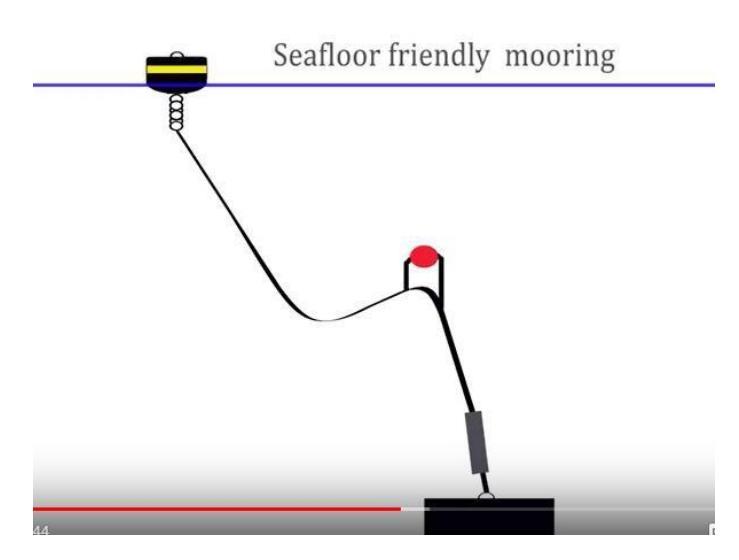
Novel boat mooring system that allows rope and chain to float above the eelgrass, eliminating scouring and degradation of this habitat.
